# Inspection report, Final: PO003459

## KS106366-NAVY BLAZER: ALL I WISH FOR - JEWELRY

### 1st inspection

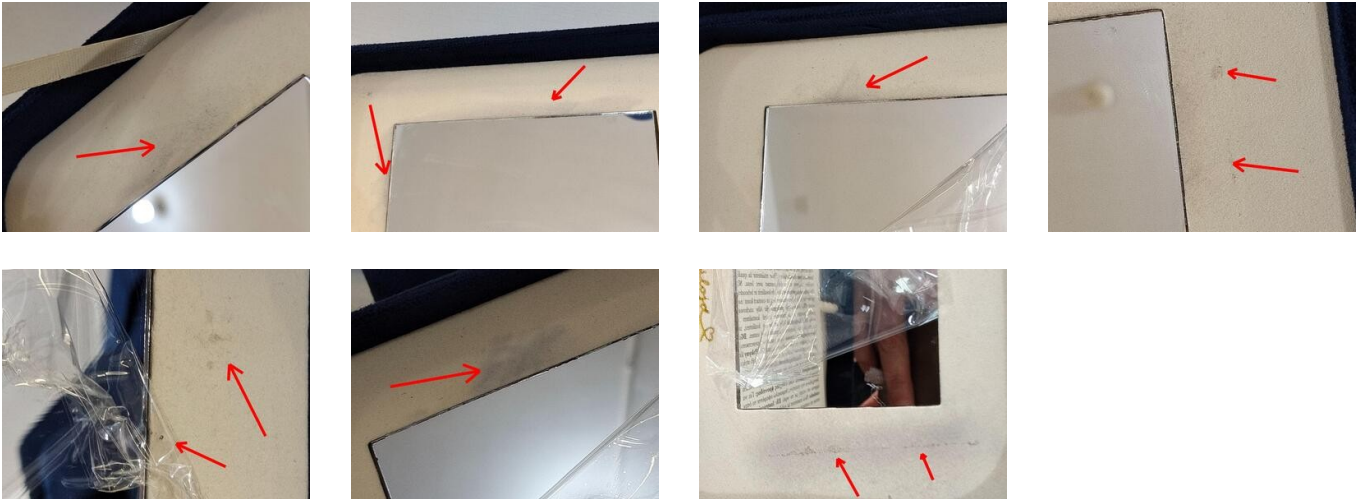
| 1 | F1 Soiling/stains. There was a lot of glue residue around the mirror inside the jewelry box.<br>(Automatic translation) | <div>MAJOR</div> <div>Items affected: 7</div> |

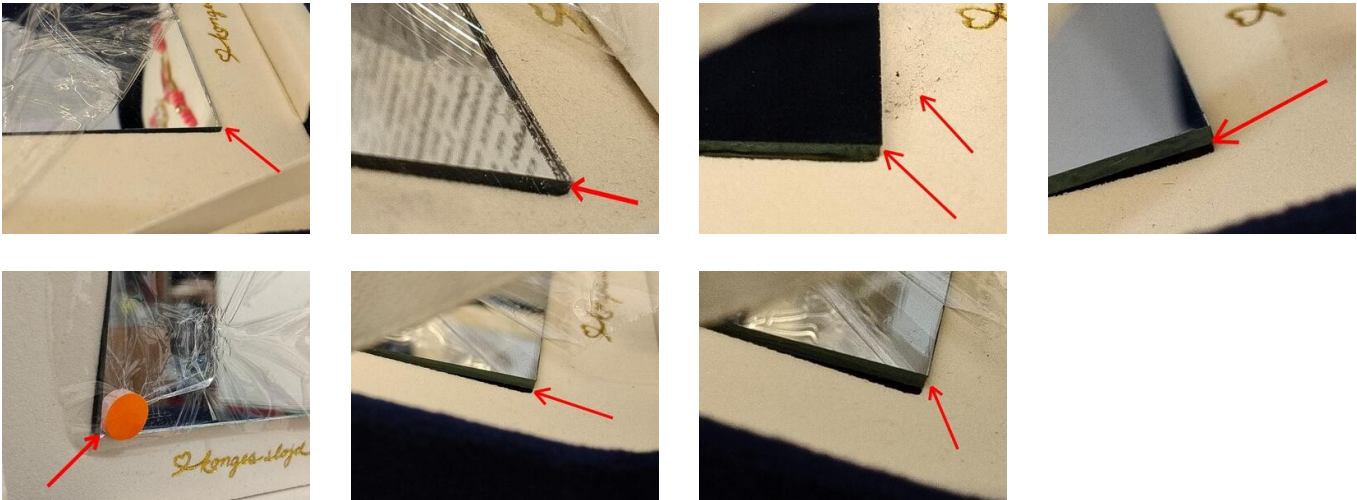
| 2 | WX Other. The sharp edges of the mirror can easily scratch your fingers.<br>(Automatic translation) | <div>MAJOR</div> <div>Items affected: 7</div> |

- 1. The protective film on the lens is not applied evenly.  
Whether the film needs a warning label must be confirmed with the customer.
- 2. The mirror's edges are protruding and sharp, easily scratching fingers. The mirror should be completely recessed.
- 3. Excessive glue penetration and glue residue around the mirror inside the jewelry box are unacceptable.
- 4. The Batch No. 062026 on the cardboard box is correct, but the Batch No. 012026 on the barcode sticker is incorrect. Please confirm with the customer.

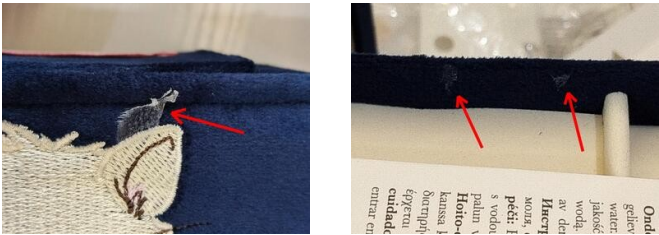
| 3 | WX Other. glue<br>(Automatic translation) | <div>MAJOR</div> <div>Items affected: 2</div> |
