# Inspection report, Final: PO003459

## KS102883-GOLD: UNICORN JEWELRY SET

| Inspector | QC-JOJO Chen | Inspection Date | Jun 04, 2026 |

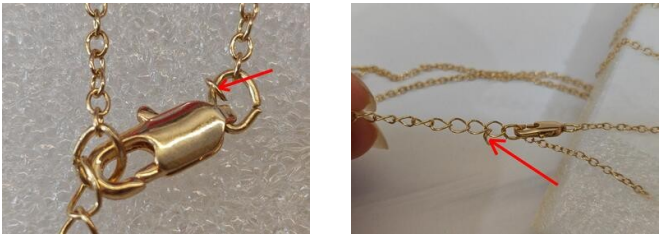
| 2 | WX Other. redundant circles<br>(Automatic translation) | MINOR<br>Items affected: 2 |

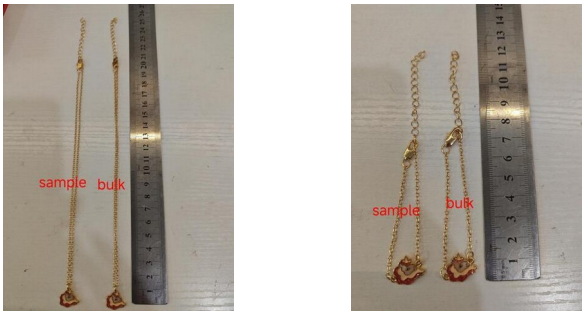
| 3.6 | Measurement | OK |

| The bulk order and the confirmed sample are the same length.<br>(Automatic translation) | | |
