# 135 Fiddlers Hill Road

Puhoi 0994 - Auckland

## OVERALL STATUS **NEEDS CHECKING**

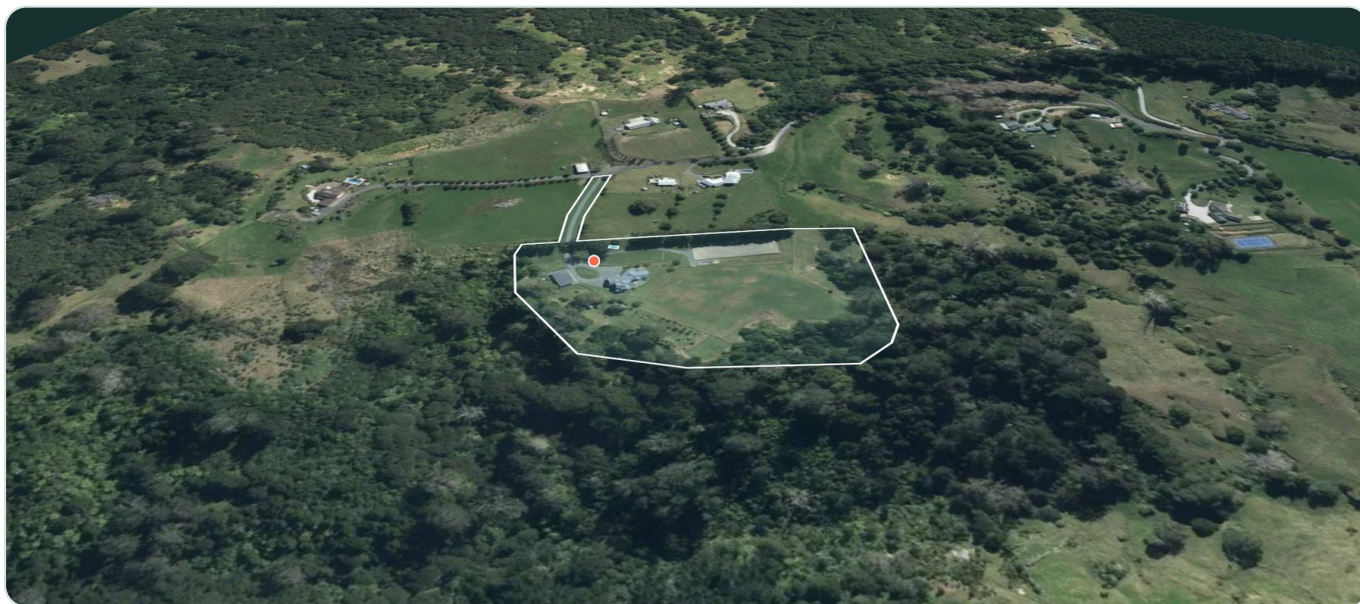
Oblique LINZ aerial draped over terrain. White = parcel; blue = illustrative pool; red = matched address point.

The address and parcel match successfully. The 3.57 hectare title contains broad open areas, and the system can geometrically fit a large pool shell. However, that fit is plan-view only. The real aerial shows a rural hillside property with vegetation, formed access and existing buildings. A buildable pool location cannot be confirmed until slope, earthworks, drainage, wastewater, legal interests and vehicle access are checked onsite.

**Proceed to a site visit and levels check - not directly to quotation.**

A site visit should identify one or two genuinely level or economically terraceable zones, then the pool footprint can be repositioned without hiding conflicts.

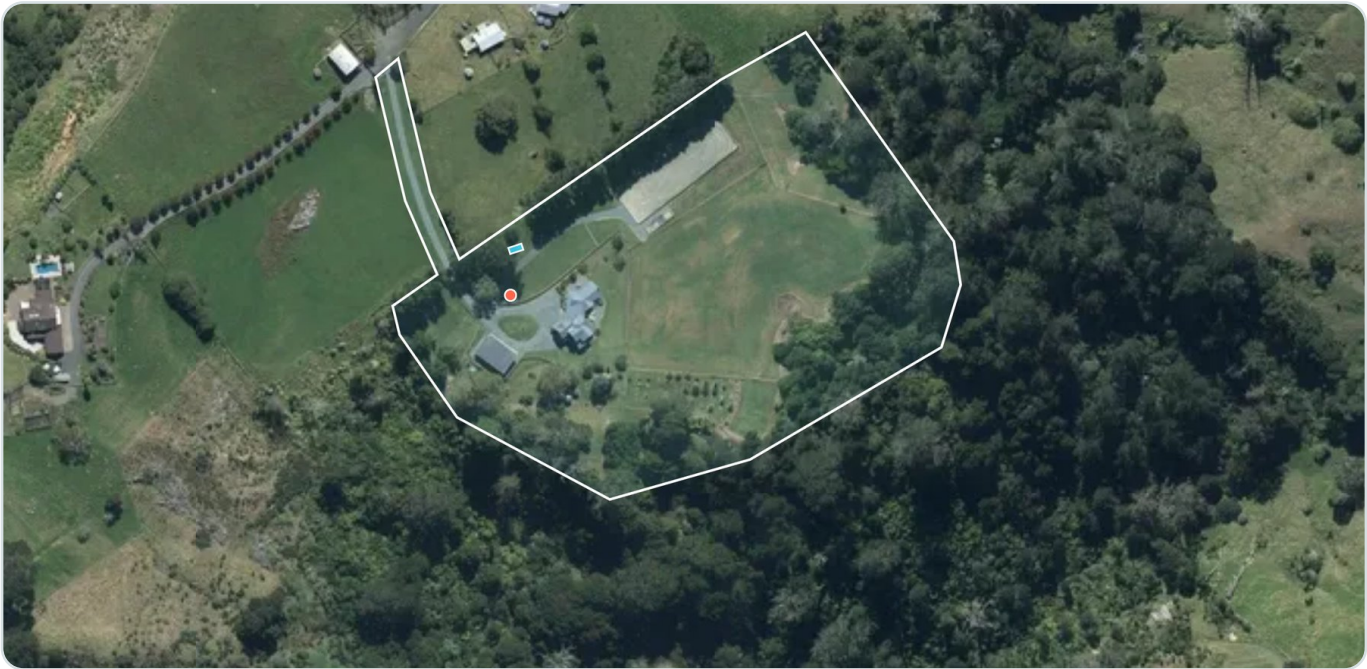
Illustrative pool footprint only - not surveyed, engineered or approved. Placement may be invalid after site checks.

| Geometric space | INDICATED | Engine returned about 35,164 m2 of plan-view candidate area and fitted a 9 x 4 m shell. This is not level or constructible area. |
| Terrain and slope | NEEDS CHECKING | No engineering-grade slope result was available. The 3D aerial shows meaningful relief around the site. |
| Flooding and drainage | NEEDS CHECKING | The saved assessment flagged an apparent overland flow-path conflict; specialist confirmation is required. |
| Construction access | NEEDS CHECKING | A formed driveway is visible, but truck, crane and excavation access were not assessed. |

Use the report as an address-screening brief. Do not treat the blue footprint as the chosen pool position.
