PHASE I
ENVIRONMENTAL SITE ASSESSMENT

CALVARY BIBLE COLLEGE
RICHARDS-GEBAUR MEMORIAL AIRPORT
KANSAS CITY, MISSOURI

PSI PROJECT NUMBER 5985E106C

OCTOBER 16, 1995

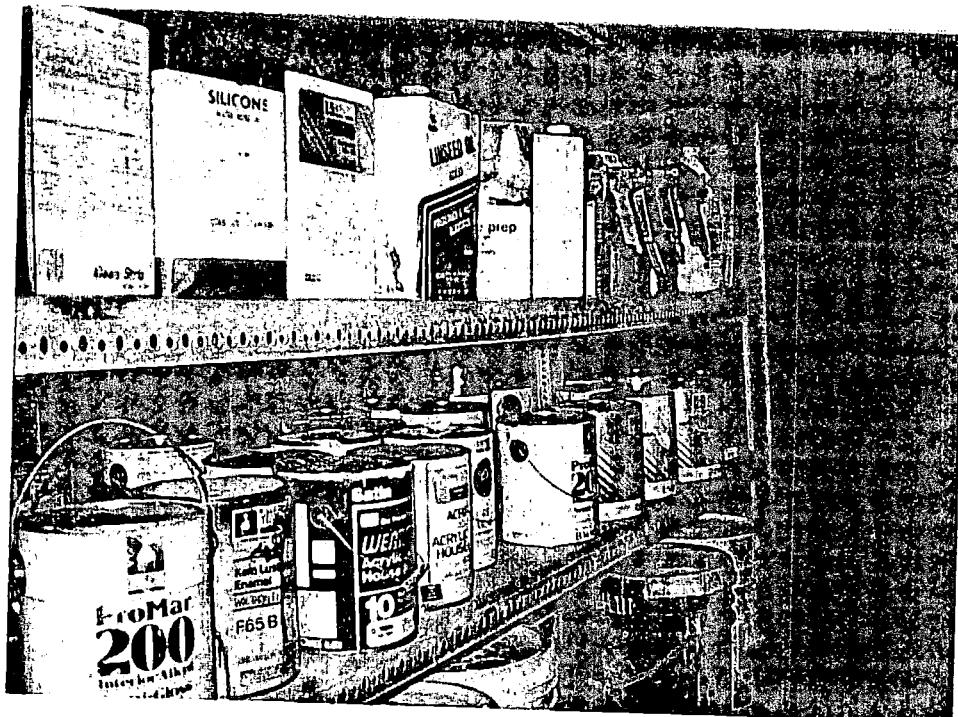
PHOTOGRAPH 36: Building 426 - Maintenance Building - Paint room.

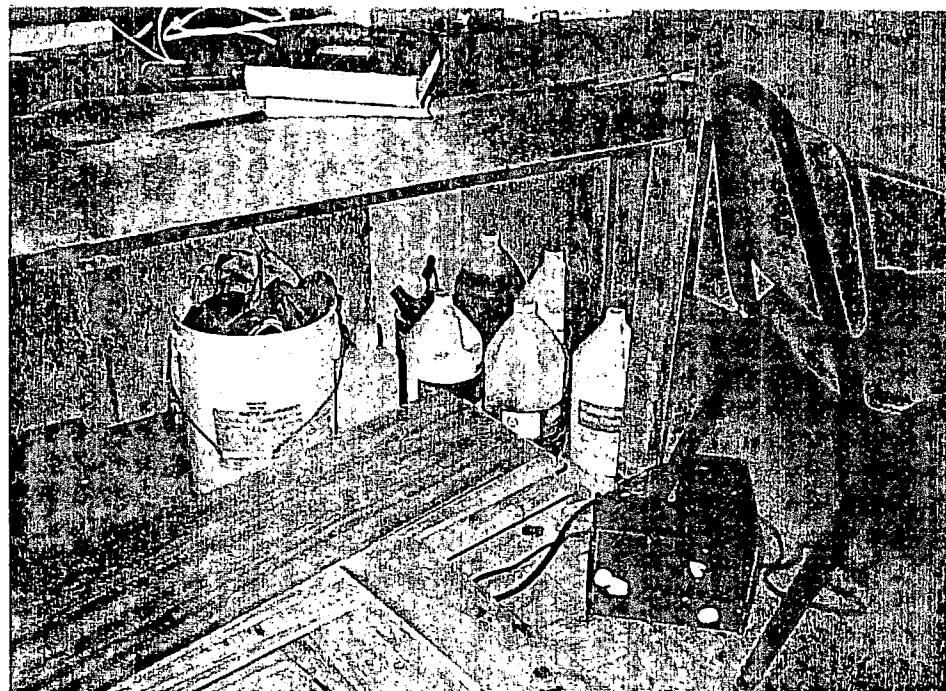
PHOTOGRAPH 38: Building 426 - Dark room.

A small *Dark Room* was located in the eastern portion of the building which contained photographic chemicals, including developer, fixer and other flammable liquids. The chemicals were stored in open areas under and on the counters and in a wooden wall cabinet. A gas can was observed under a work table along with a fire extinguisher and a canister containing used rags.

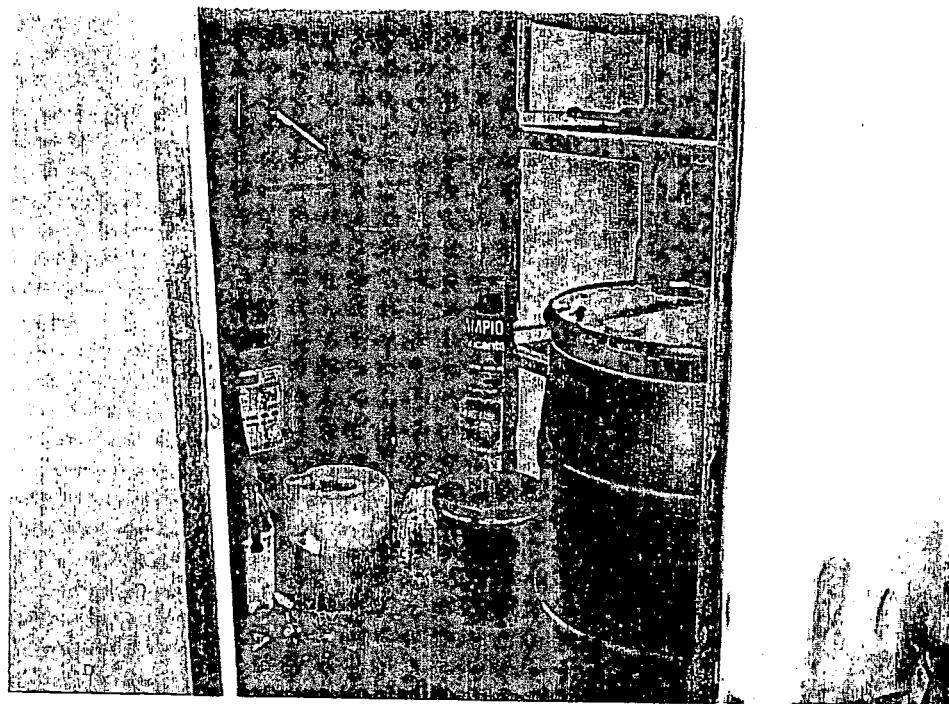
PHOTOGRAPH 47: Metal storage shed - view of drum storage.
