PHASE I
ENVIRONMENTAL SITE ASSESSMENT

CALVARY BIBLE COLLEGE
RICHARDS-GEBAUR MEMORIAL AIRPORT
KANSAS CITY, MISSOURI

CITY OF KANSAS CITY, MISSOURI
AVIATION DEPARTMENT

PSI PROJECT NUMBER 5985E106C

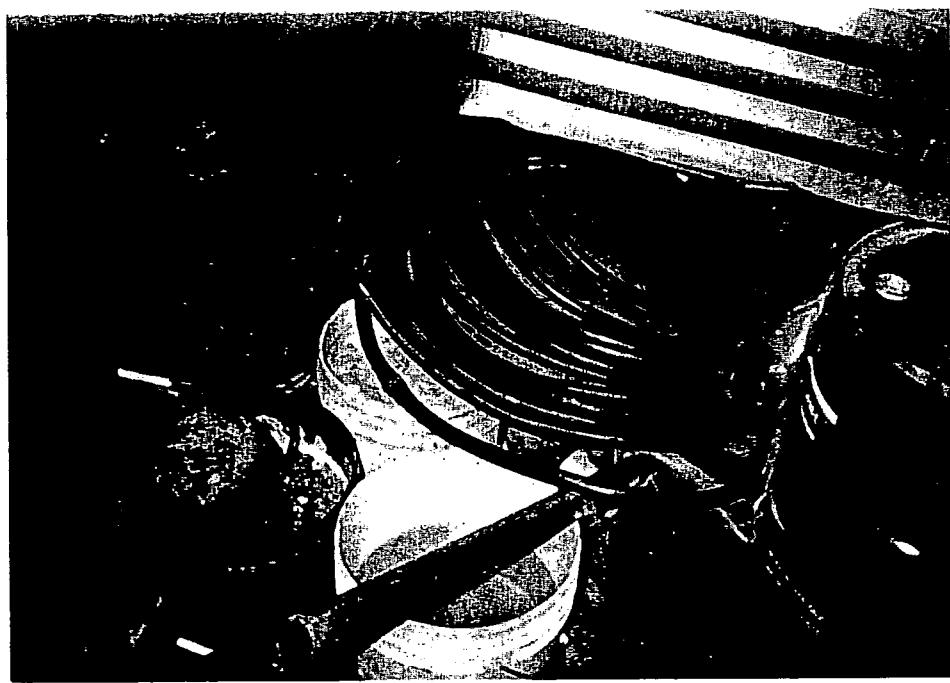
PHOTOGRAPH 13: Building 407 - Sub-basement utility room - unknown solids and liquids.

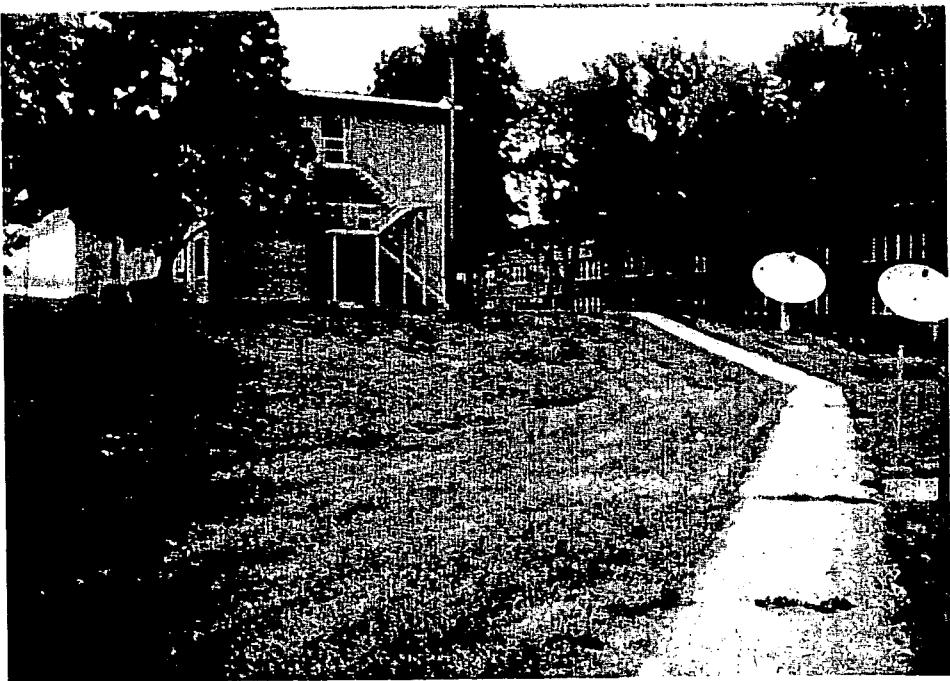
PHOTOGRAPH 14: Building 408 - Dormitory and apartments.
Building 409 - Administration.

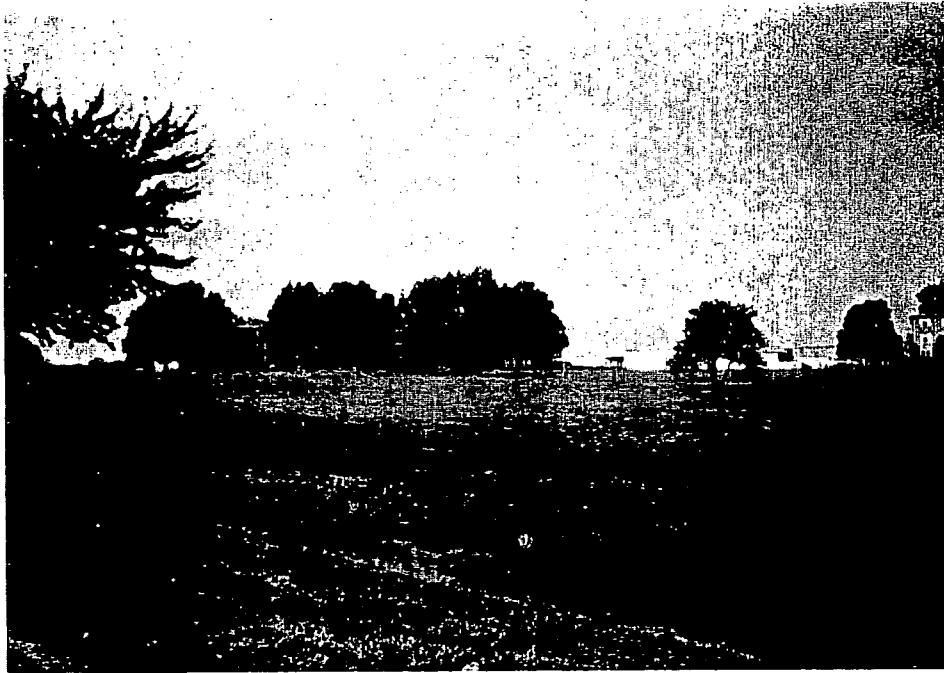
PHOTOGRAPH 15: Building 409 - Administration

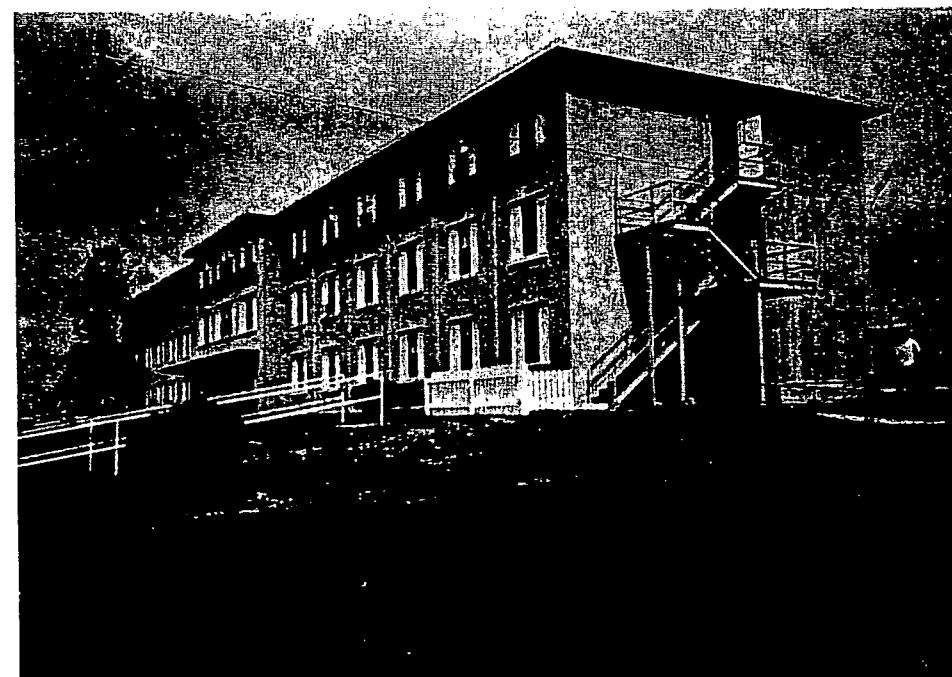
PHOTOGRAPH 16: Building 410 - Esther Dorm (Girl's dormitory).

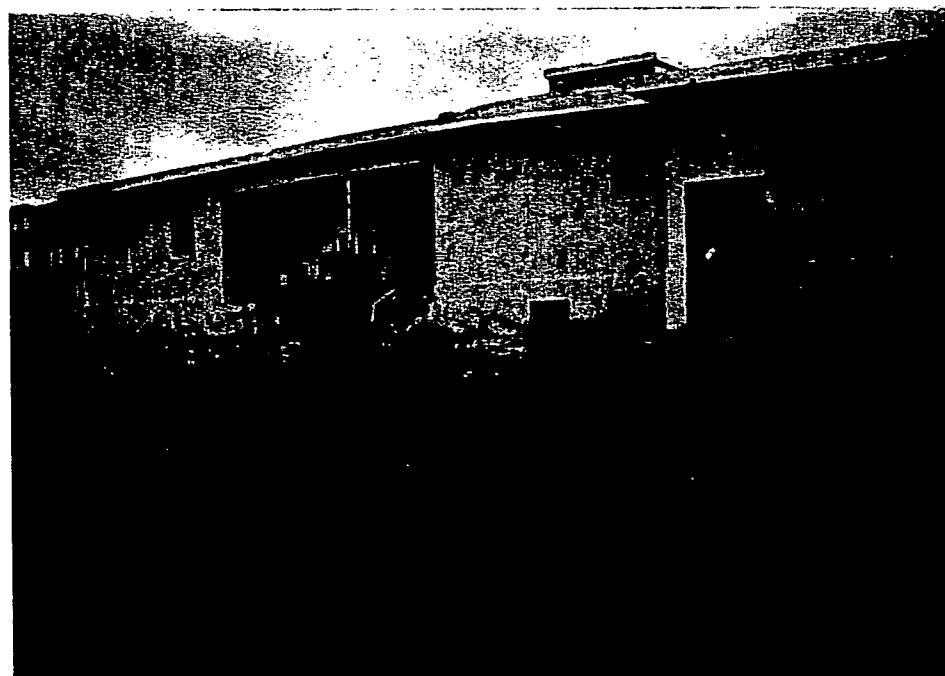
PHOTOGRAPH 18: Building 412 - Cafeteria.

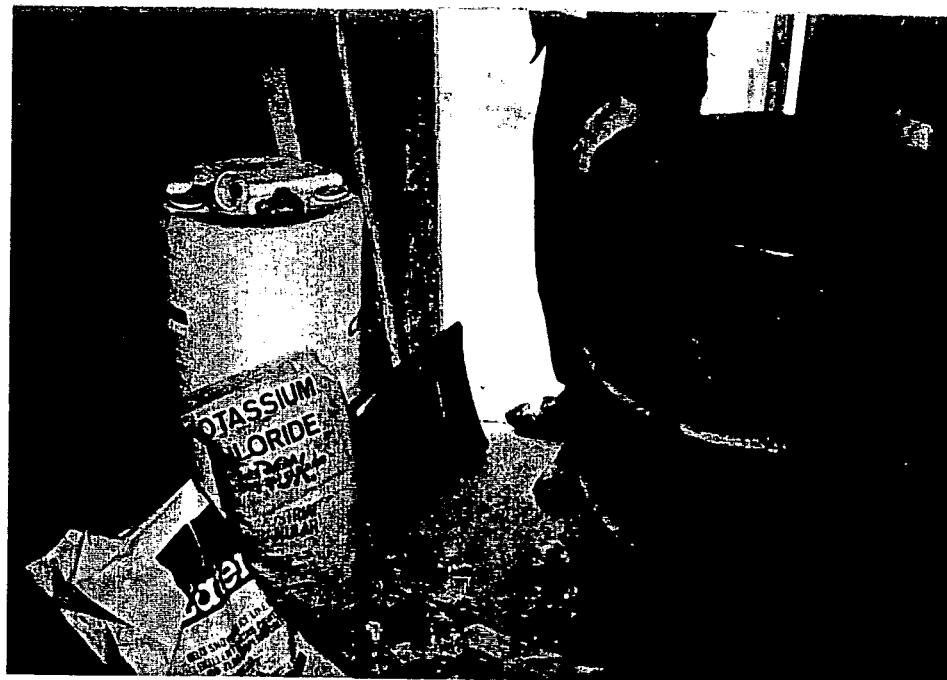
PHOTOGRAPH 19: Building 412 - Storage room.

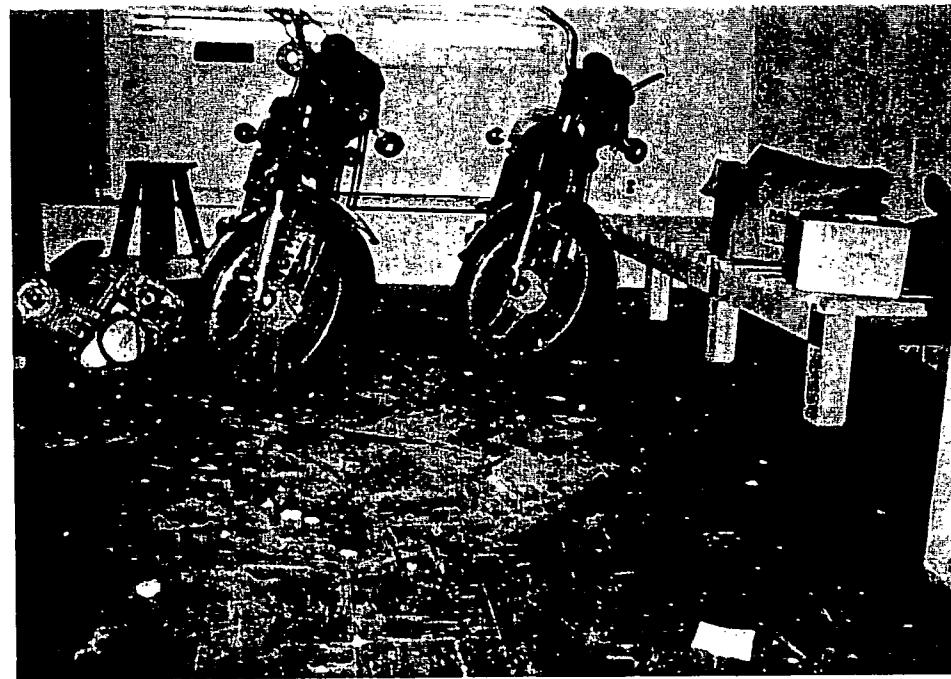
PHOTOGRAPH 26: Building 414 - Timothy Dorm, Room 121.

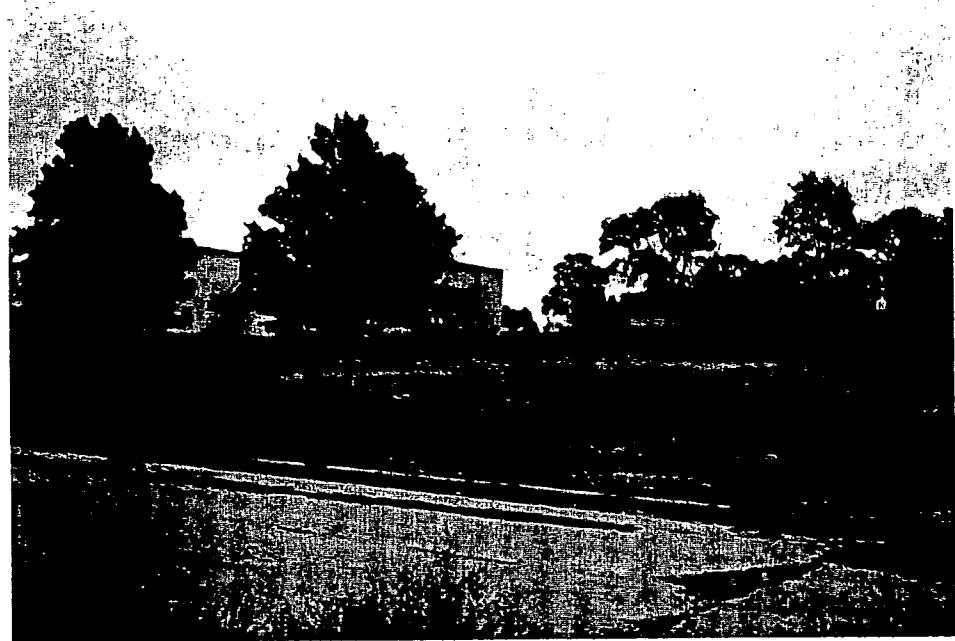
PHOTOGRAPH 27: Building 415 - Married couples duplex.

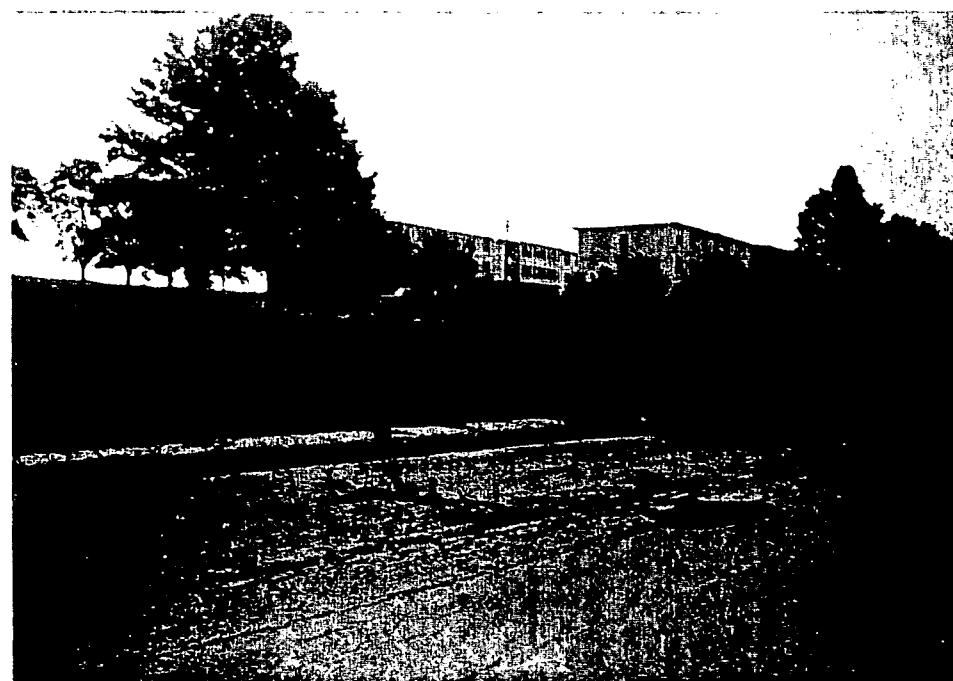
PHOTOGRAPH 28: Building 416 - Maintenance shed.
Buildings 420 & 421 - Storage and unused space.

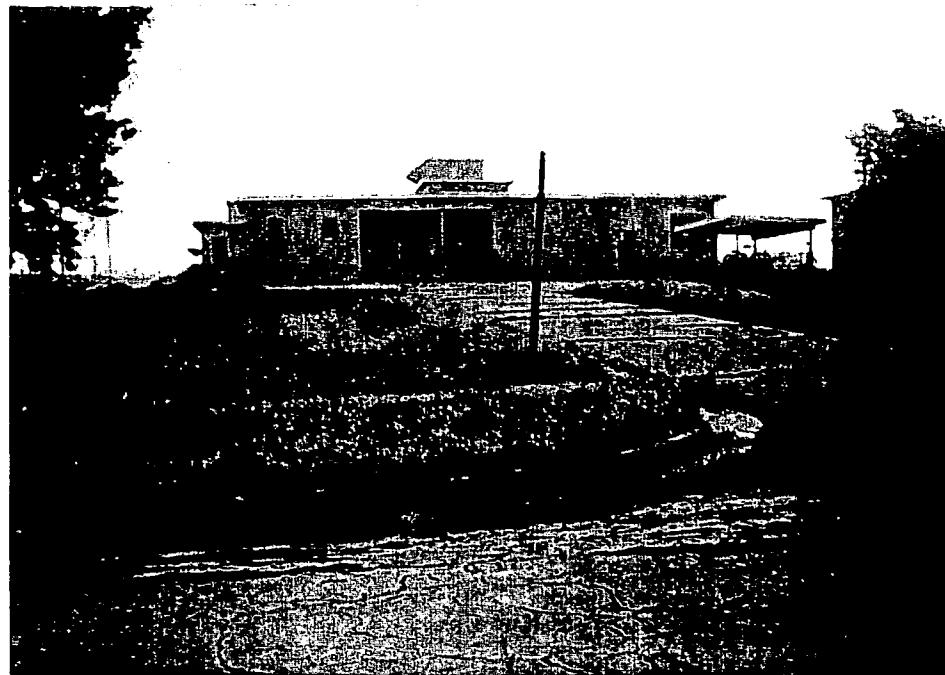
PHOTOGRAPH 30: Building 422 - Storage and unused space
(leased to Blue Ridge Christian School)

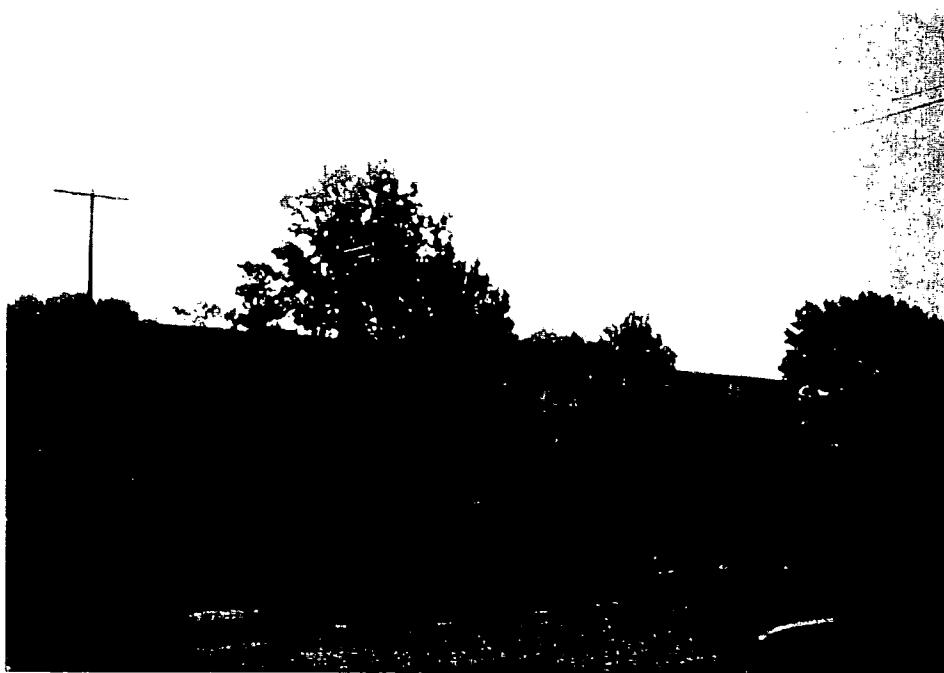
PHOTOGRAPH 31: Building 424 - Storage - leased to the Army Reserve.

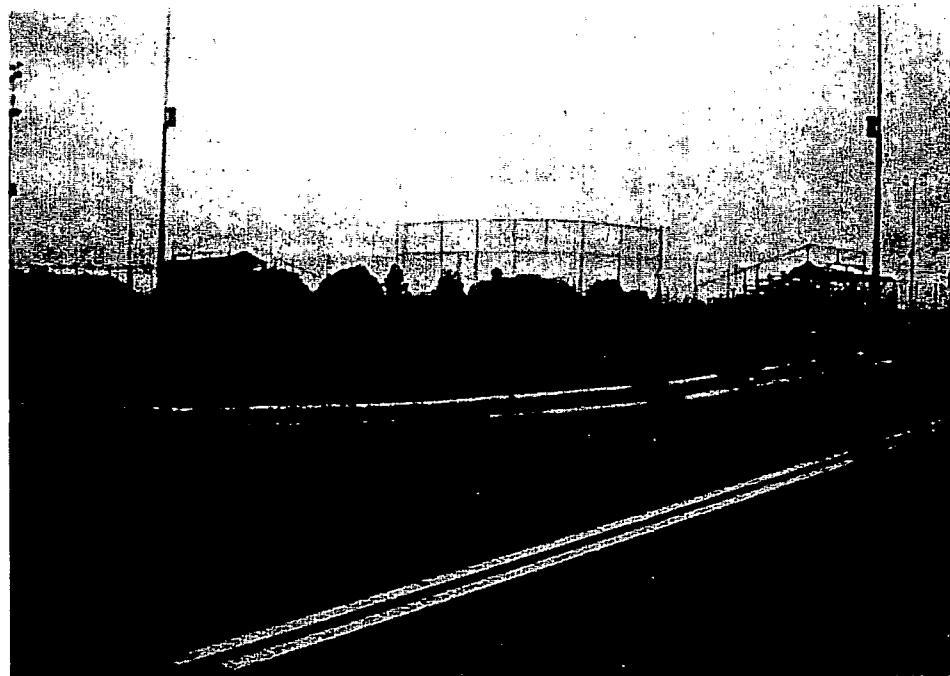
PHOTOGRAPH 33: Baseball field

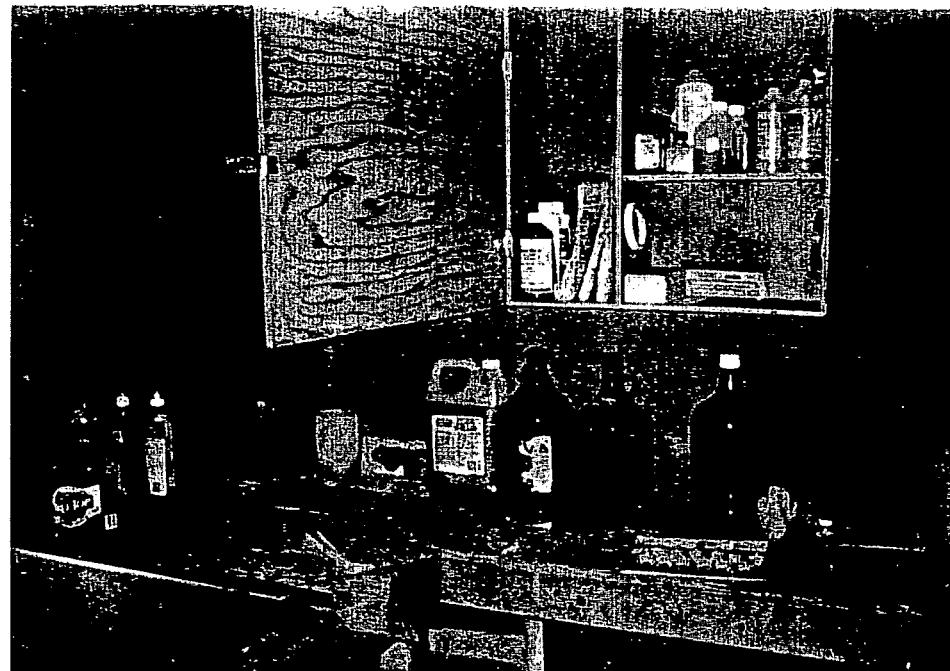
PHOTOGRAPH 37: Building 426 - Maintenance Building - Dark room.

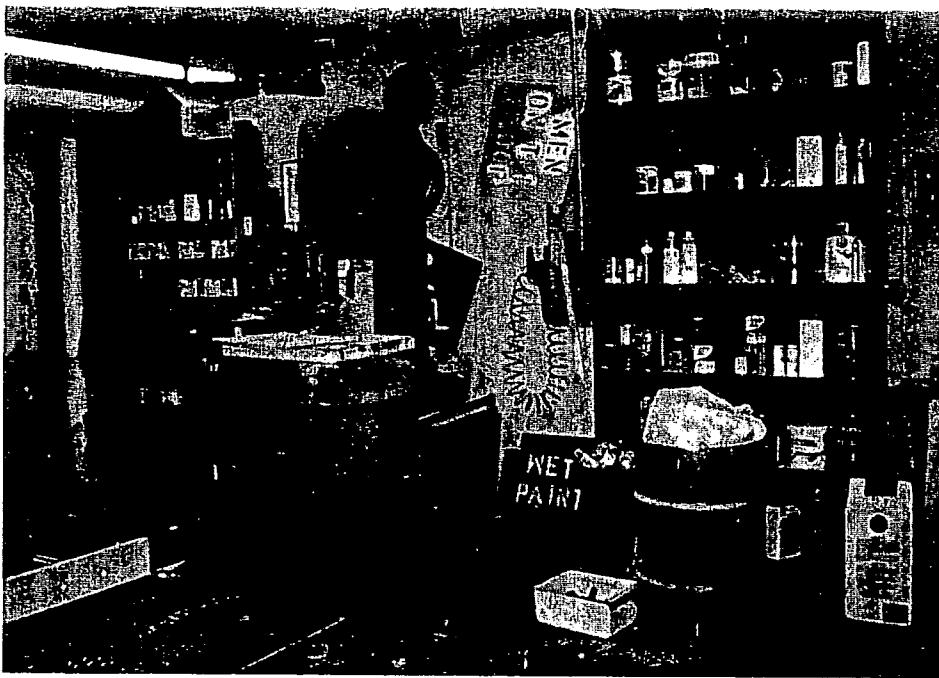
PHOTOGRAPH 39: Building 426 - Maintenance Building - Wood shop.

The Maintenance Building is located near the center of the college complex and contains several storage and shop areas. The *Wood Shop* is located on the north end of the building and contained a locked flammable storage cabinet. There were few chemicals observed in the shop with the exception of several cans of paint, stains and sealant on work benches or shelving.

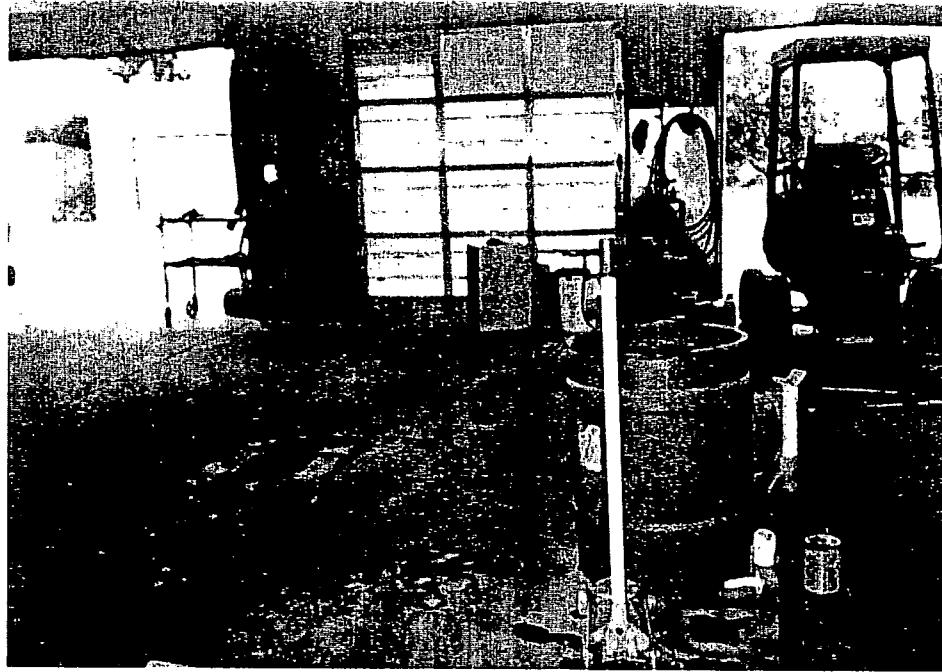
- A hydraulic lift was observed in the shop area of the Maintenance Building. A release of fluids from reservoirs associated with this lift could adversely impact the subject site. However, the extent of the impact should be limited to the area immediately surrounding the lift which is, at this time, under the building foundation.

A hydraulic lift was observed in the shop area in the Maintenance Building. A release of fluids from reservoirs associated with this lift could potentially impact the subject site.

PHOTOGRAPH 41: Building 426 - Maintenance Building - Hydraulic lift system.

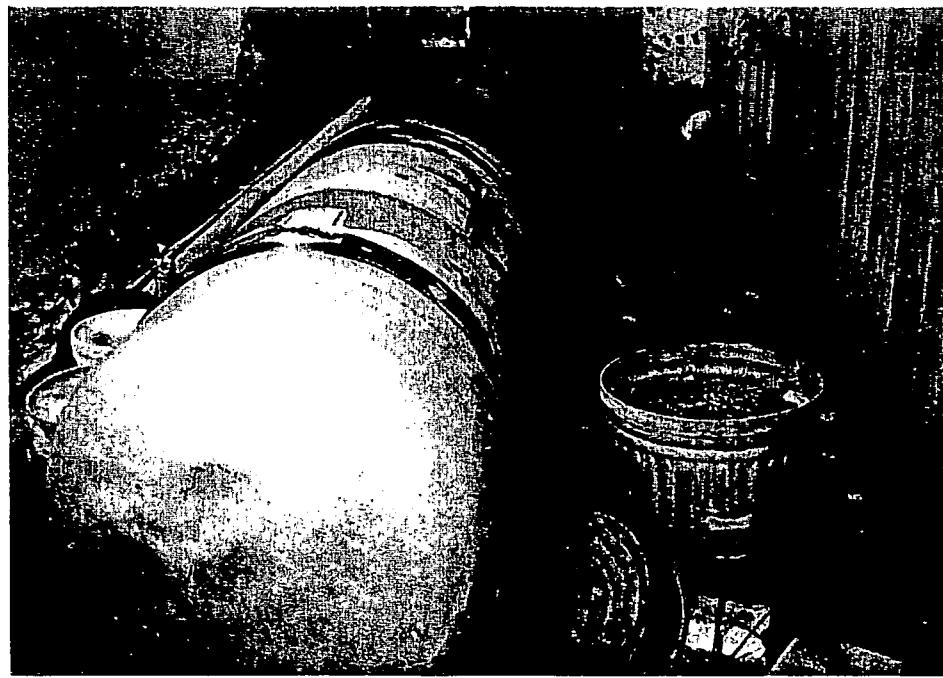
- An aboveground waste oil tank was observed by the Maintenance Building. This tank may not be in compliance with federal and/or state regulation regarding spill prevention, documentation and labeling. Evidence of soil staining was observed around the waste oil tank and several nearby batteries.

An area of staining was observed on soil around the waste oil tank by the Maintenance Building. Evidence of staining around several batteries was also observed in this area.

PHOTOGRAPH 42: Building 426 - Maintenance Building - 500-gallon waste oil AST, notable staining.

- The owners of the on-site waste oil tank should evaluate compliance with federal and state regulations and non-compliant items should be corrected.
- Soil staining was observed in the area of the waste oil tank. The extent of impacted soil should be determined and appropriate remedial action should be initiated.
- If future renovation or demolition activities involve the shop area in the Maintenance Building, an assessment should be performed in the area of the hydraulic lift to evaluate potential subsurface contamination from the leakage of hydraulic fluids.
- The existing asbestos survey should be updated to incorporate abated areas and reevaluate the condition of all ACBM. Following this update, an Operation and Maintenance Plan should be developed to manage existing ACBM.

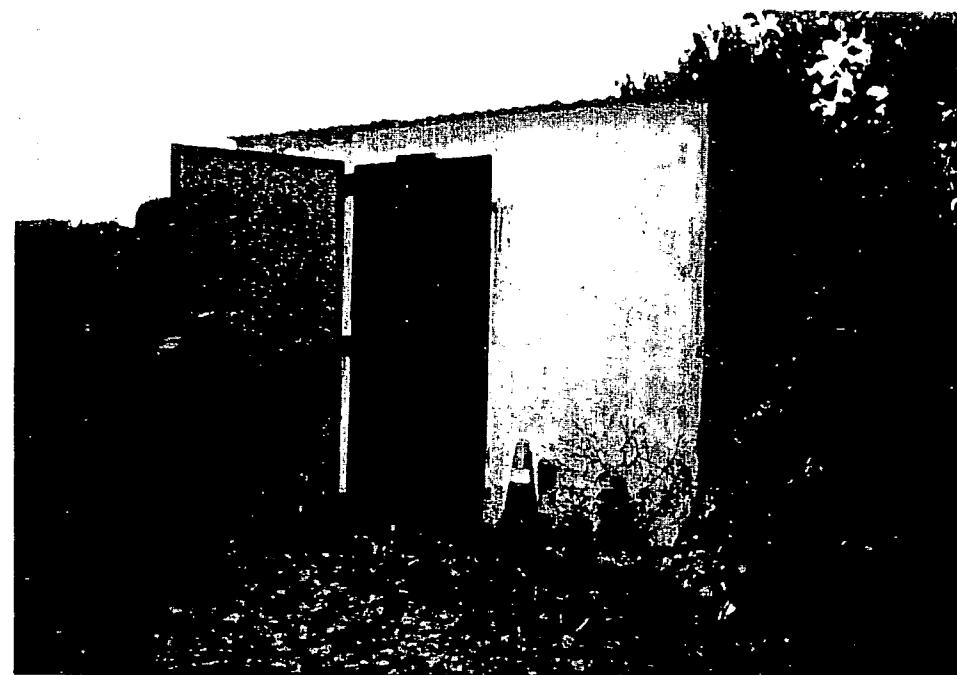
PHOTOGRAPH 45: Building 426 - Maintenance Building - Metal storage shed.

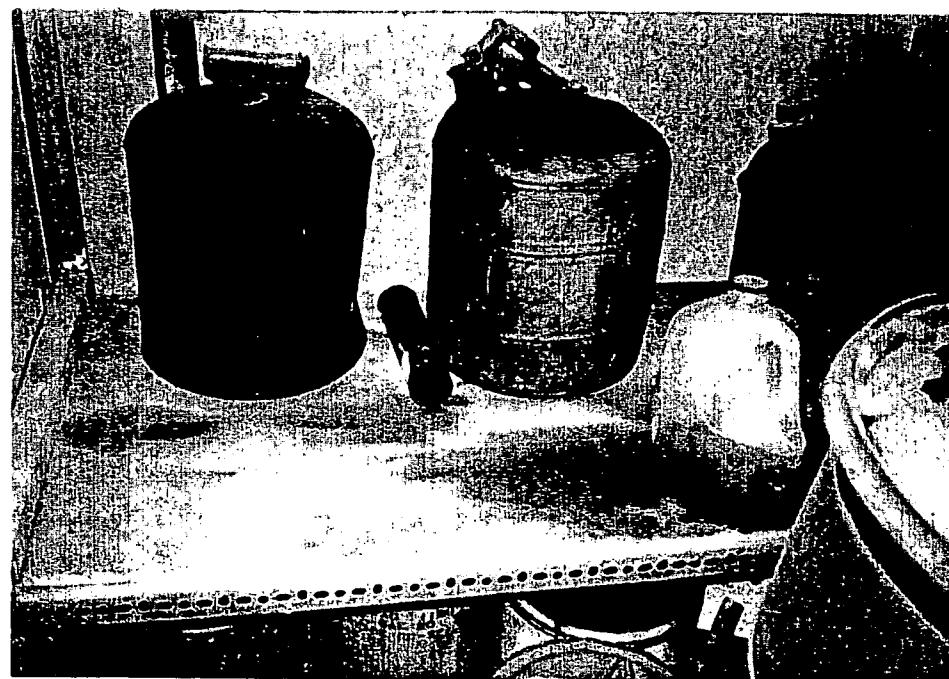
PHOTOGRAPH 46: Metal storage shed - unlabeled containers

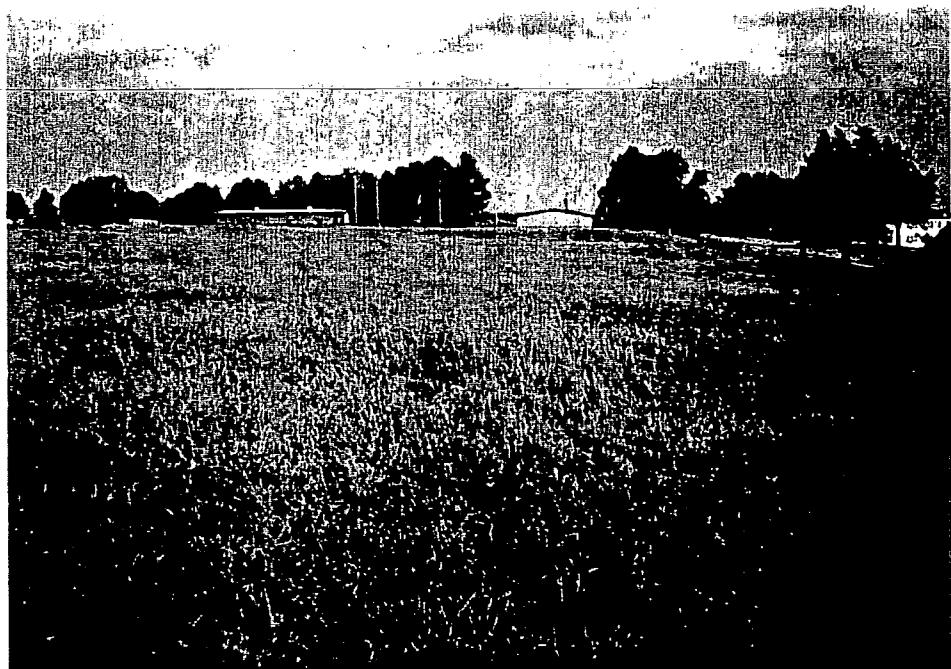
PHOTOGRAPH 51: Building 434 (Right) - Classrooms.
Building 437 (Left) - Seminary.

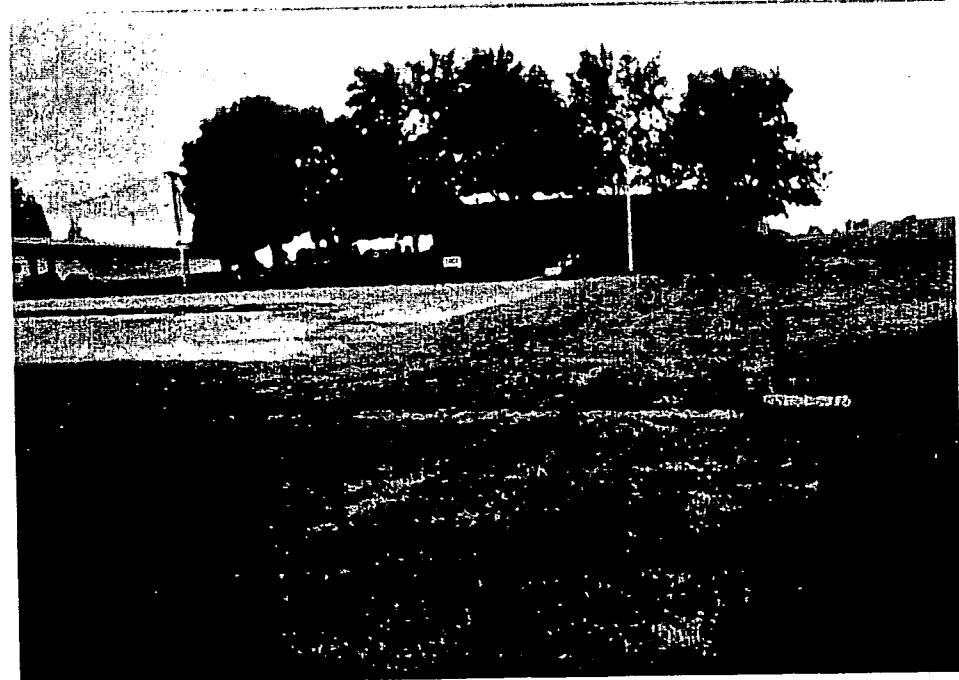
PHOTOGRAPH 52: Building 437 - Seminary.
Building 434 (Left) - Classrooms.

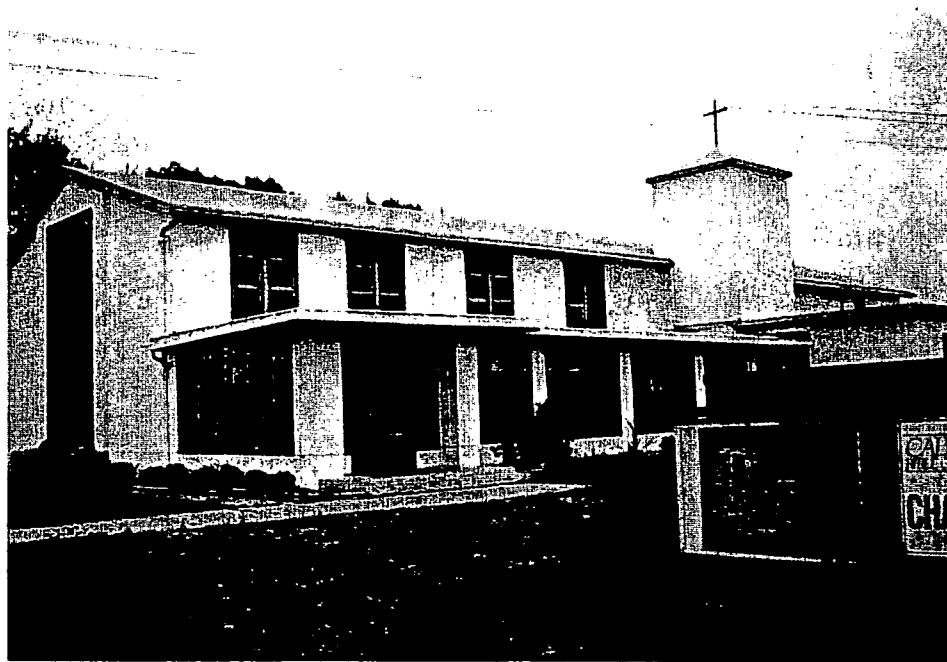
PHOTOGRAPH 53: Building 523 - Chapel.
