REPLICA  
**PHASE I**  
**ENVIRONMENTAL SITE ASSESSMENT**

**RICHARDS-GEBAUR MEMORIAL AIRPORT**  
**55-ACRE TRACT**  
**(INCLUDES RIFLE RANGE, SKEET RANGE & LANDFILL)**  
**KANSAS CITY, MISSOURI**

**PSI PROJECT NUMBER 5985E110**

**October 30, 1995**

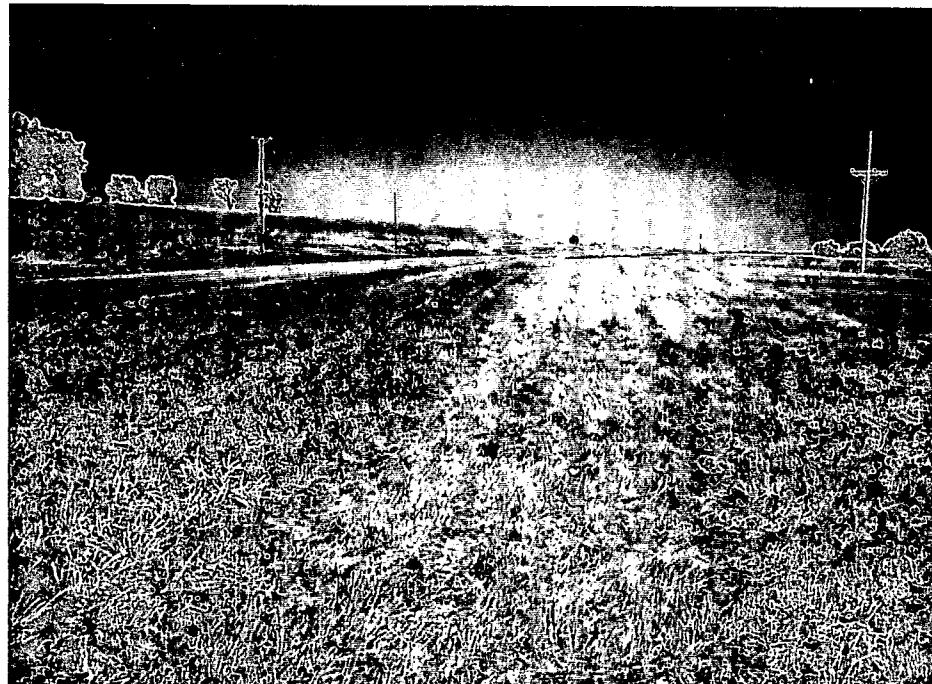
**PHOTOGRAPH 2:** Vacant grass land located south of Andrews Road.

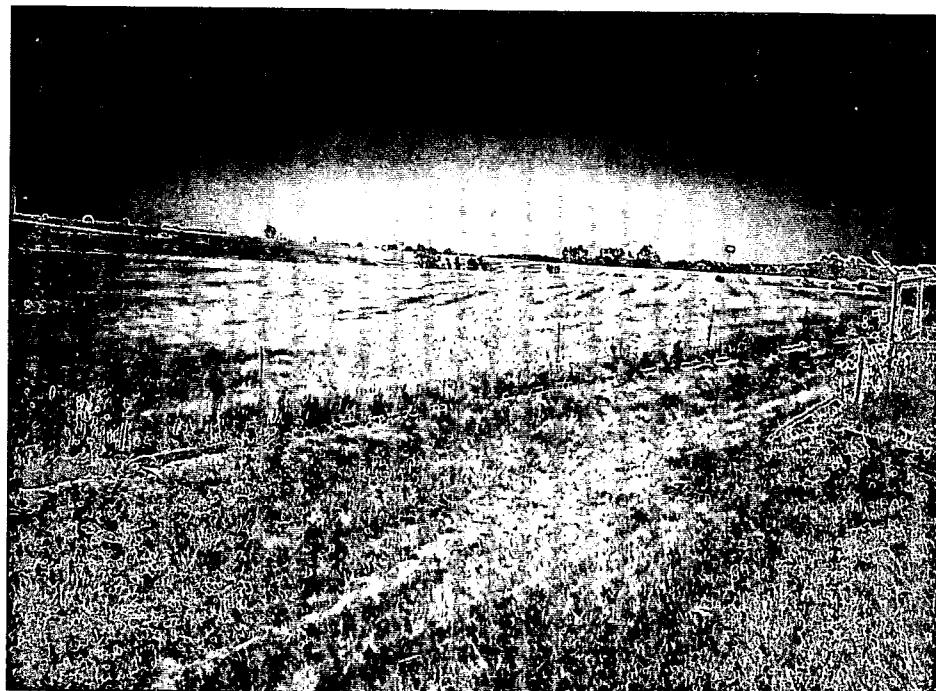
**PHOTOGRAPH 6:** North area of subject site viewing northeast.

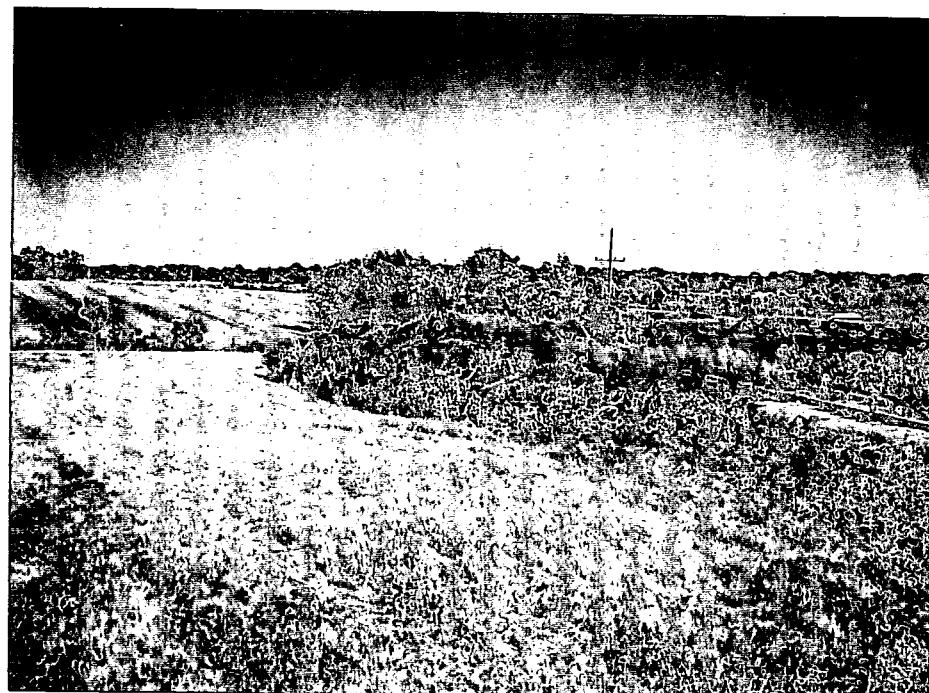
**PHOTOGRAPH 8:** View of railroad spur which runs across the subject site.

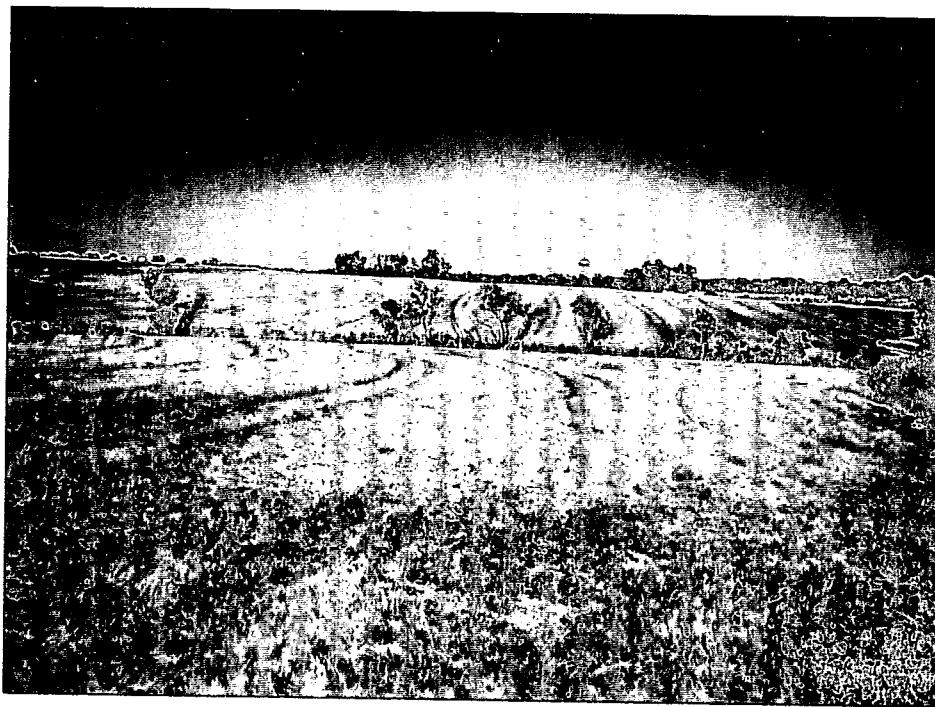
**PHOTOGRAPH 9:** North area of subject site viewing east across the vacant grass land.

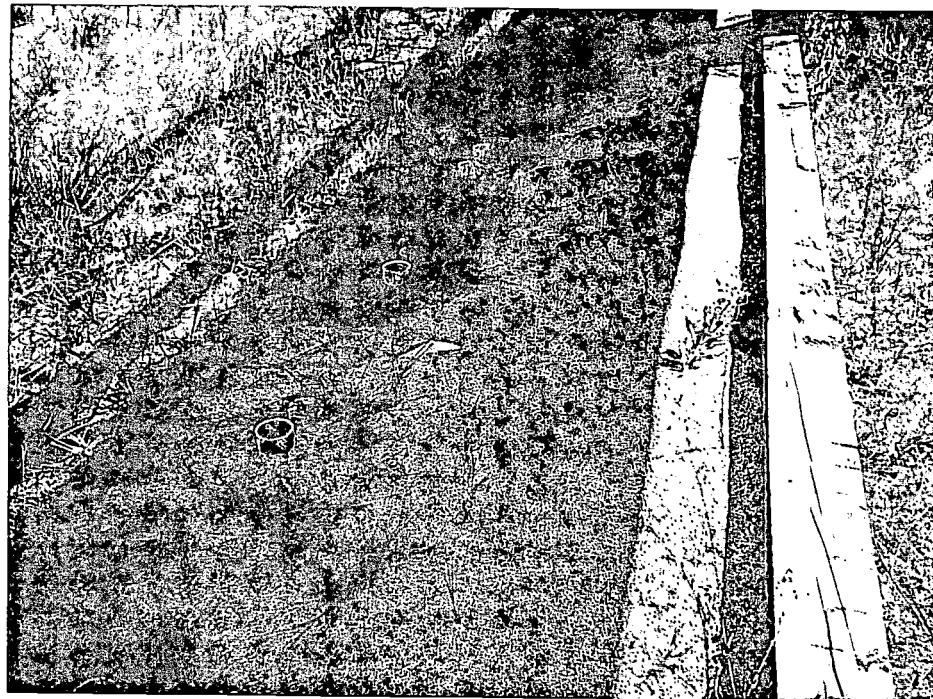
**PHOTOGRAPH 13:** Stormwater drainage system located in firing range.

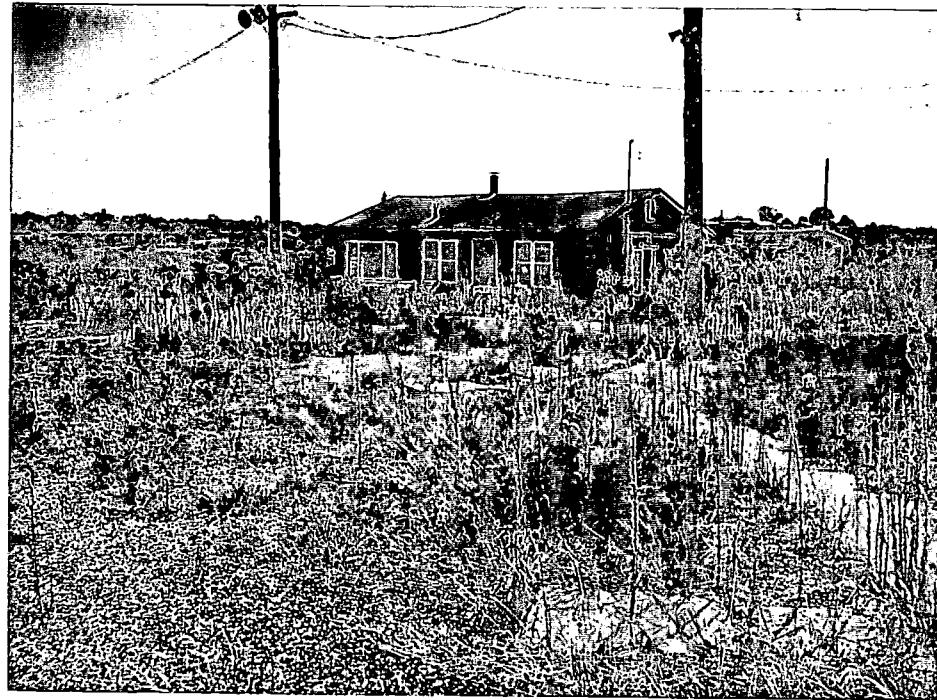
**PHOTOGRAPH 17:** Skeet Range and on-site building.

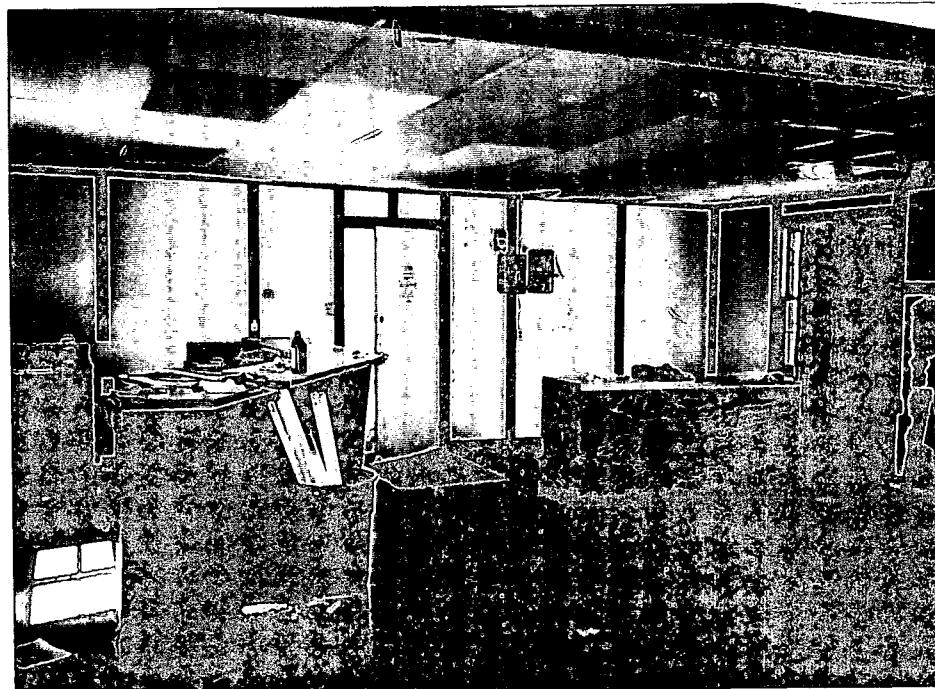
**PHOTOGRAPH 18:** Interior of Skeet Range building.

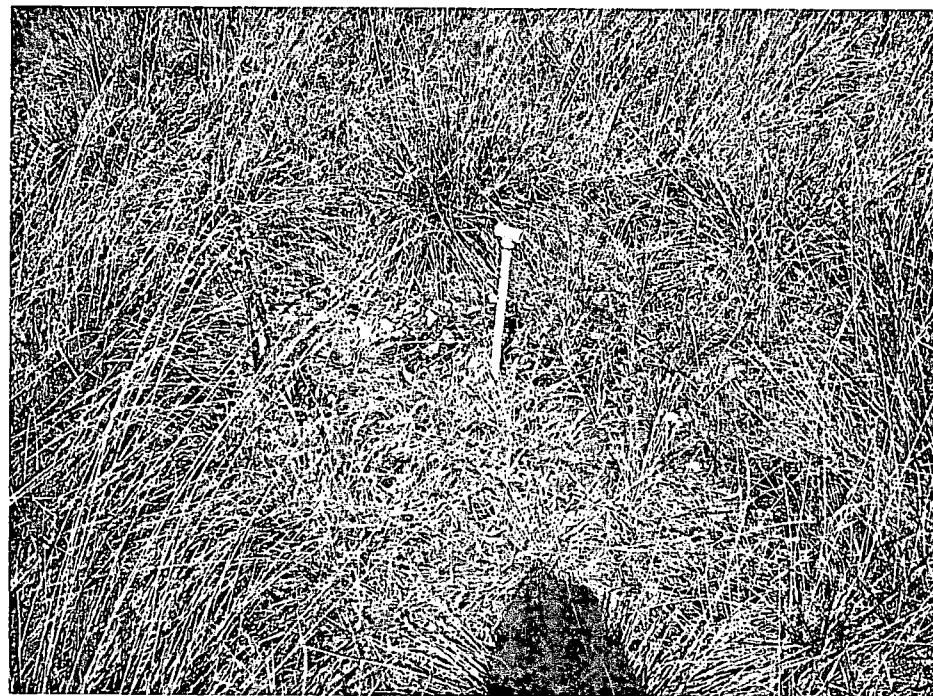
**PHOTOGRAPH 25:** Unknown pipe and localized stressed vegetation identified on the north area of the Skeet Range.

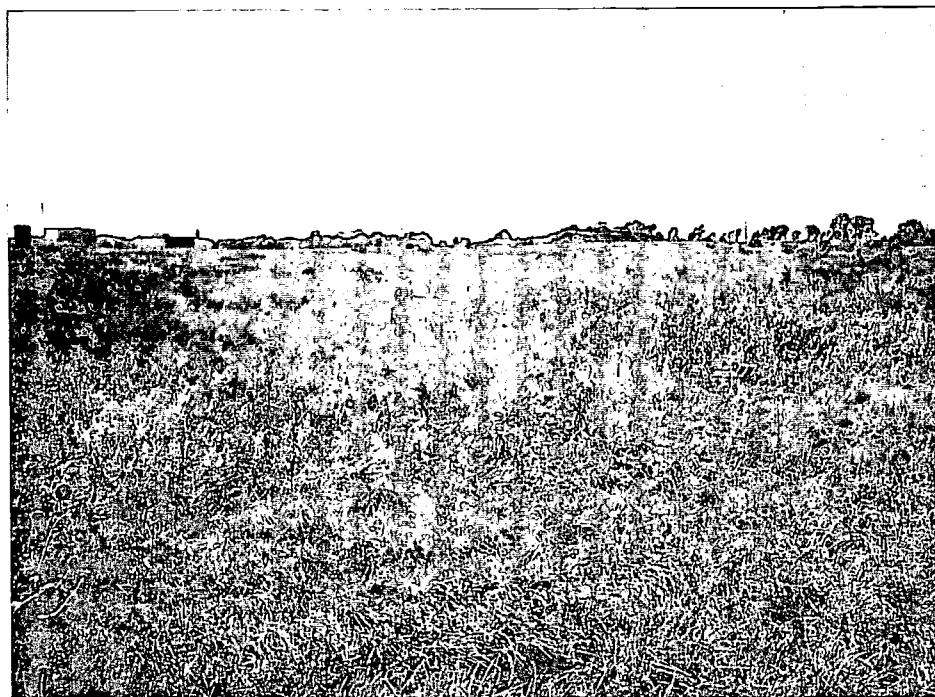
**PHOTOGRAPH 31:** View west across the on-site landfill area.

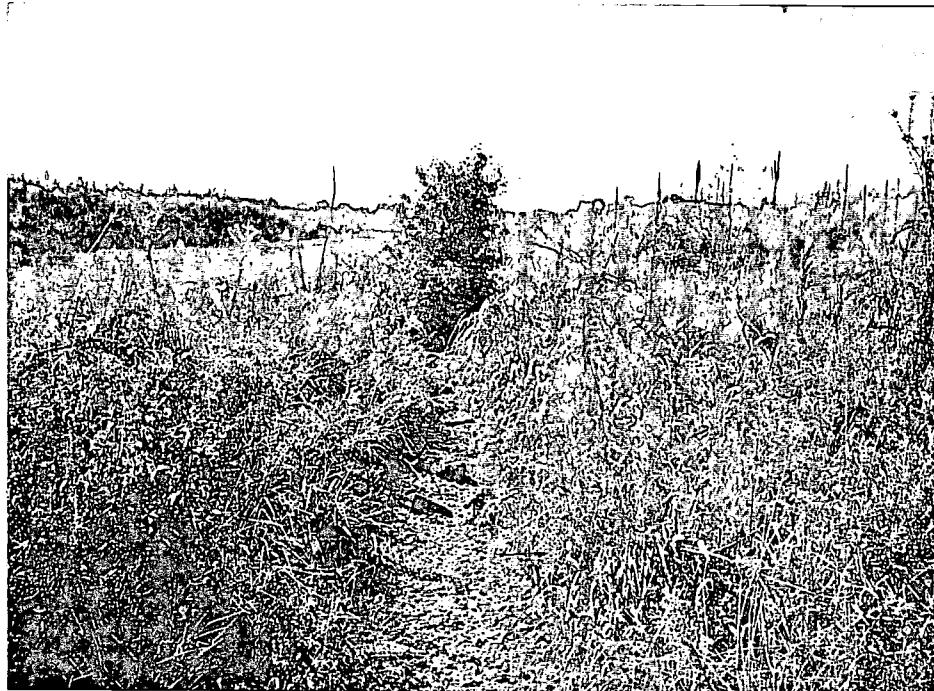
**PHOTOGRAPH 33:** Open drainage channel located south of the landfill.

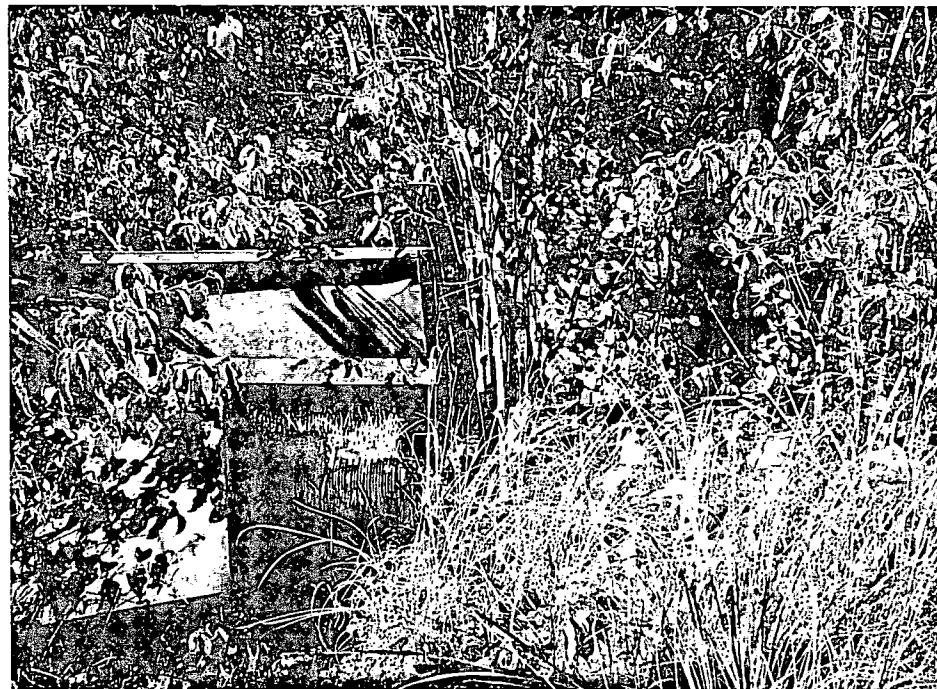
**PHOTOGRAPH 36:** Discarded equipment located on the east area of the subject site.

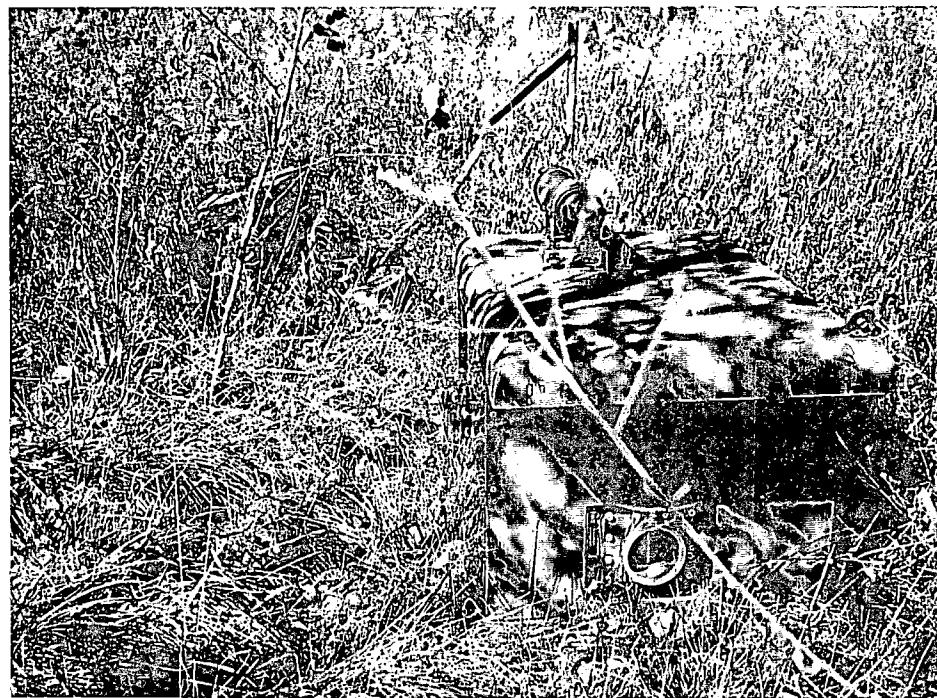
**PHOTOGRAPH 37:** Discarded equipment located on the east area of the subject site.

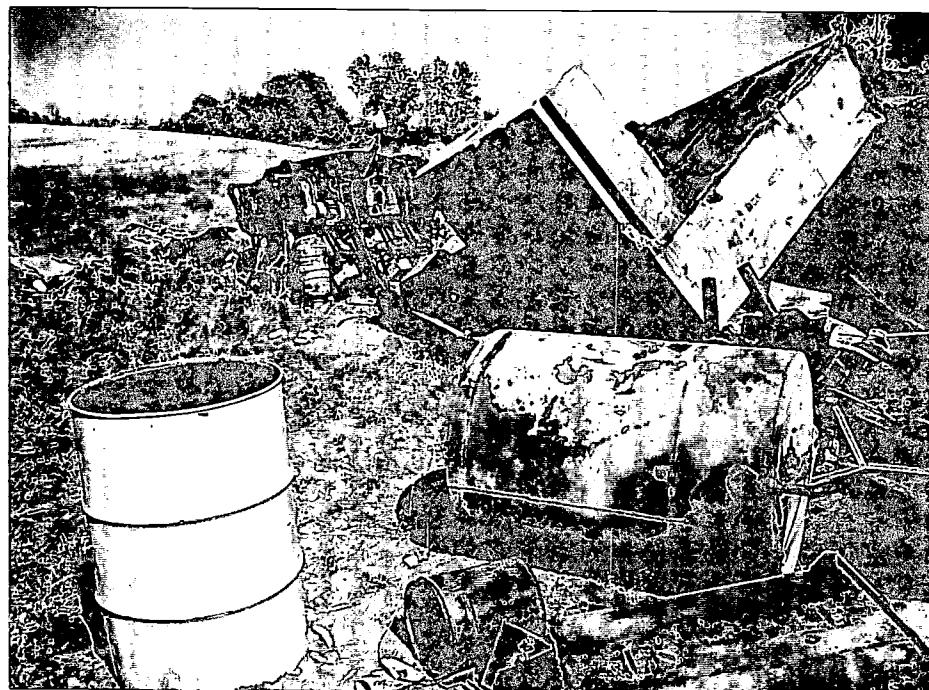
**PHOTOGRAPH 42:** Containers associated with the railroad car dismantling project.

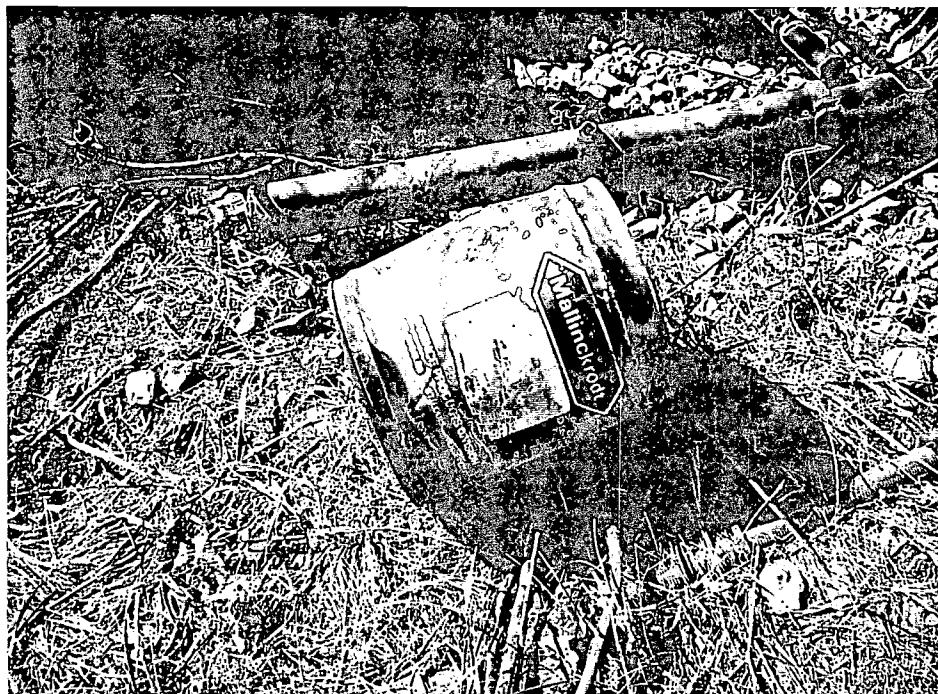
**PHOTOGRAPH 45:** Chemical containers located at the railroad car dismantling area.

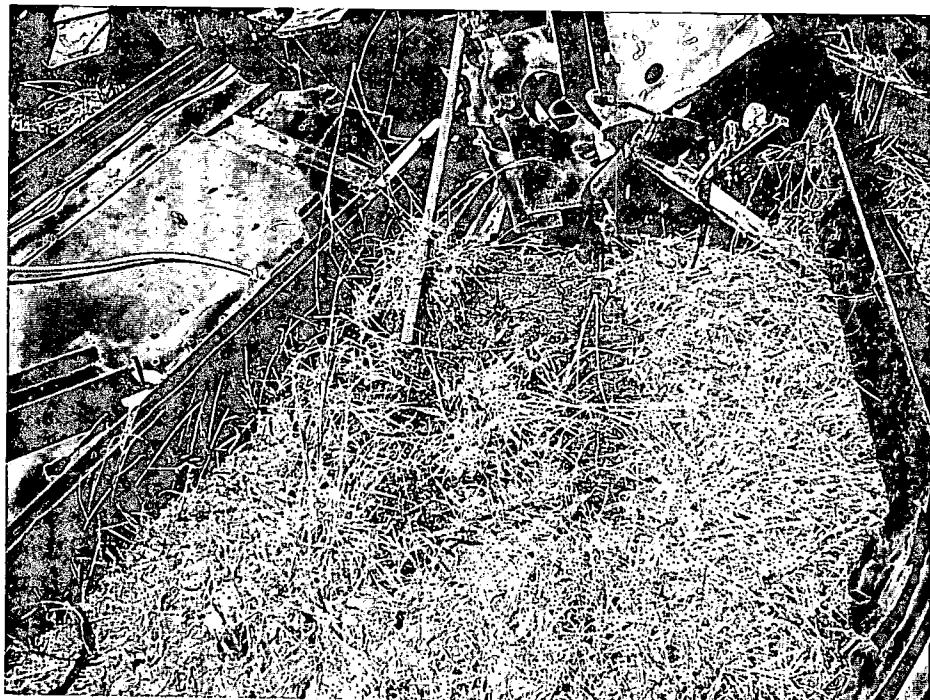
**PHOTOGRAPH 47:** Chemical spill located at the railroad car dismantling area.
