REPORT NUMBER: INS-421186

REPORT DATE: 08-01-2025

A) GENERAL INFO	RMATION	I					
Product Description	TEE-SHIRT						
Buyer	JENNYFER						
Supplier	SABARAN	G FASHION LTD			A . A		
Factory	SABARAN	G FASHION LTD					
Order No.	583316+5	83318					
Order Quantity	6000+120	= 6120 PCS					
Shipment Quantity	6042+120	PCS=6042 pcs					
Style No.	43RIBDEU	SM					
Colour	60-NOIR+2	255-BLANC					
Size Range	XS+S+M+L	+XL					
Inspection Date	07.01.202	5					
Inspection Location		8, BLOCK-K, RUP MIRPUR,DHAKA					
Inspector Full Name	1	DSSAIN SOHEL (D			Product photo		
	[X] Buyer- Reference [] Self Reference						
Inspection Service	[X] Final R	andom Inspection [] 1st [] 2nd [] 3rd Re-ins			pection [] 100% Inspection

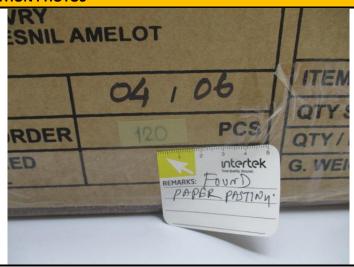
3.	43RIBDEU	100% of the inspected cartons were found 5 ply, but client packing manual shown it should be 7 ply. Image#02.							
4.	SM	During inspection 07 Out of 18 inspected cartons shipping mark were found paper pasting. Image#01

During inspection 07 Out of 18 inspected cartons shipping mark were found paper pasting. Image#01

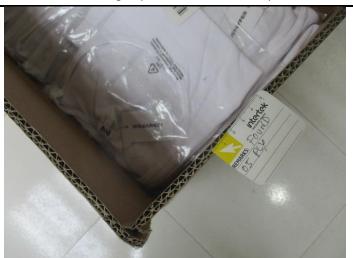
100% of the inspected cartons were found 5 ply, but client packing manual shown it should be 7 ply. Image#02

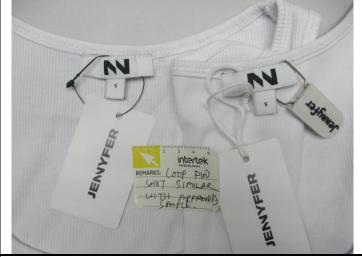
5.		During the inspection 100% inspected samples were found hangtag attached by loop pin. Which was similar with approved trims card & tech pack. But the approved samples were found hangtags attached by cord. Image#03

During the inspection 100% inspected samples were found hangtag attached by loop pin. Which was similar with approved trims card & tech pack. But the approved sample were found hangtag attach by cord. Image#03
