# Church of St Cuthbert and St Mary, Worksop

## Quinquennial Inspection

February 2025

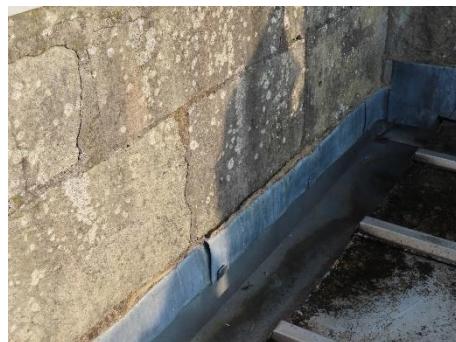
The lead flashings are becoming loose and will need to be raked out and pointed. The roof slope and gutter have a significant amount of moss which will need to be cleared. The moss could block the gutter and result in water ingress.

Rake out and secure the perimeter **2** flashings.

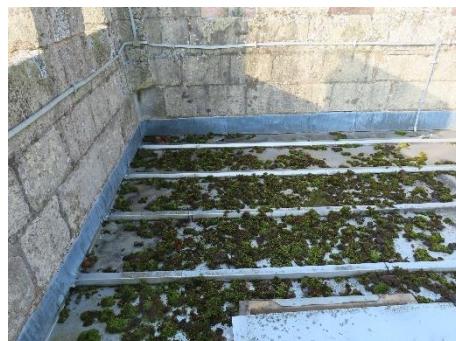
Clear the moss to the roof covering **1** and north gutter.

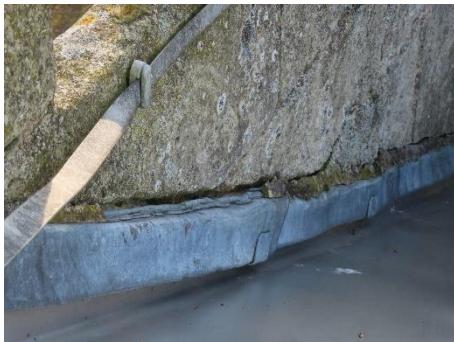
The lead flashings are becoming loose and will need to be raked out and pointed. The gutters and outlets have a significant amount of vegetation which will need to be cleared. The vegetation could block the gutter and result in water ingress.

Rake out and secure the perimeter **2**  
flashings.

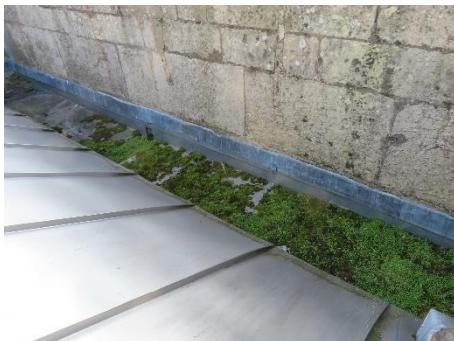
Clear the vegetation to the roof gutters **1**  
and outlets.

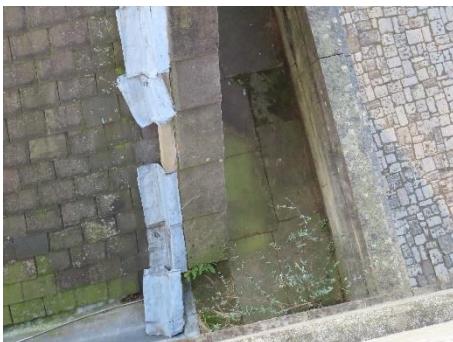
Secure the flashings to the west gable. **2**

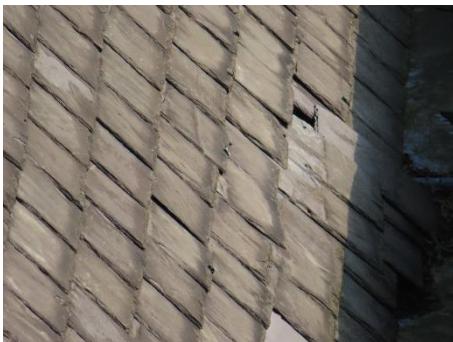
There is missing slate which has resulted in a small hole to the south slope which will need to be refixed.

Refix the missing slate to the south **2** slope.

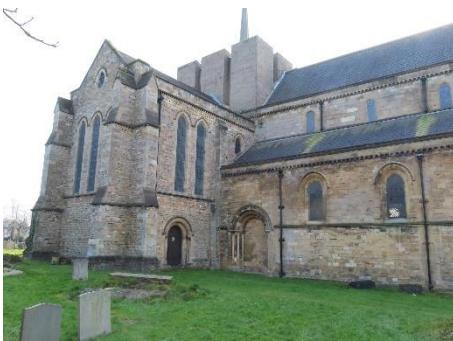
There are slipped slates to the north slope to the east end which will need to be resecured.

Refix the slipped and missing slates to **2** the north slope.

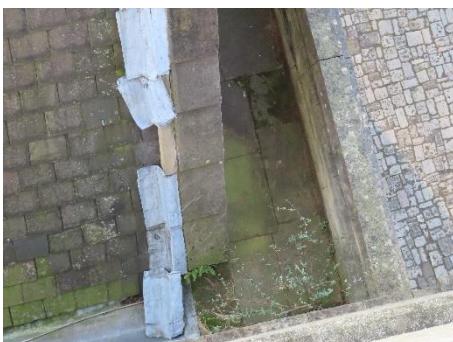
The vegetation growth to the stone wall cap to the west needs to be removed and the open joints pointed.

Remove the vegetation growth to the **2** wall cap and repoint.

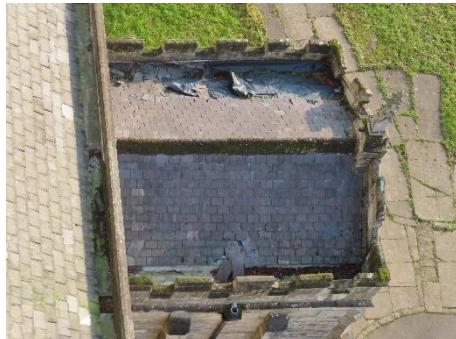
The roof is in poor condition, the lead gutters have been stolen and the slate coverings damaged. The roof slopes are beyond repair and will need complete replacement.

Replace the porch roof and parapet **3**  
gutters.

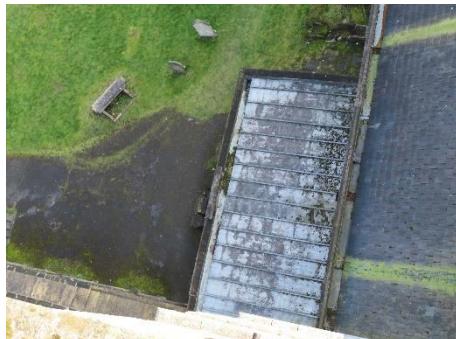
There is a build-up of moss within the parapet gutter which will need to be removed. The vegetation could block the gutter and result in water ingress

Remove the vegetation growth to the **1**  
parapet gutter.

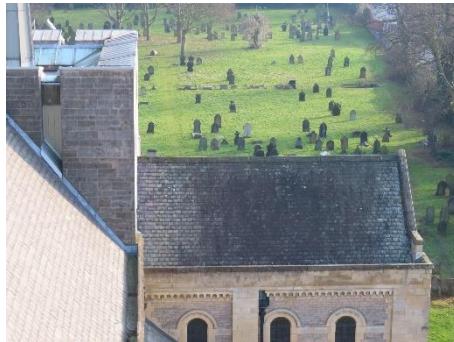
There are slipped slates to the west slope which will need to be refixed. The condition of the parapet gutters needs to be inspected.

The slipped slates to the west slope **2**  
need to be refixed.

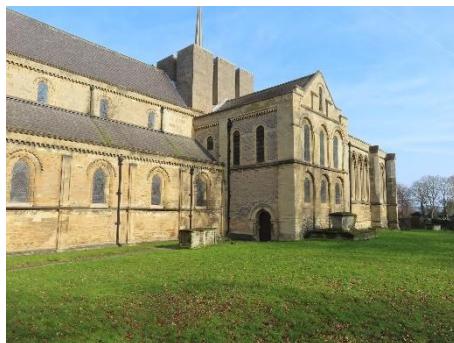
Arrange for the east and west parapet  
gutters to be inspected by a competent  
contractor and report to the church  
architect. **2**

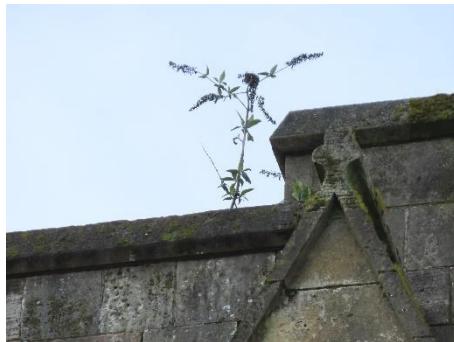
There is visible vegetation growth to the east gutter over the parapet wall which will need to be removed. The condition of the parapet gutters needs to be inspected.

Remove the vegetation growth to the  
east gutter. **1**

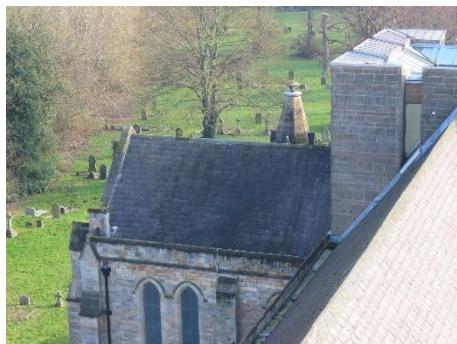
Arrange for the east and west parapet gutters to be inspected by a competent contractor and report to the church architect. 2

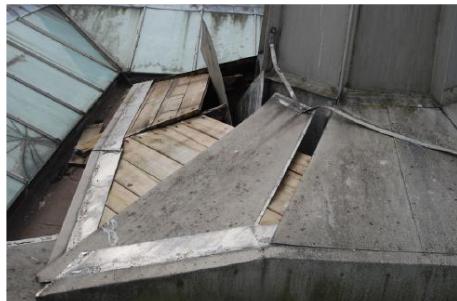
Although there was no safe access to the roof the structure inspection carried out in 2019 has indicated that the roof is in poor condition with dislodged galvanised panels to the spire skirt with damage to the timber substrate.

Galvanised panels failed to the spire skirt and timber substrate need to be repaired. 1

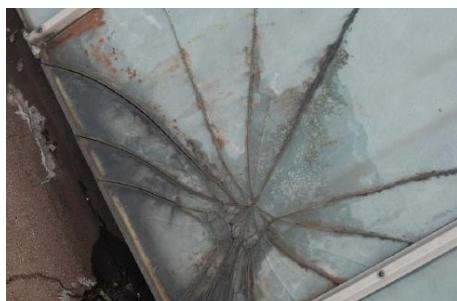
The asphalt gutter is cracked, and the glazed panels are damaged and letting in water.

The perimeter glazing needs to be replaced with a new system 1

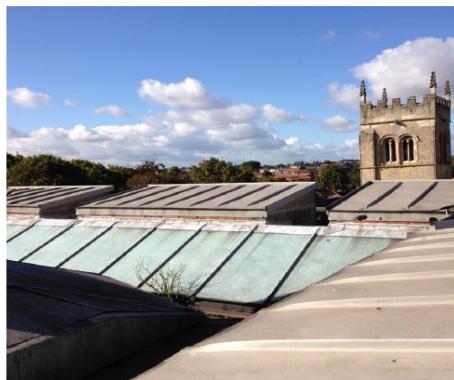
The internal asphalt gutters and outlets **1** need to be replaced.

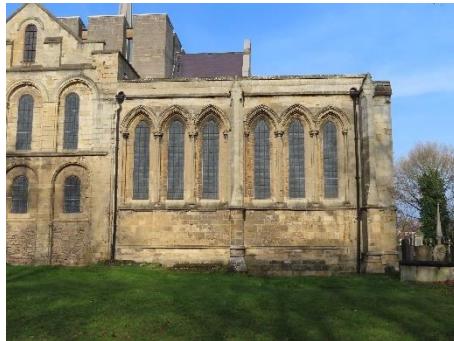
The lead roof covering was not accessed or inspected at the time of the survey.

Arrange for access and an inspection **2** of the roof covering by a competent contractor.

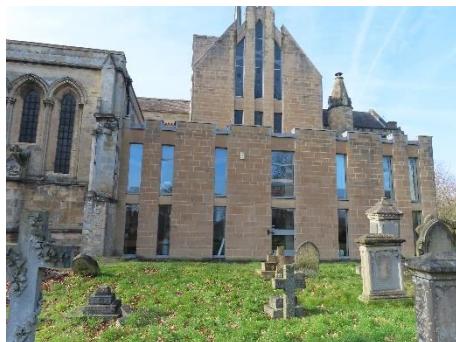
The asphalt roof covering was not accessed or inspected at the time of the survey.

Arrange for access and an inspection of the roof covering by a competent contractor. 2

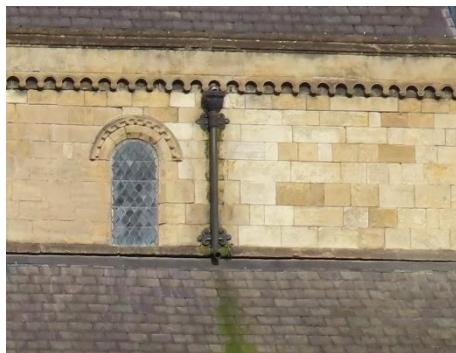
There is visible staining to the wall behind suggesting that some of the downpipes may be leaking from the joints or cracks. The downpipes may need to be repaired.

Repair and re-seal the damaged rainwater goods **3**

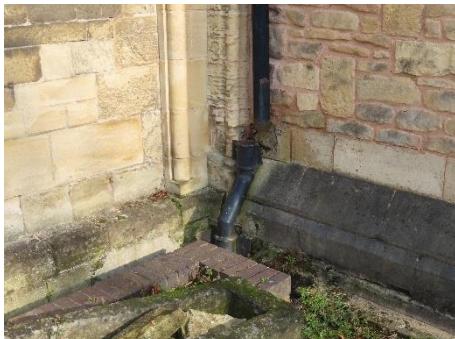
The lower section of the downpipe to the west is disconnect and will need to be reinstated to ensure the surface water discharges to the drainage system.

Reinstate the disconnected section of 1  
downpipe to the west.

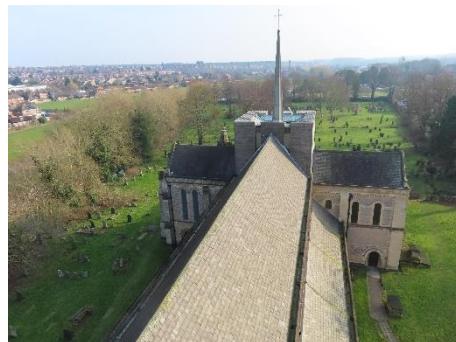
There is some concern over the condition of the modern tower and a structural inspection has identified the need for further investigation works to better understand the issues.

Arrange for structural investigation works to be completed. **2**

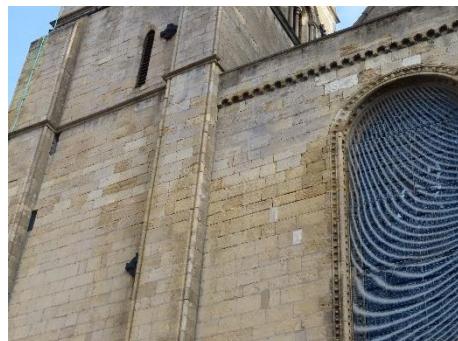
There are large areas of open joints either side of the window which will need to be raked out and pointed with lime mortar.

Rake out and point the open joints to **3** each side of the window.

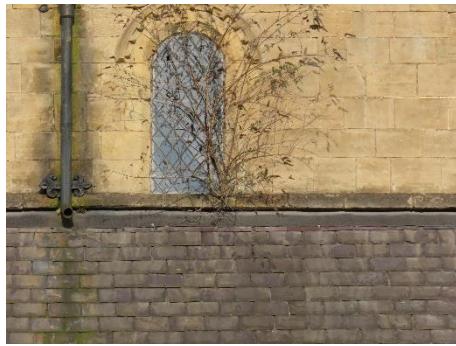
There is significant vegetation to the string course at the east and west ends that will need to be removed, treated with weedkiller and pointed with lime.

Remove the established vegetation in two locations, treat with weed killer and point the open joint. 2

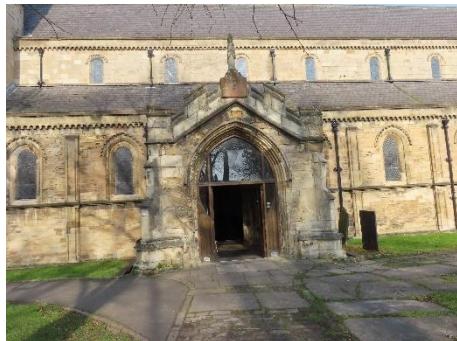
There are open joints to the stonework over the arch which will need to be raked out and pointed with lime.

Rake out and point the open joints over the arched opening to the door. 3

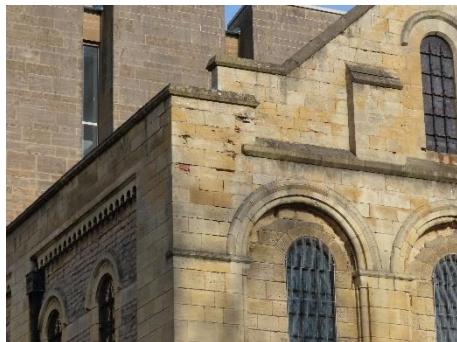
There are open joints at high level to the east and west sides which will need to be raked out and pointed.

Rake out and point the open joints to each side at high level. 3

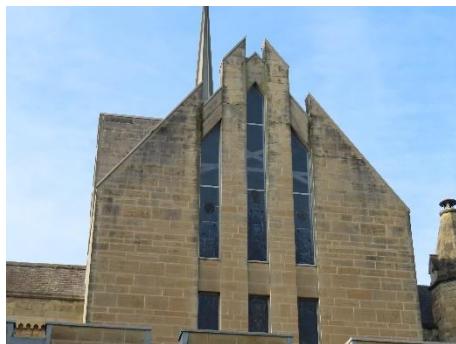
There is some concern over the condition of the modern tower and a structural inspection has identified the need for further investigation works to better understand the issues.

Arrange for structural investigation **2**  
works to be completed.

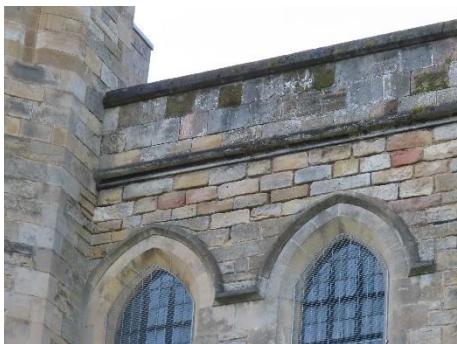
There are open joints at high level which will need to be raked out and pointed with lime.

Rake out and point the open joints at **3** high level.

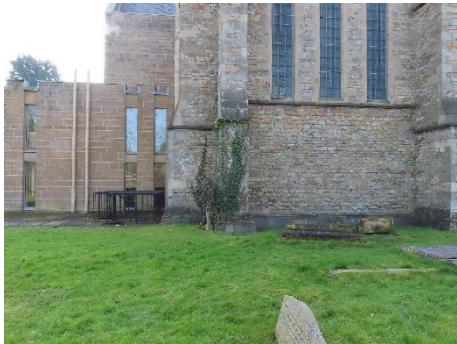
There is ivy growth to the east buttress which will need to be removed, and the open joints pointed will lime.

Remove the ivy from the east buttress **2** and point open joints.

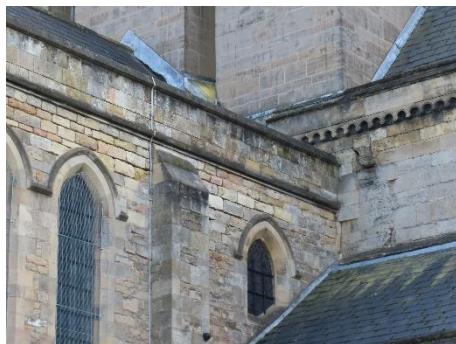
There is an area of open joints below the parapet wall which will need to be raked out and pointed with lime. There are also open joints to the north buttress in need of pointing with lime.

Rake out and point the open joints to the parapet. 3

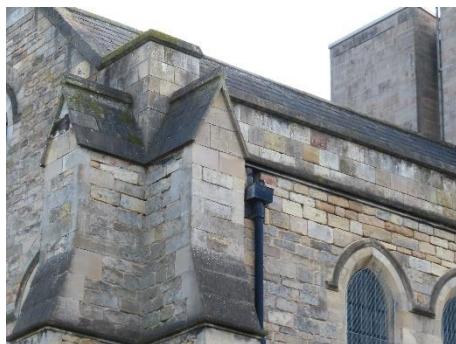
Rake out point the open joints to the buttress. 3

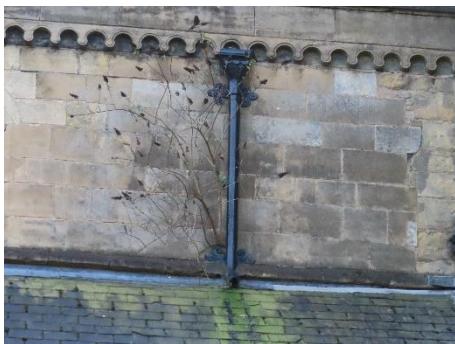
There is established vegetation to the string course at the east and west that will need to be removed and the open joints pointed.

Remove the established vegetation to the east and west and point the open joints. 2

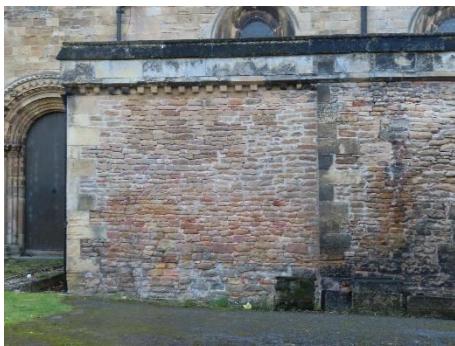
There are open joints to the east below the parapet wall which will need to be raked out and pointed with lime.

Rake out and point the open joints to the east. 3

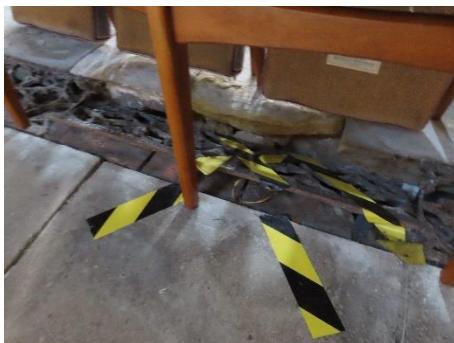
A section of the metal grille is damaged and marked with hazard tape. It appears that the stone support to each side is damaged and will need to be replaced. It may be possible to provide alternative support within the duct.

Arrange for the damaged grille to be **2** repaired.

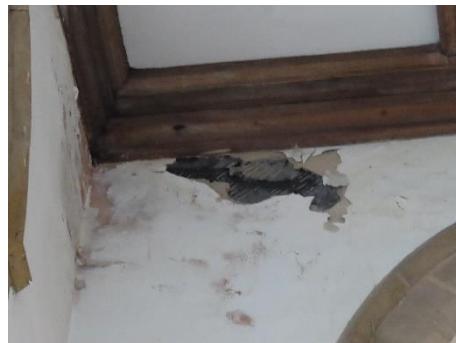
The water ingress at high level has caused some plaster damage to the northeast corner which will need to be repaired.

Repair the area of damaged plaster to **3** the east wall.

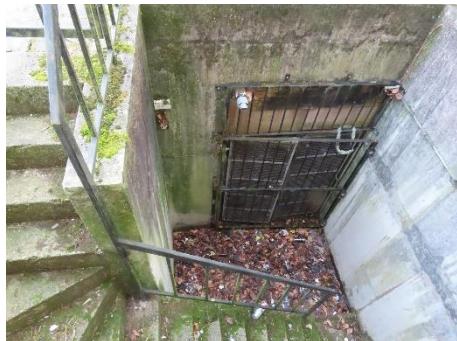
It is not known when the boilers were last inspected. A GasSAFE certificate is required annually.

Arrange for the boilers to be serviced **1**  
and a GasSAFE certificate to be issued.

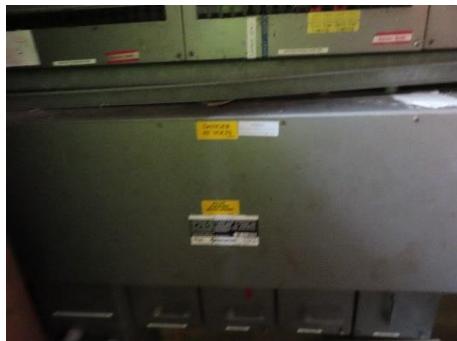
Arrange for the 5 yearly electrical **1**  
inspection to be completed.

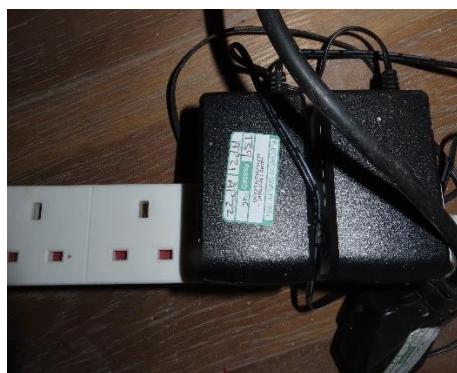
Arrange for the PAT testing to be **1**  
completed.

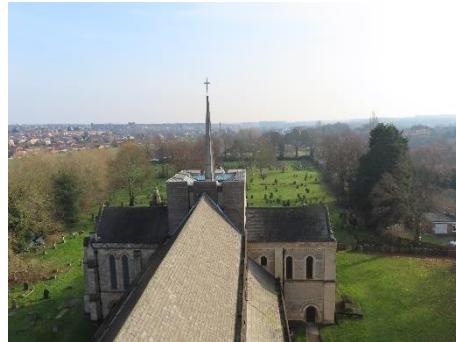
The lightning protection system needs to be inspected and tested in accordance with BS EN 62305.

Arrange for the lightning protection **1**  
installation to be inspected and tested.

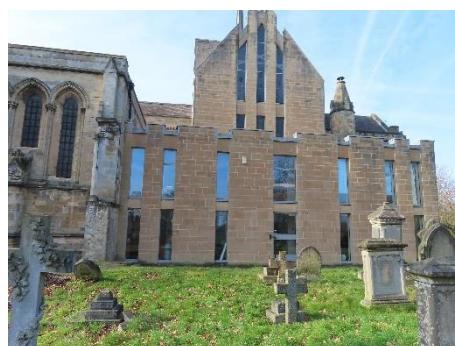
The PCC are to arrange for an asbestos management survey to be completed. The report should be retained at the church.

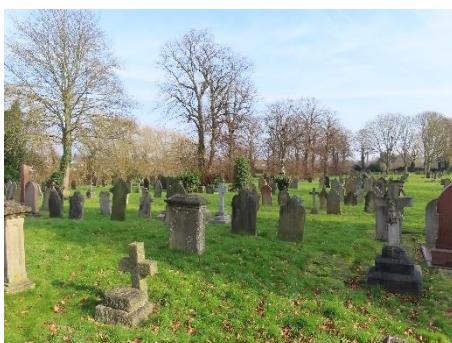
Any leaning grave markers will need to 2 be checked for stability.

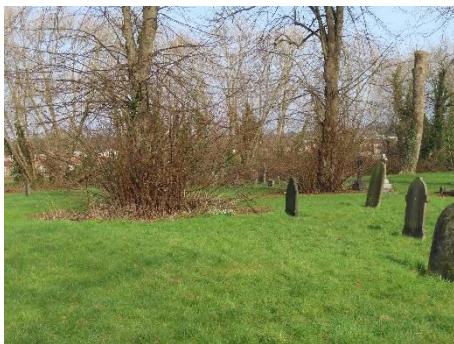
A tree survey should be carried out to ensure that they remain well maintained.

Arrange for the trees to be surveyed by **2** a specialist.
