TLC HOME INSPECTIONS

1234 Main Street
Austin TX 78759

PROPERTY INSPECTION REPORT FORM

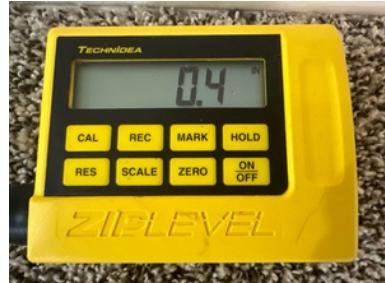
Back Middle

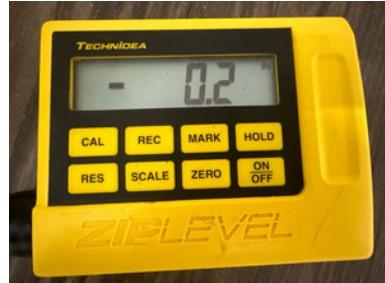
Back Left, with laminate variance

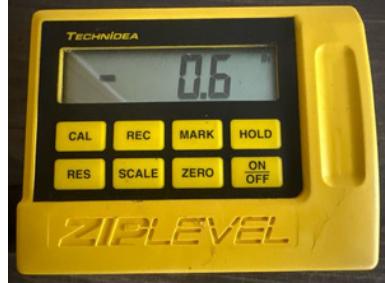
Left Middle, with laminate variance

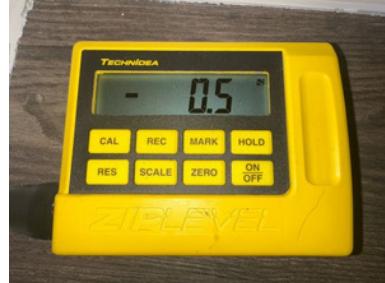
Front Left, with laminate variance

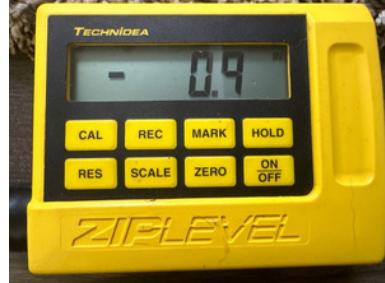
Laminate Drop Varience

Zip Level Performing : Foundation elevations were measured throughout the home using a Zip Level. Point zero was set at the center of the home and measured through each side of the residence (only interior, excluding the garage). Variances detected in a slab can indicate possible signs of settlement. Based on these readings, the foundation appeared to be performing as intended at the time of the inspection.

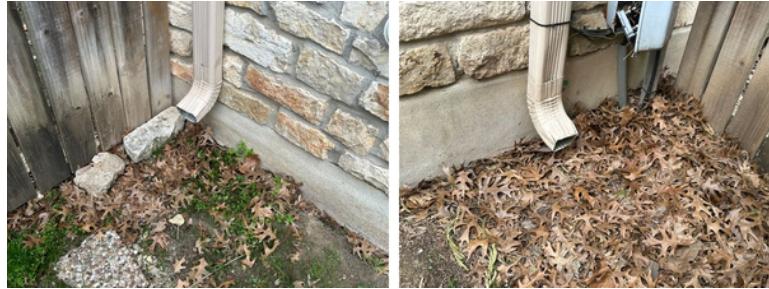
3: Negative Grade

Negative grading observed, which may result in moisture damage due to improper drainage toward the structure. Soil should slope away from a structure declining 6 inches in the first 10 feet.

Recommendation: Contact a qualified landscaping contractor

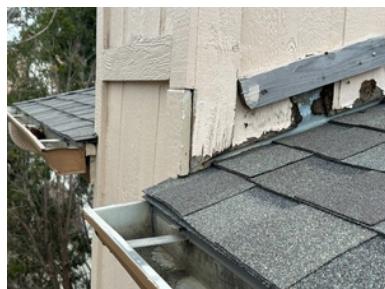
1: Missing Kick out Flashing

The roof covering is missing kick-out flashings along lower adjacent siding materials.

Recommendation: Contact a qualified roofing professional.

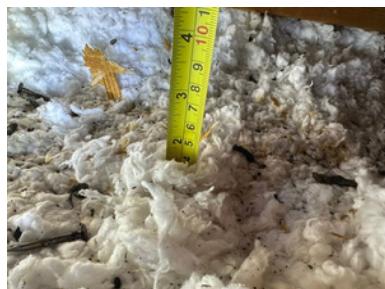
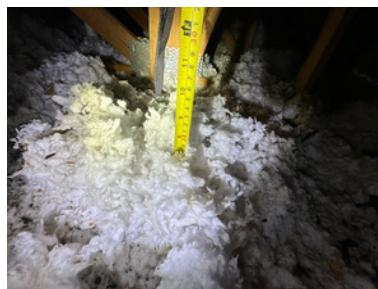
Roof/shingle debris and cardboard debris were present in the attic at the time of inspection.

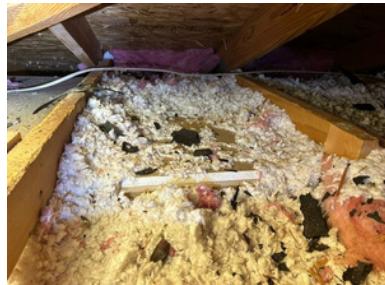
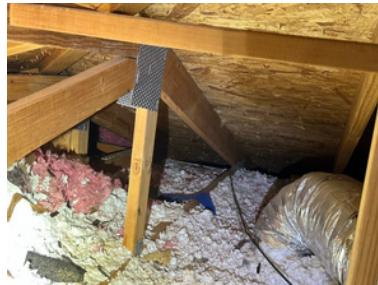
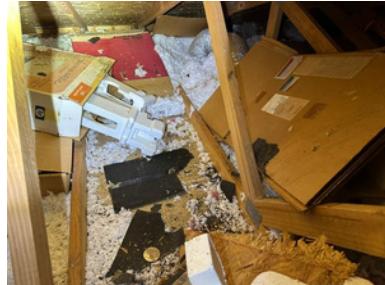
Compressed or displaced insulation was observed in the attic space. Insulation voids were observed. Compression of insulation materials can decrease the energy efficiency of the residence.

Recommendation: Contact a qualified insulation contractor.

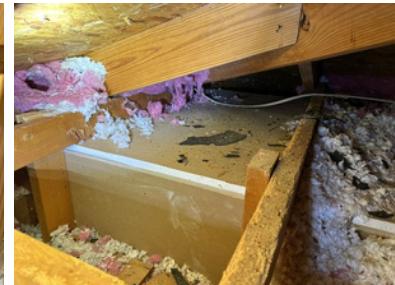
**3: Uneven Insulation****● Moderate Concern**

Uneven insulation was observed in the attic space.

Recommendation: Contact a qualified insulation contractor.

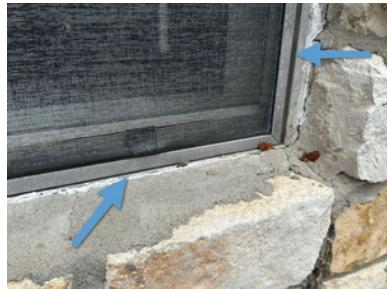
Multiple Locations

**3: Damage Present** **Moderate Concern**

Damage observed to the siding materials.

Recommendation: Contact a qualified siding specialist.

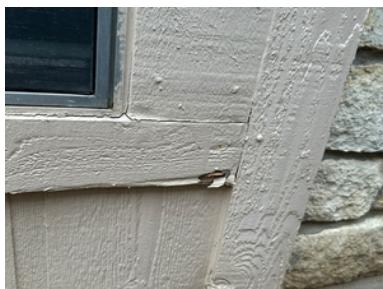
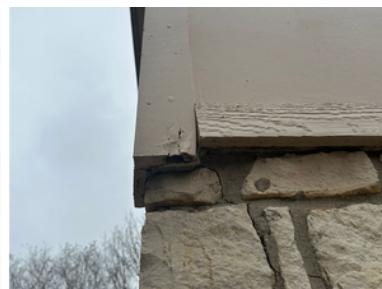
Wood deterioration/rot was observed at siding/trim.

Recommendation: Contact a qualified professional.

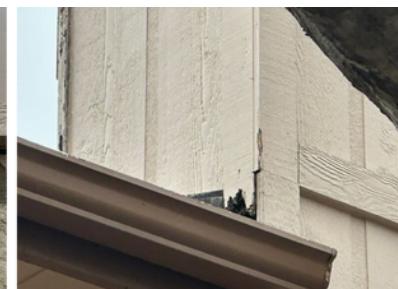
**6: Missing Weep Holes****● Moderate Concern**

Missing/blocked weep holes for the exterior masonry siding materials observed. The drying potential for non-structural brick is limited. Weep holes should be present no more than 33" apart on-center around the perimeter of the residence.

Recommendation: Contact a qualified siding specialist.

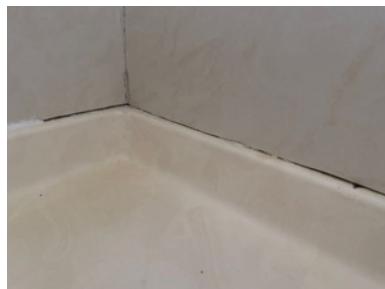
Gap(s) / crack(s) present to the grout/sealant joint(s) located in the bathtub/shower enclosure. Recommendation: Contact a qualified tile contractor

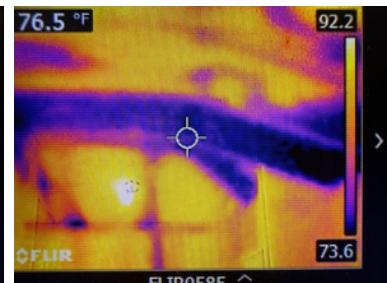
Thermal Abnormalities Present

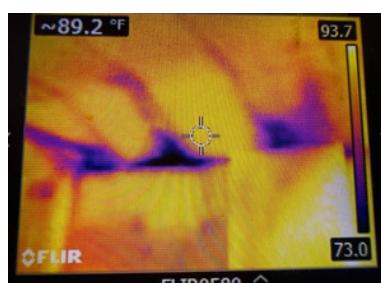
Thermal Abnormalities Present

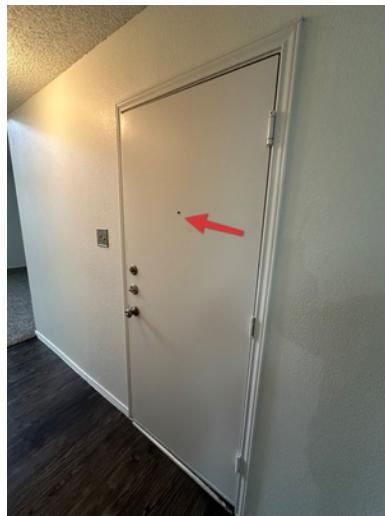
A solid wood door or properly fire-rated door is missing between the garage and residence.

Recommendation: Contact a qualified handyman.

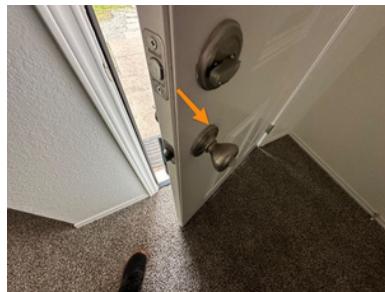
**7: Door Does Not Seal Properly****Moderate Concern**

Garage/living door does not seal properly.

Recommendation: Contact a qualified professional.

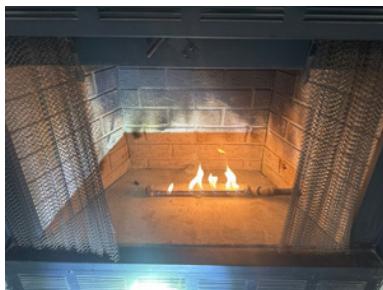
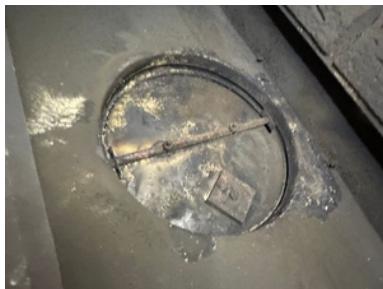
**1: Missing Damper Clamp**🔗Minor Concern

A missing damper clamp was noted inside the fireplace flue above the firebox. This device is required for all gas-fueled fireplaces.

Recommendation: Recommended DIY Project

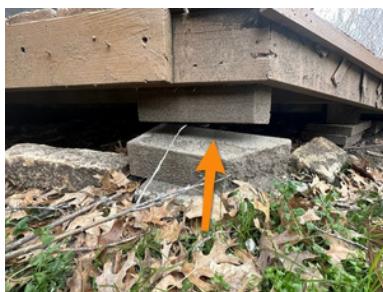
**3: Improperly Supported
👉Moderate Concern**

Deck structure was not supported properly. Tree roots are causing deck deflection.

Recommendation: Contact a qualified professional.

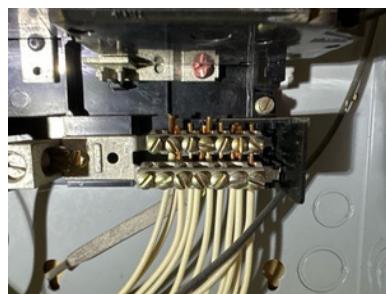
1: Double Tapped Neutral - Sub Panel**Moderate Concern**

Double taps were observed to the neutral bus at the subpanel. This configuration is improper, as it can cause electrical arcing or overheating. Recommend further evaluation by a licensed electrician.

Recommendation: Contact a qualified electrical contractor.

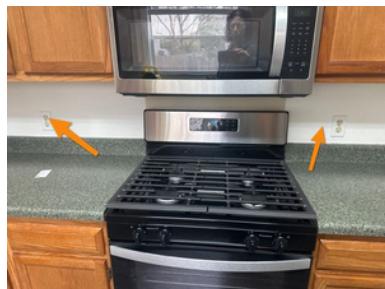
Missing at kitchen

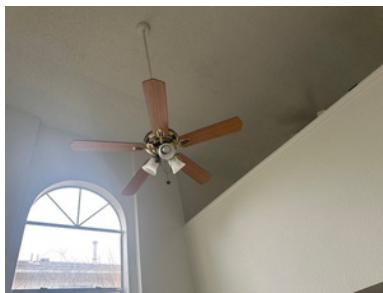
Living Room

The pull chains were not long enough for the fan/light controls at the overhead ceiling fan.

Recommendation: Contact a qualified handyman.

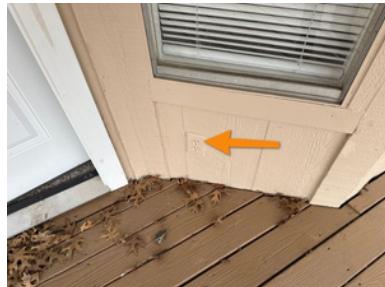
Improper outlet cover(s) were present. A plastic, water-proof bubble cover is required at the exterior.

Recommendation: Contact a qualified handyman.

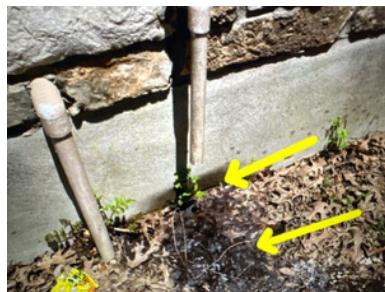
Condensate line terminates too close to structure. Condensation is corrosive and can damage building materials. Line should terminate at least 3' from structure to prevent moisture build up next to foundation and should slope away from the structure.

Recommendation: Contact a qualified professional.

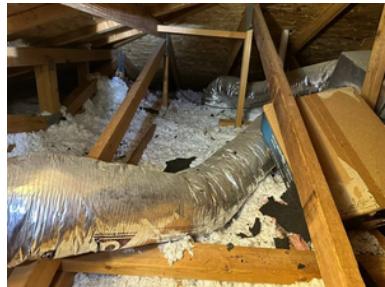
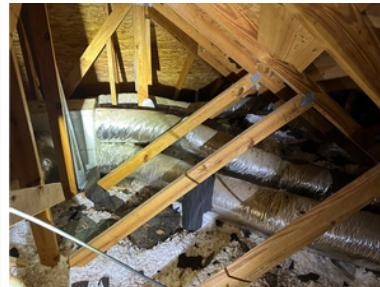
Ductwork was not properly supported in the attic space. Ductwork should be supported every 5 ft to prevent kinks and sags in the line that can adversely affect performance. The lines should also not be kinked/compressed, as this may impede air flow or result in condensation.

Recommendation: Contact a qualified HVAC professional.

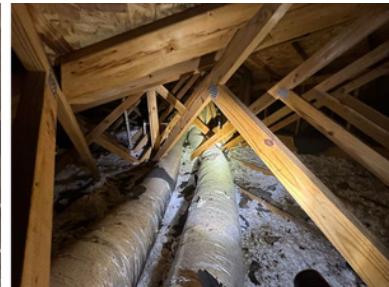
**3: Plenum Not Sealed****● Moderate Concern**

The air handler plenum is not properly sealed. Air loss detected. Recommend sealing the system to ensure maximum performance.

Recommendation: Contact a qualified professional.

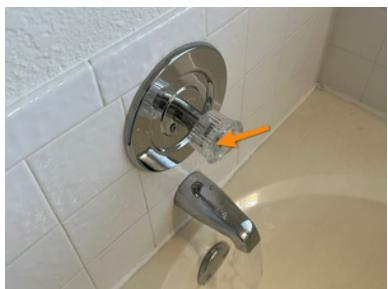
Master Tub

The sink faucet Hot and Cold are reversed in the upstairs bathroom

Recommendation: Contact a qualified professional.

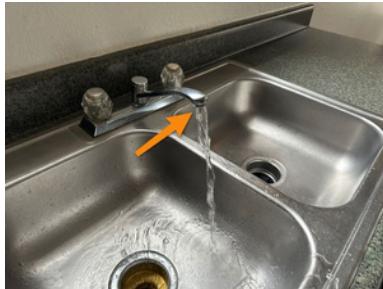
Missing aerator was observed at kitchen sink.

Recommendation: Contact a qualified professional.

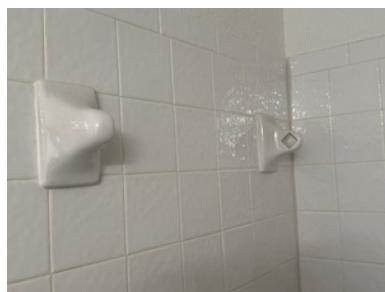
Missing towel bar at guest bathroom.

Recommendation: Recommended DIY Project

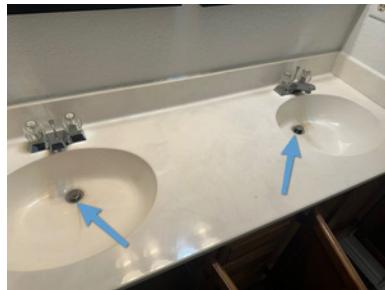
The drain stop was not functioning as intended.

Recommendation: Contact a qualified plumbing contractor.

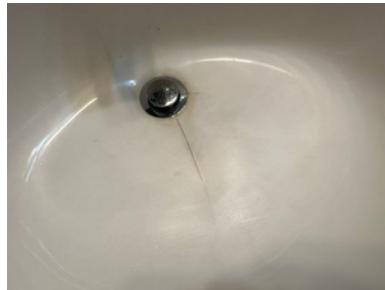
The surface finish was damaged at the sink.

Recommendation: Contact a qualified professional.

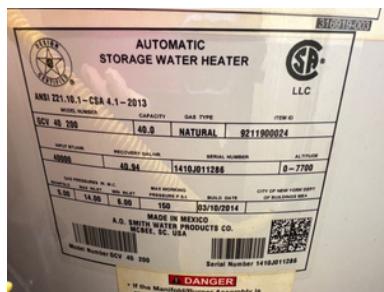
Insulation was missing or incomplete for the supply/delivery lines at the water heater.

Recommendation: Contact a handyman or DIY project

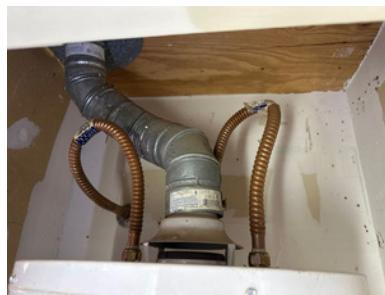
2: Excessive Temperature

Excessive hot water temperatures (over 120 degrees) was observed. Recommend further evaluation. Recommendation: Contact a qualified plumbing contractor.

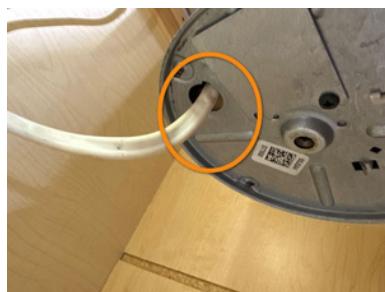
The disposal was missing an electrical fitting at the base of the unit. Recommend addition to prevent damage to the electrical wiring for the unit.

Recommendation: Contact a qualified professional.

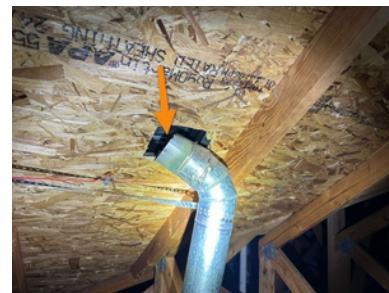
The exhaust fan ductwork/flue did not extend to the exterior of the residence.

Recommendation: Contact a qualified professional.

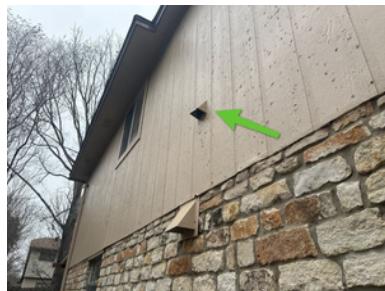
Trapped lint was observed in the visible dryer vent flue at the time of the inspection. Recommend cleaning the dryer line to prevent a potential fire hazard.

Recommendation: Contact a handyman or DIY project

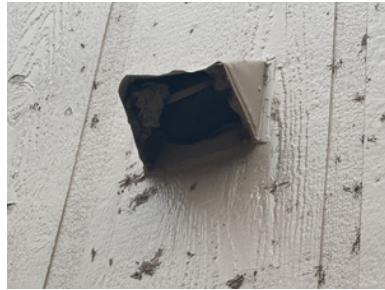
The dryer vent cover flap does not seal properly with the exterior wall. This presents a possible intrusion point for pests.

Recommendation: Contact a handyman or DIY project
