## Audit of Existing Conditions

## 1.0 Audit of Existing Conditions

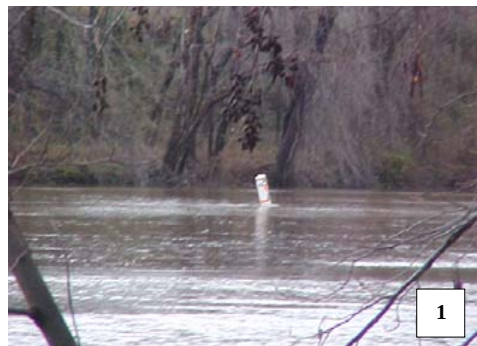
**Of the current messages presented, many are underscaled and can't be interpreted in the appropriate length of time.** For example, the message on the buoy in photo 1 is too small to be read from a distance and the speed of the water would not likely allow for someone to leisurely approach and read its message.

This can place users of the river in jeopardy. Message length should also be taken into consideration whenever viewers are in motion (e.g. boating down the river or biking the land trail (photo 2)).

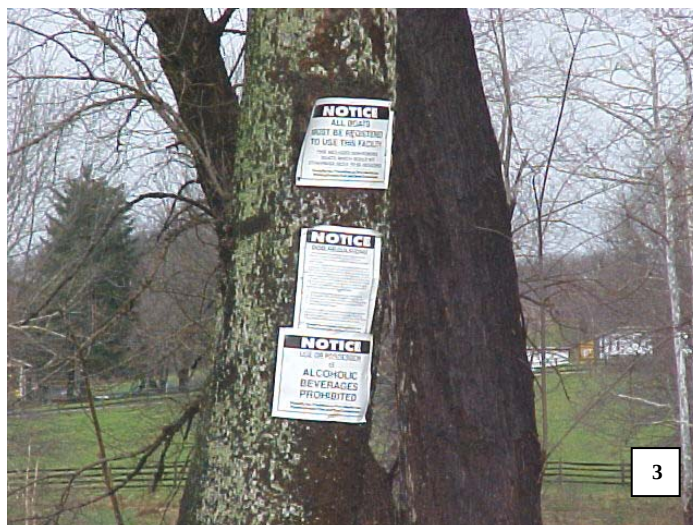
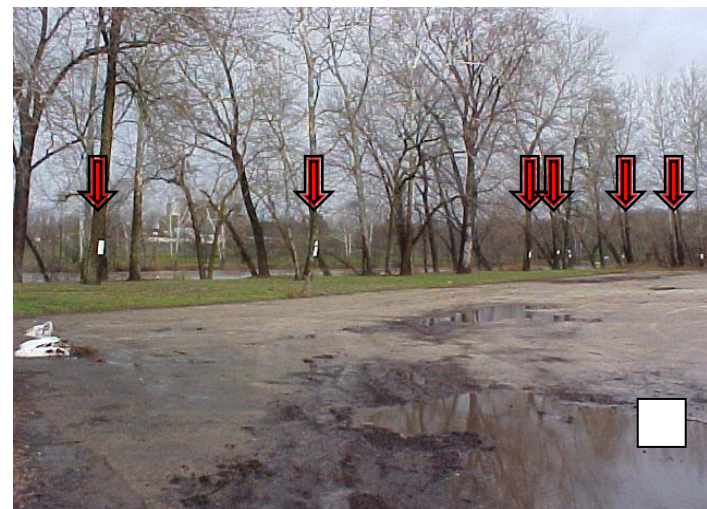
**In the case of a “semi-natural” trail system the signs should reflect sensitivity for the setting.** In some areas the current signage detracted from the natural environment, both because of its quantity and its poor condition. Many users might be more dismayed at the “sign pollution” (photos 3 & 4) than interested in the messages. These photos were taken at the Phoenixville PA Fish and Boat Commission Access, above Black Rock Dam.

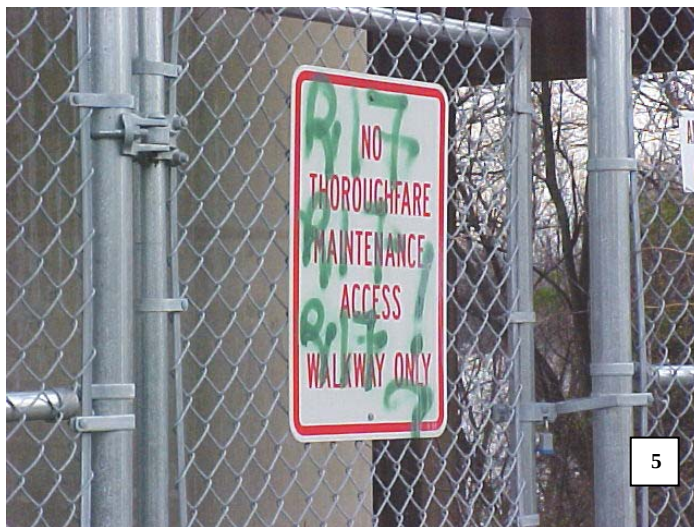
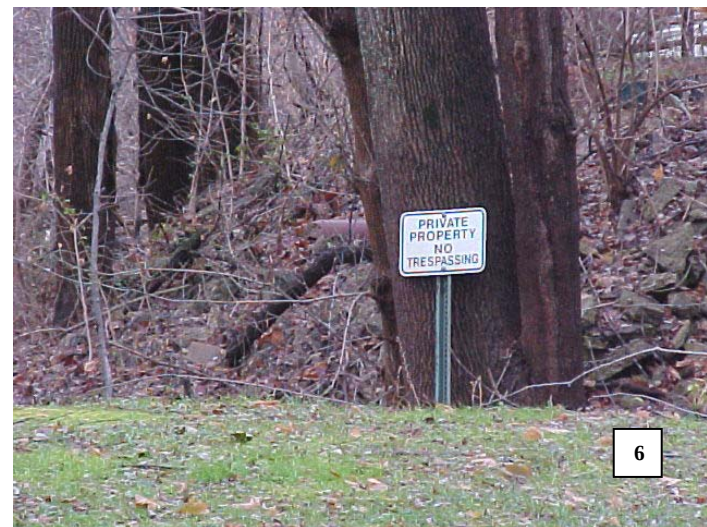
**Sign placement also needs to consider the immediate physical features;** currently there are signs obscured by trees or buried in vegetation. River hazard warning signs buried in the woods may contribute to serious liability issues in the case of injury or death. Other hidden signs may encourage extremely risky behavior (photo 5).

Damaged signs expose passersby to sharp edges. The post on the pictured sign below was broken at the ground. The sign and post can be used as a weapon. That the sign is on private property at the edge of the park at the Linfield Dam does not diminish the related risks.

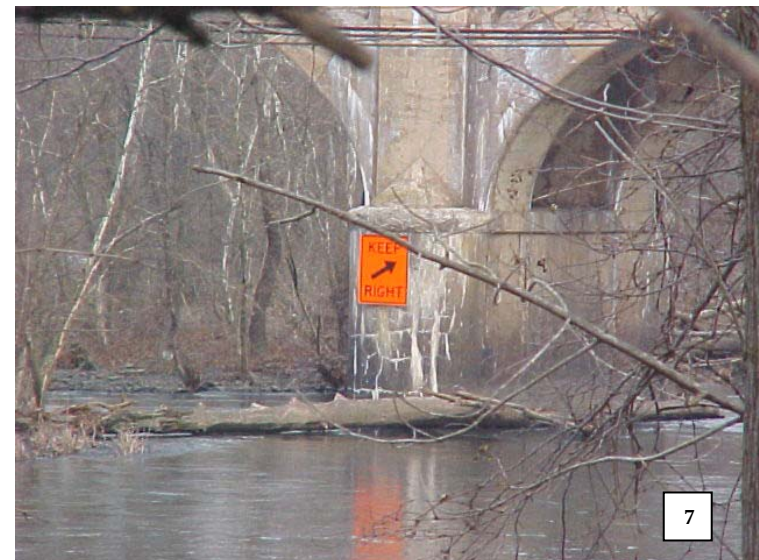
Upriver bridge abutments displayed few signs, if any. One exception was the Route 82 bridge in Birdsboro (photo 7). A “KEEP RIGHT” sign was added to the bridge supports to warn boaters to the right to avoid dangerous hydraulics on the left.

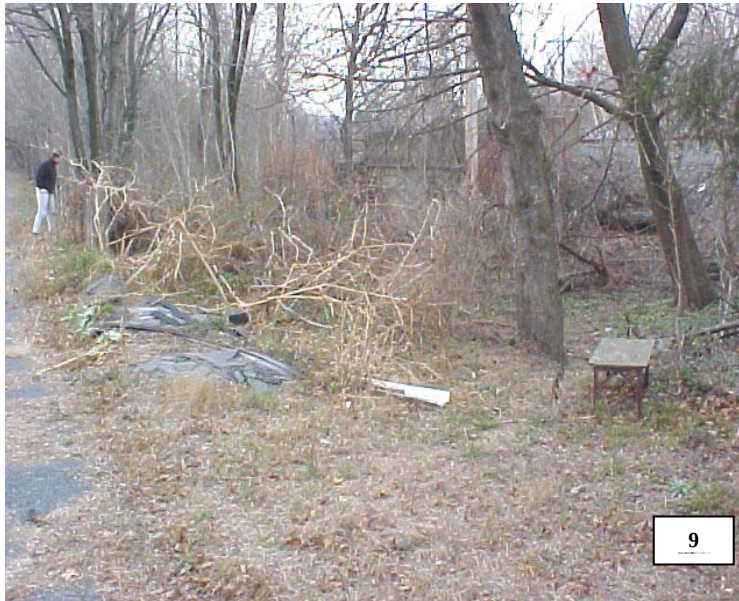
**Vegetation prevents effective surveillance** (photo 9). Even though it is defoliated due to the onset of winter, vegetation is still thick along the trail edges and results in numerous hiding places from which inappropriate actions can take place. Trail-side debris bears out the observation that miscreants hide in the woods, drink, smoke and use drugs (needle found along with bottles). Though the trail is generally wide enough on the prepared surface it is not wide enough on the sides to facilitate observations by trail users.

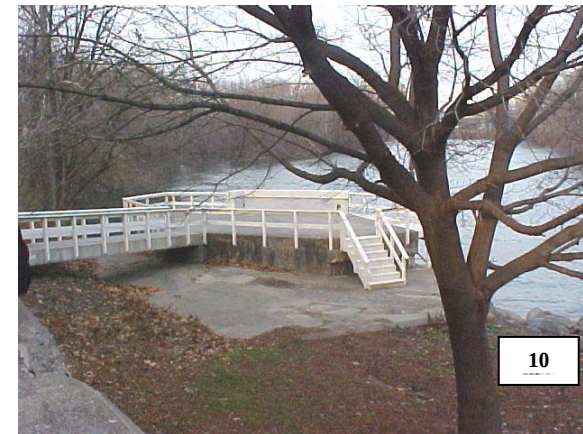
The observation platform in Bertolet (photo 10) is an appealing and attractive location that should draw visitors, but during the tour the odor of human fecal matter was noticeable. Nearby there was evidence of homelessness and vagrancy as well as gang activity. Mattresses, general trash and drug activity debris make this area feel very unsafe. If trail users feel this area is unpleasant or unsafe they will likely avoid the area, further surrendering it to the unintended users.

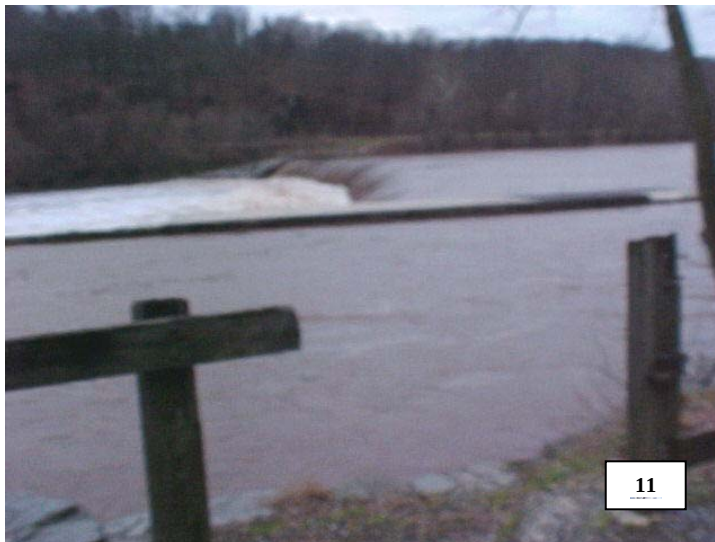
**Manufactured items need to be monitored and repaired periodically just as signs do.** For example, at the Manayunk Bicycle Trail there is a broken fence on the river-view segment of trail, exposing users to the possibility of accidental falls through broken segments. Flat Rock Dam is visible in the fence picture (photo 11).

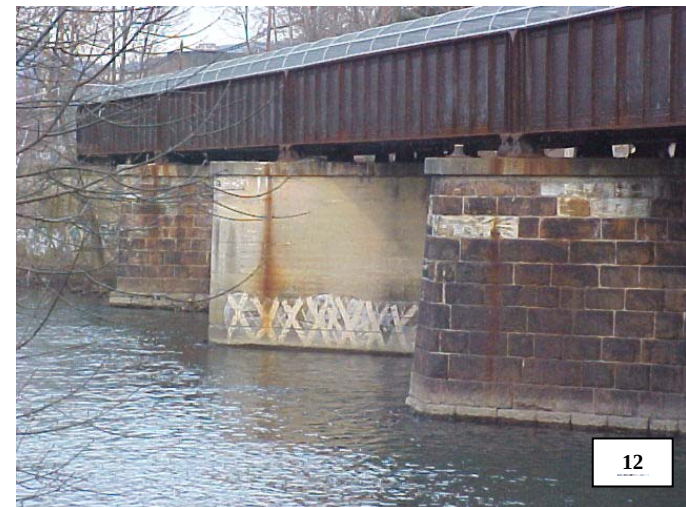
**As in the general concept of "Broken Windows" tagging invites more tagging.** However in photo 12 the tagging represents a conflict that may be dangerous; the crossed-out tagging indicates territorial conflict not usually found in tagging.

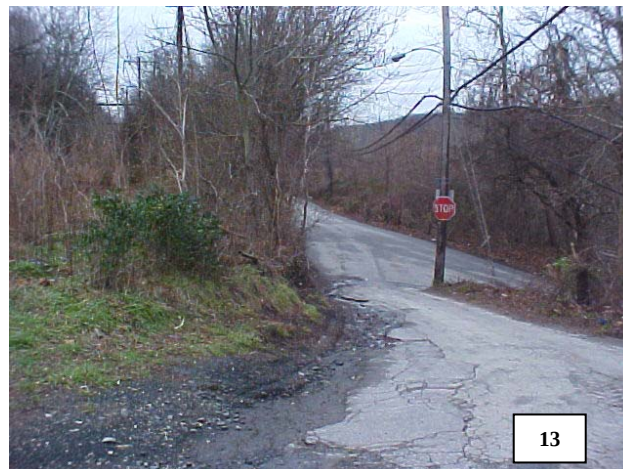
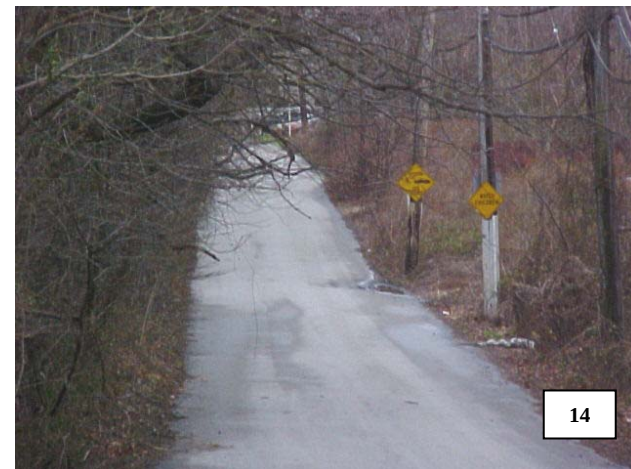
**Some perimeter hazards are also trail interior hazards.** Dangerous trail road crossings exist for bicycles and pose unfortunately high risks. Pictured here, in photos 13 & 14, is a slope in the trail leading down to a roadway with signage that is inappropriate and not maintained. The warning sign on the pavement was worn away making it undecipherable. Additionally, warning signage to indicate an impending risk for drivers is placed so far down the road from the source of the conflict/risk so as to render it nearly useless.

As mentioned before, **the incorrect placement of signage indicating hazards adds another level of danger.** The sign asking drivers to share the road is placed after the area in which they are to come across bicyclists coming down the slope of the paved trail. It is not hard to imagine someone on a bicycle entering the roadway without looking over his or her right shoulder (a difficult maneuver on a bicycle) to look

for conflict or danger. The angled intersection is visible in the first picture in this section titled “Hazards.” The angle of entry for crossing roadways is a known concern for the SRGA, as demonstrated during the tour.

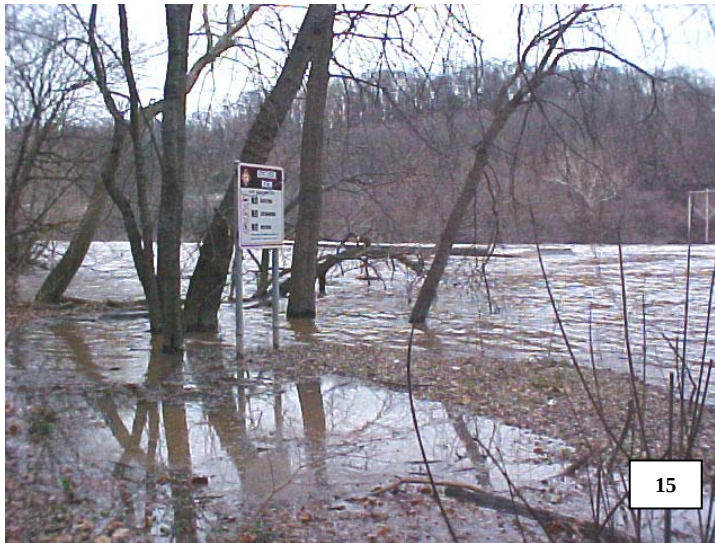
Pictured here, in photo 15, is a warning sign stating that no boating is allowed and that people should stay 200 feet back. The sign is in the woods on the bank of the river in alignment with the dam that was not visible under high water conditions. It would be a fair conclusion to make that the sign placement could contribute to serious injury or death. The liability seems extreme and avoidable.

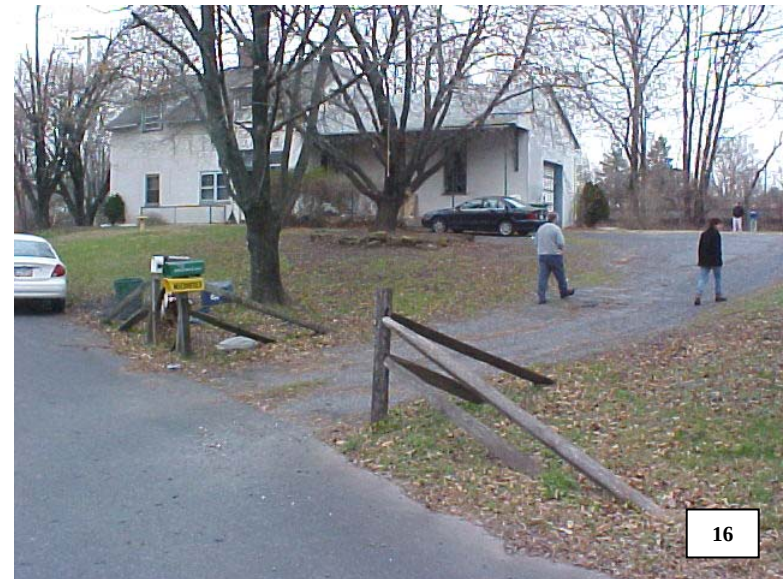
**There are disconnects between neighborhoods and trail locations among those visited.** Trailhead identification markers are non-existent for the most part. Simple railings and posts, photo 16, are the most common types of markers but they say nothing about the community in which they are found. What may appear to be a private drive or walkway is in fact an entrance to a trailhead. Some of the trailheads were difficult to locate during the tour. This reflects the ever-changing areas around some of the trailheads. Without appropriate signage there is a tendency to depend upon geographic indicators of place to find trail features.
