| SIO Shipyard Representative Bi-Weekly Progress Report | | |
| <b>Project: AGOR 28</b> | <b>Contract No.: N00014-12-C-0305</b> | <b>Shipyard: Dakota Creek Industries</b> |
| <b>Distribution Statement A:</b> Approved for public release; distribution unlimited. | | <b>Report No. A002.086</b> |

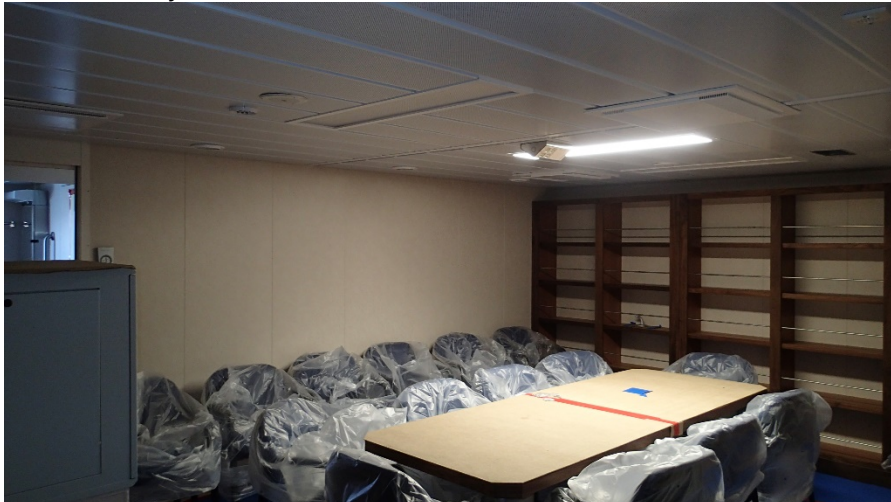
- Accommodation Spaces – DCI continues with the cleaning and prepping of staterooms for close-outs. Tile is being laid in the stair towers. Overheads and furniture have been installed in the Library/Conference Room.

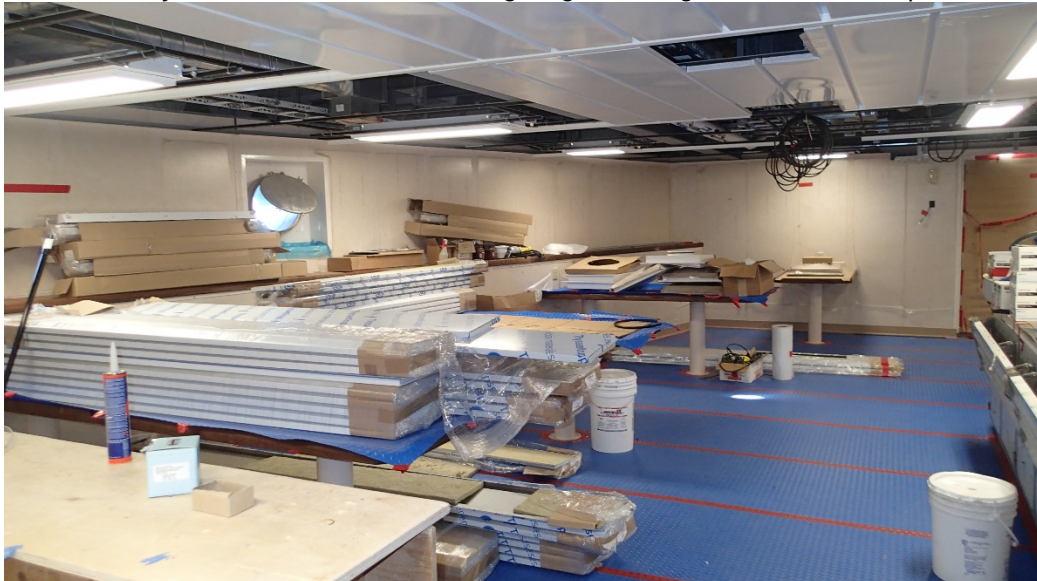
- Galley & Mess – Overheads and lighting are being installed in both spaces.

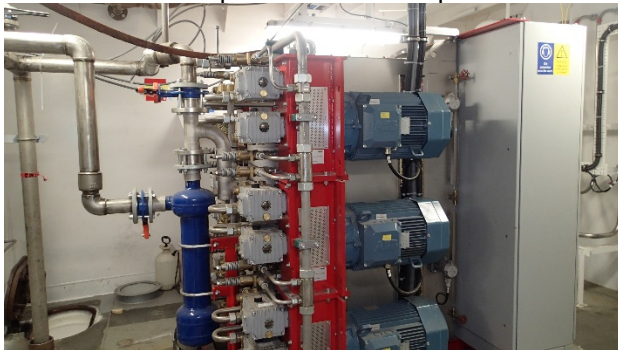
- Deck Machinery – Both the SSHD, CTDHD and Portable Crane were weight tested. The yard was unable to complete the weight tests for both the Stern Frame and Main Crane because both Allied HPU's would not produce the required hydraulic oil pressure needed. The pressure settings for both HPU's have since been corrected by Allied to their specifications. Both the Crane and Stern Frame will be retested.
- Hi-Fog System – The system was commissioned and successfully demonstrated to the USCG, with a couple of minor discrepancies that will be correct when new panel buttons arrive.

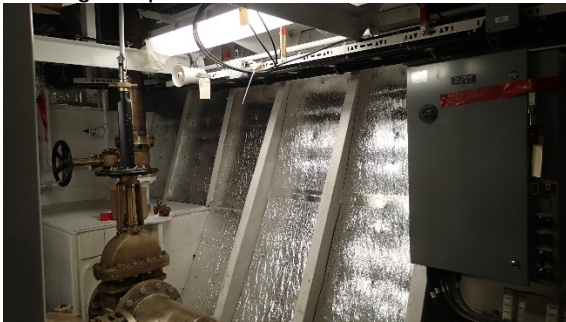
- Sally Ride Quad-Zero MLV – The yard is finishing up the last of the insulation and Quad-zero in the engine space.

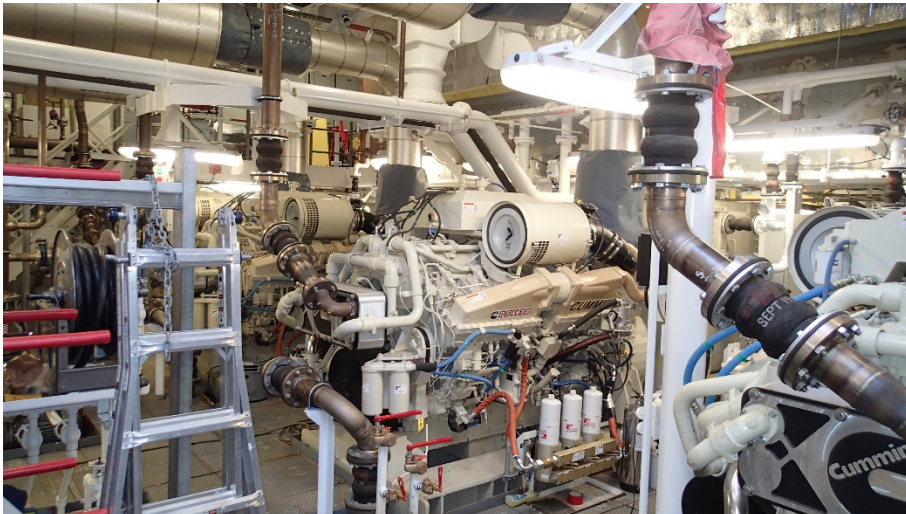
- Main Engine Room – The scaffolding has been removed and the yard is finishing up insulation and painting above the deck plates. Once this is completed, the bilge and deck plating will be cleaned and painted.
