| SIO Shipyard Representative Bi-Weekly Progress Report | | |
| <b>Project: AGOR 28</b> | <b>Contract No.: N00014-12-C-0305</b> | <b>Shipyard: Dakota Creek Industries</b> |
| <b>Distribution Statement A:</b> Approved for public release; distribution unlimited. | | <b>Report No. A002.045</b> |

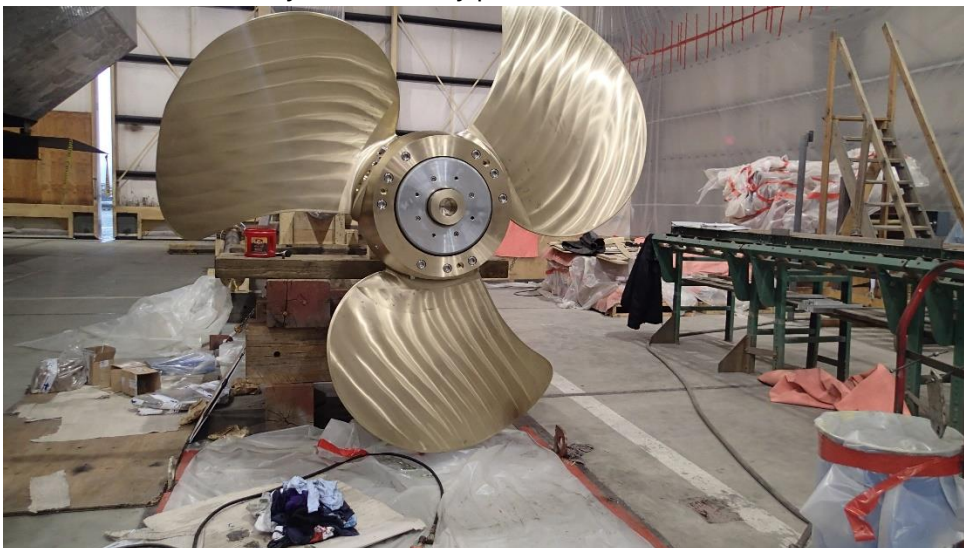
- Sally Ride Port Rudder – Inspected welds and pressure tested with ABS in attendance. No leaks found.
- Neil Armstrong CP Props – The man from Hundested was on site to install the blades to the hubs. The bolts were torqued, but the locking wire will remain off until after the pitch test has been done. 2.5-man days at a leisurely pace to do the work.

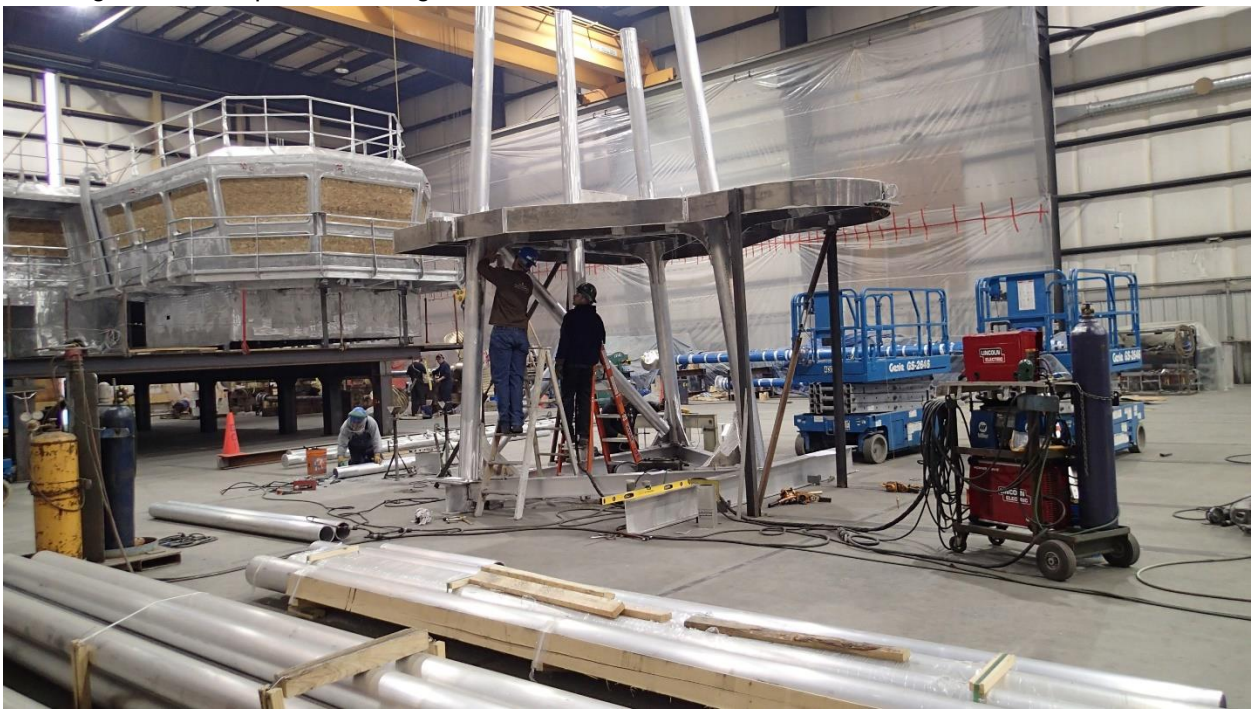
- Sally Ride Pilot House – A majority of the welding and fabrication has been completed. The exterior has been prepped for sand blasting and paint. DCI plans on painting the interior and installing the window prior to moving it onto the hull. Insulation to be installed as well.

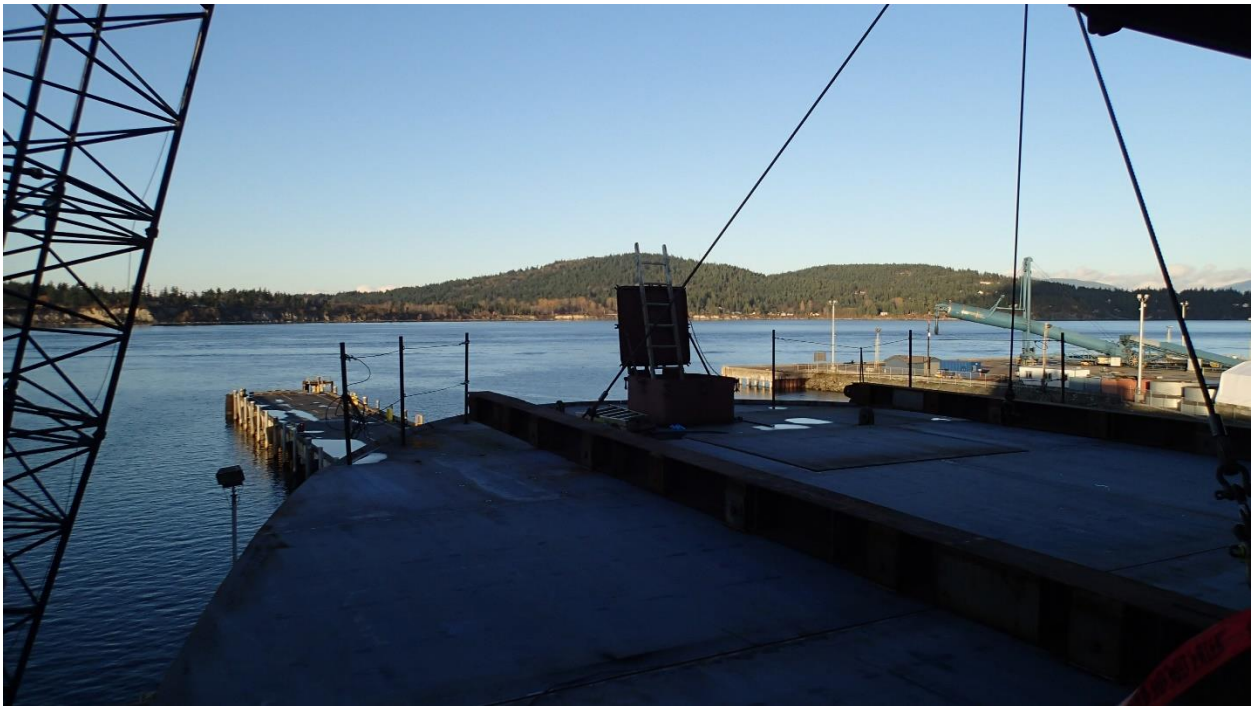
- Sally Ride Bow – The foc's'le deck was landed on the bow.
