| SIO Shipyard Representative Bi-Weekly Progress Report | | |
| <b>Project: AGOR 28</b> | <b>Contract No.: N00014-12-C-0305</b> | <b>Shipyard: Dakota Creek Industries</b> |
| <b>Distribution Statement A:</b> Approved for public release; distribution unlimited. | | <b>Report No. A002.079</b> |

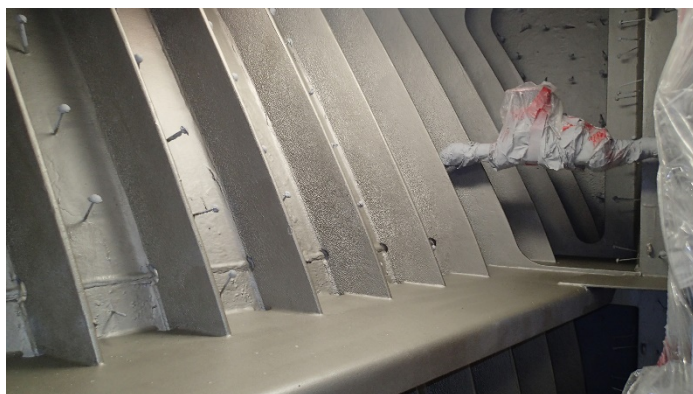
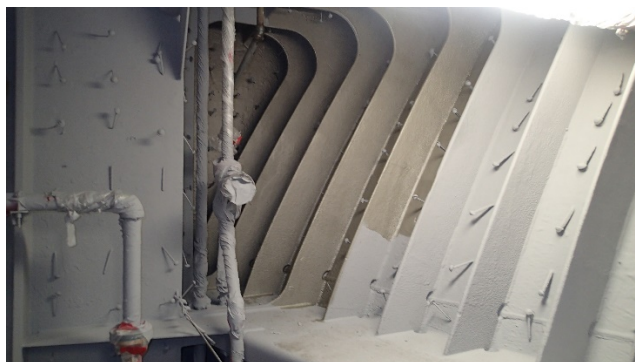
*Bow Thruster Room – Port and Starboard*

- **Tuff-Mass MLV and Acoustic Tiles** – The application of Delta-db in the BT room is complete and the treated surfaces are being painted. Tiles have been remove from the Tunnel Thruster space. To date, these and the area below the anti-roll tank are the only locations where the yard has removed tile.

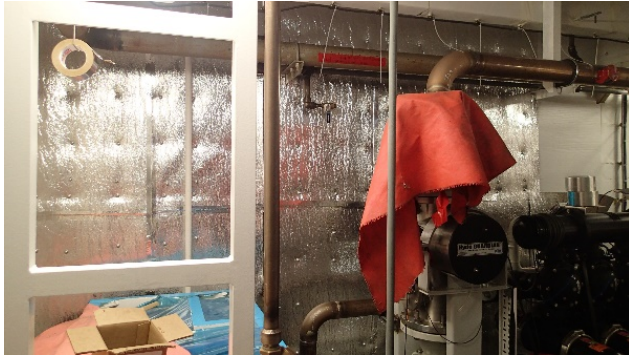
*Upper Machinery Space, Aft Starboard Bulkhead with Quad-Zero*

- **Sally Ride Quad-Zero MLV** – The yard continues to install the Quad-Zero in location with no sound dampening tiles. This includes the Main Engine Space overhead and aft bulkhead. The insulators switched to a 4-inch wide foil tape vice the 2-inch tape used previously, as they were having trouble getting the narrower tape to adhere to the insulation panels that are sheathed in Mylar.

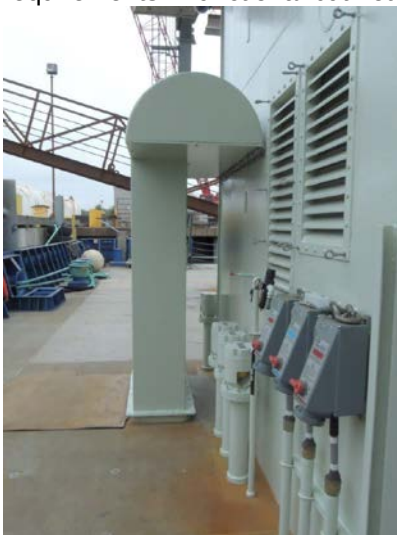
- **Main Deck Vent Closures** – DCI has installed a traction winch exhaust ventilation gooseneck on the main deck of Armstrong. The vent is fitted with a hinged closure and will meet reg body requirements. Functional but not pleasing to look at.

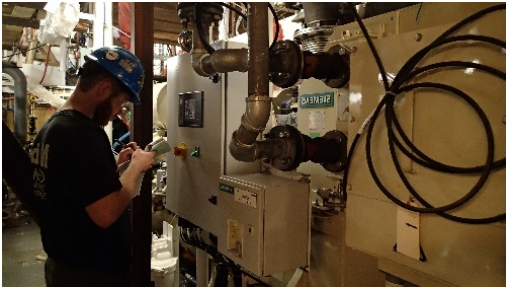
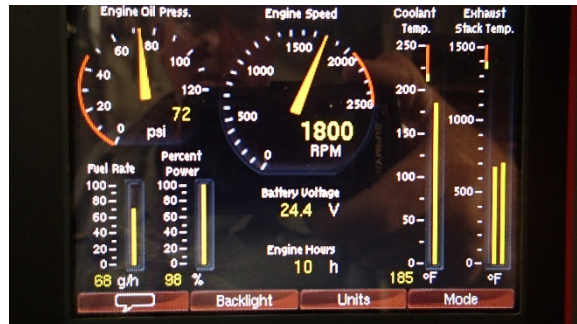
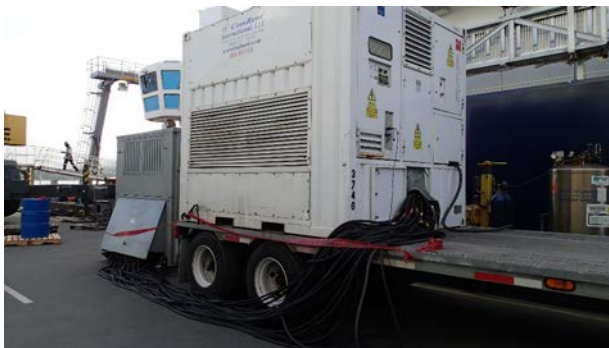
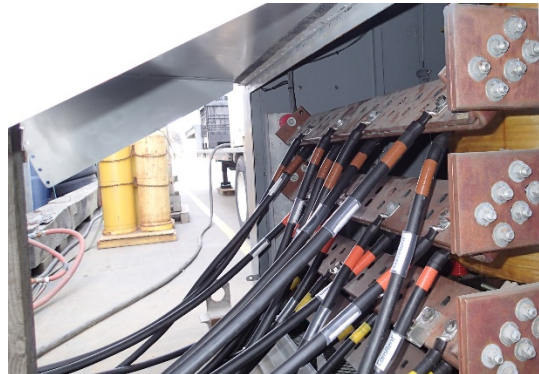
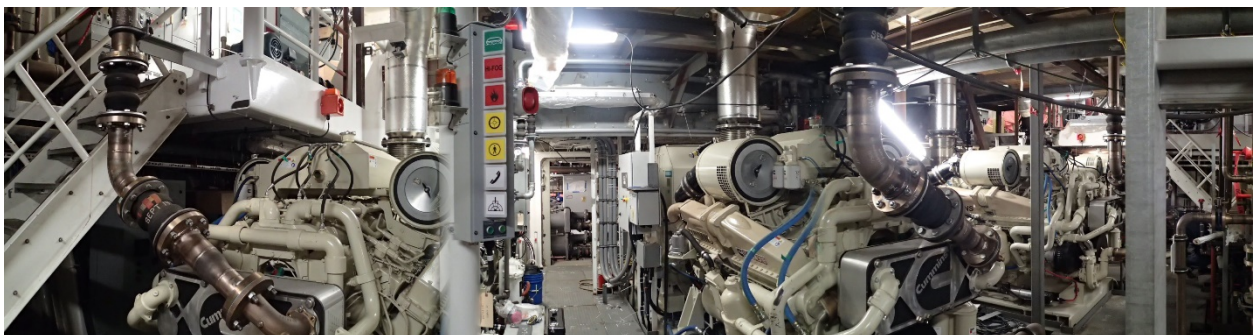
- Load Bank Testing - The Emergency Genset was tested at 100% load for 4-hours. The SSDG's were tested two at a time while in parallel for a total of 4-hours each at 100% load. Prior to load banking all engine alarms and shutdowns were demonstrated and found to be functioning. Siemens is now grooming their systems to the engines. Testing of various AC plant configurations and loads will continue this week.

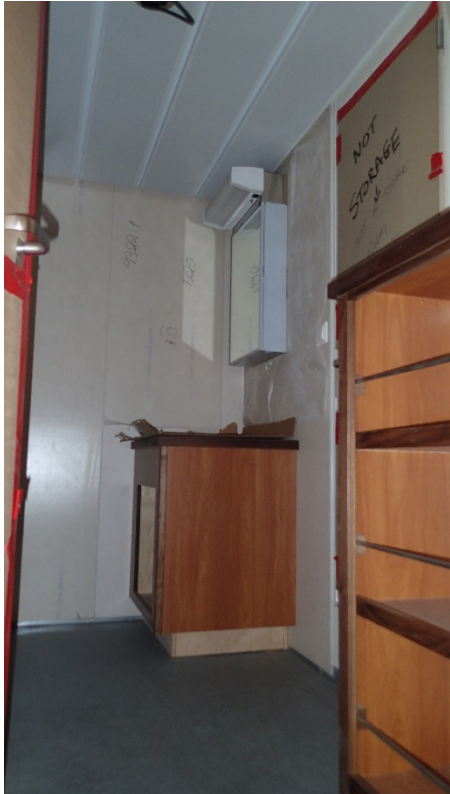
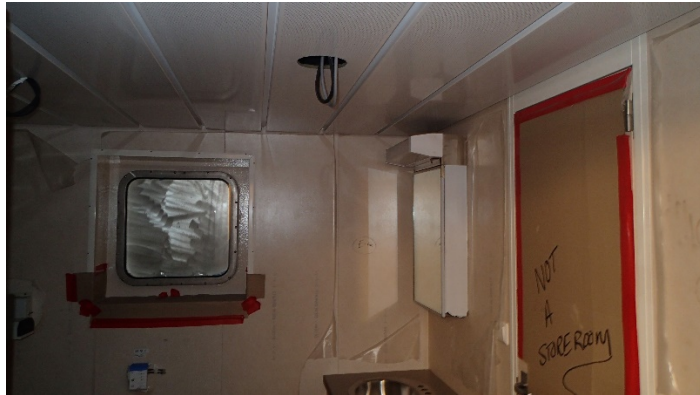
- Engine Exhaust – Work continues on completing the exhaust system insulation. During load bank testing, each exhaust joint was inspected for leaks while the engine was at 100% load.
- Central Fresh Water Cooling – Heat runs were performed on both pump sets, with cold and hot resistance readings. Current, voltage, flow and pressure readings were taken at 15-minute intervals for one hour.
- Sea Water Cooling – Heat runs were performed as described above.
- Deck Machinery Hydraulic Piping – Hard pipe is installed and leak testing has been started.
- Accommodations – Ceiling panels are up in several Foc'sle deck staterooms. Furniture and fixtures are being installed.
