#### March 2015 Volume 8 Issue 3

# All Shook Up

The LADEE Spacecraft Vibration Mishap

# SYSTEM FAILURE CASE STUDY

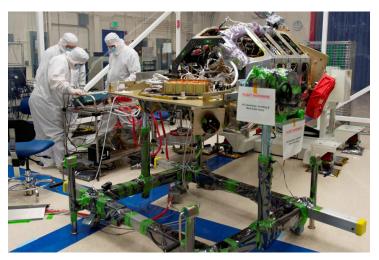
Figure 3. The LADEE spacecraft undergoing laboratory testing. Source: NASA
