## Cement and concrete as an engineering material: An historic appraisal and case study analysis

Colin R. Gagg \*

The Open University, United Kingdom

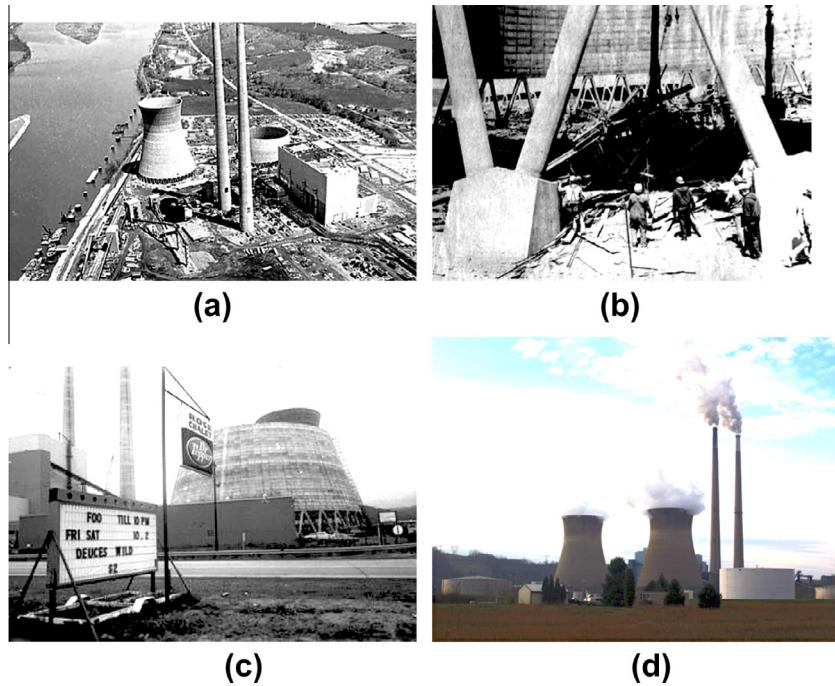
The Willow Island, West Virginia cooling tower collapsed ([Fig. 7](#)) while under construction on April 27, 1978, killed 51 workers in the worst construction disaster in U.S. history [[8–10](#)]. A jump form system was being used, with the formers secured by bolts in one-day and three-day-old concrete. The formers were designed to be progressively raised up the tower, as it was built. However, the temperature had dropped to one or two degrees Centigrade during the night. The National Bureau of Standards found that the concrete had not attained enough strength to support the formers. The report concluded that

**Fig. 7.** The collapse of a cooling tower at Monongahela Power's Willow Island Power whilst under construction (a–c); the site as it is today (d).

"the most probable cause of the collapse was the imposition of construction loads on the shell before the concrete of lift 28 had gained adequate strength to support these loads [11].

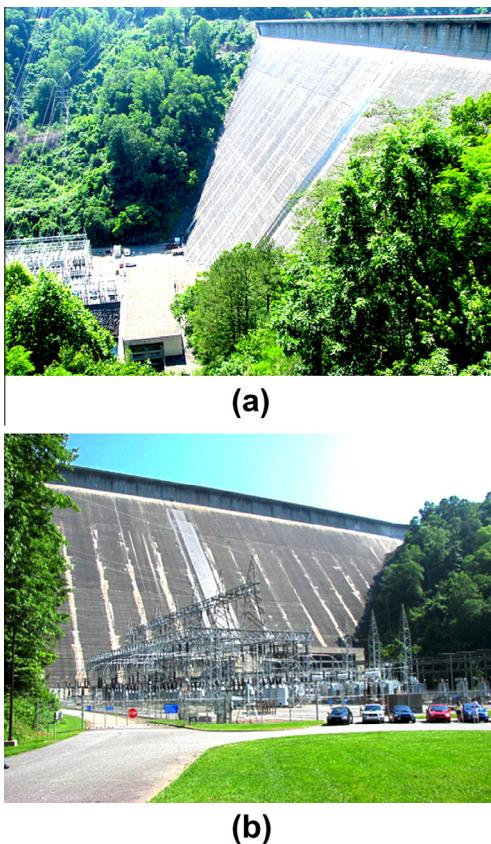
Dam failures and incidents involve unintended releases or surges of impounded water. They can destroy property and cause injury and death downstream. While they may involve total collapse of a dam, that is not always the case. At the time of planning and construction, Fontana dam (Fig. 8) was one of nine dams to be built to manage the Little Tennessee River. Standing at a height of 147 m (480 ft), with a width of 721 m (2365 ft), it was constructed between 1942 and 1945, by the Tennessee Valley Authority (TVA), in an attempt to provide hydroelectric power for the war effort. As it turned out, its generators began to produce electricity only a few months before World War II ended.

**Fig. 8.** The Fontana Dam and incline leading down to the powerhouse (a); electrical substation viewed from downstream side of dam (b).

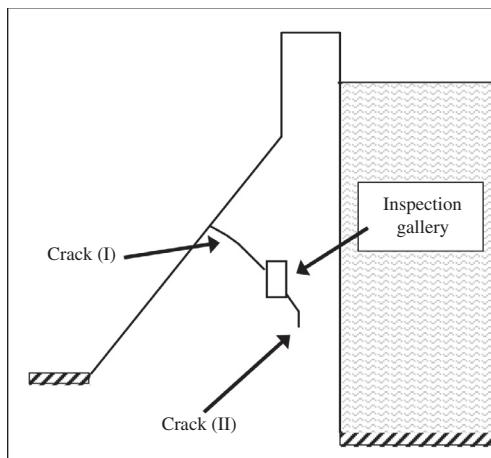
**Fig. 9.** Cracking in the Fontana concrete gravity dam as determined by the Tennessee Valley Authority (TVA) 1976.

During 1949 patterned cracking was first observed, along with what appeared to be the beginnings of an upstream movement of the dam structure. In 1972, deep cracking was observed in the walls of the foundation at the drainage gallery located in the curved portion of the dam (Fig. 9). Two hypotheses were postulated, either:

The Tennessee Valley Authority (TVA) monitored crack growth during 1973 and found that the crack was opening. Solar heat gain was thought to be the culprit. Two-dimensional analyses were performed in an attempt to determine the actual causes of cracking. This analysis determined that the foundation was not the problem; the rest of the dam was expanding and causing cracking in the curved portion.

Petrographic examination revealed an alkali-aggregate reaction i.e. a chemical reaction was occurring between the cement and the aggregate components of the concrete. This chemical reaction combined with solar heat had caused the cracking near the curved portion of the dam, with cracking of the main body of the dam being resisted by the foundation. Temporary solutions included spraying cold water on the downstream face to lower the temperature, with crack opening diminishing as a result. In addition, the area around the crack was post-tensioned with steel wire, pulling the crack closed.

A third potential cause of cracking in the dam has since been uncovered. It transpires that during construction, cooling pipes were run through the dam to lower the temperature during chemical formation of the concrete. These pipes cooled the dam too much and, as a result, it had to warm back up on the inside, in order to reach equilibrium with the outside.

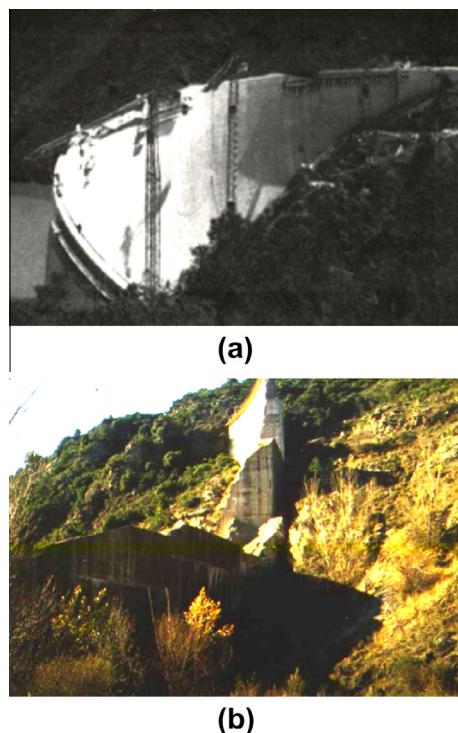
**Fig. 10.** Malpasset concrete arch dam under construction (a); right-hand buttress remnants after failure (b).

Little remained of the dam; failure had been sudden and catastrophic (Fig. 10b). The dam swung open and released the reservoir water. The dam itself broke away from the abutments and travelled downstream. A number of factors that probably contributed to the disaster seem obvious today. The geological condition of the rock was either not understood or not appreciated. Anthracite (hard coal) was then being mined at Boson just 4 km below the dam site. The thin coal deposits were mixed with grey schists and shale, and with large areas of soft white flourite. The different types of rock had incompatible qualities, exacerbated by a region with such weather extremes. In the summer, a severe lack of rain (dryness), and constant sun, baked the ground – with the differing rock types reacting in different ways. In the winter, torrential rains pounded the area, with some of the rock types absorbing the water. Furthermore, the situation would have been compounded by the probability of a non-homogeneous concrete structure, being a direct result of delays during construction.

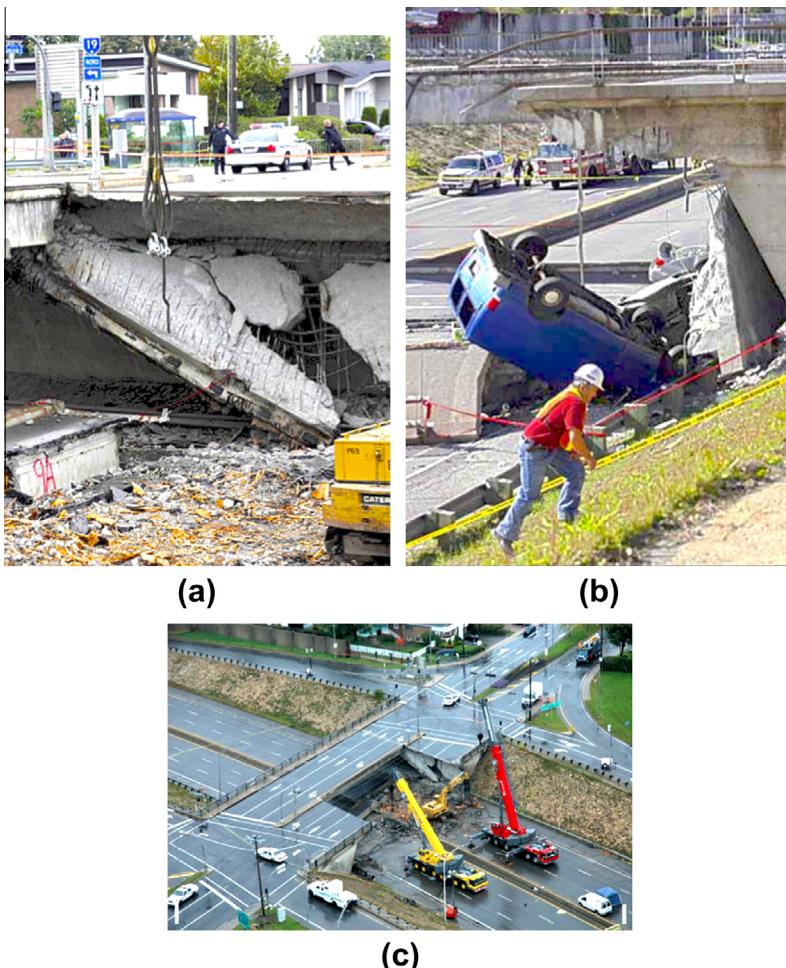
The commission found three major causes contributed to the overpass failure:

- Improper rebar support for the design, which caused a “plane of weakness” where cracks eventually occurred.
- Improper rebar installation at the time of the overpass’s construction in 1970.
- Use of low-quality concrete to build the overpass.

**Fig. 12.** Boulevard de la Concorde exit 5 overpass collapse in September 2006 (a–c).

- Shear vulnerability: The thick concrete overpass was vulnerable to shear failure because it was not reinforced to withstand cracking and deterioration.
- Lack of adequate waterproofing: A major repair job in 1992 called for a waterproof membrane. The engineer leading the project decided the concrete had deteriorated too much and did not install the protective membrane.
- Weakening of the structure in 1992: The routine replacement of expansion joints was a bigger repair job than expected, and engineers had to remove more concrete than originally anticipated to make the fix, weakening the structure.

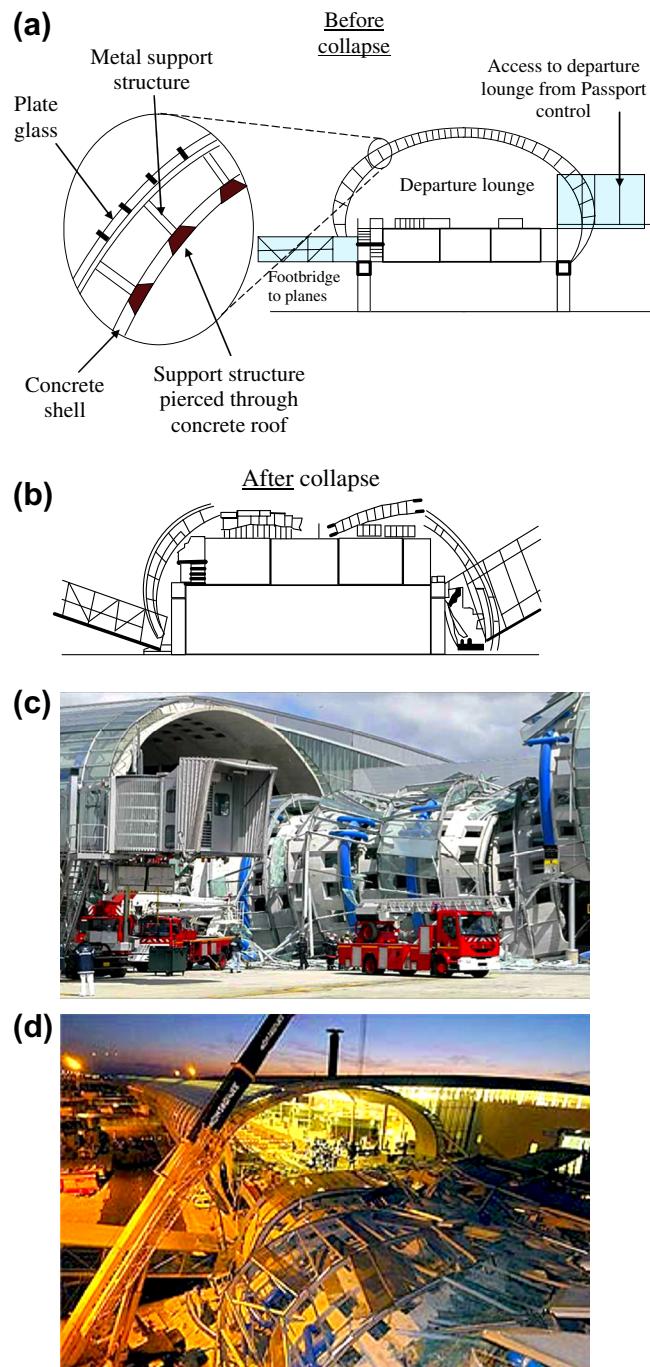
**Fig. 16.** Collapse of the newly constructed terminal 2E at Paris' Charles de Gaulle airport.

Several solutions for subsequent repair had been considered, but none offered a guarantee for the security of personnel and passengers. Therefore, the entire vault of terminal 2E was pulled down and rebuilt.

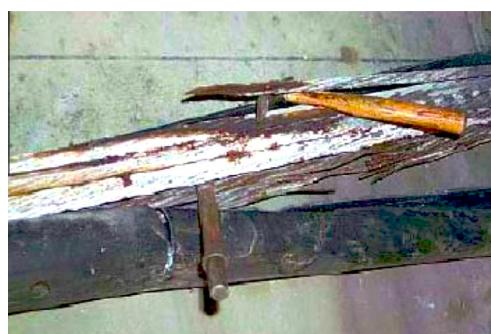
In the USA, during the spring of 1999, a corrosion-related failure of an external tendon was found in the Niles Channel Bridge, Florida, after the bridge had seen 16 years of service. Niles Channel Bridge is one of a series of low-level segmental bridges stretching over seawater in the Keys area. Further inspection revealed that two steel strands were corroded in the tendon anchorage. In 2000, due to corrosion problems, eleven tendons out of a total of 846 were replaced in the Mid Bay Bridge after seven years of service. Also, in the same year, numerous corroded steel strands were discovered in segmental piers of the Sunshine Skyway Bridge, built in 1986. The corrosion was a result of seawater entering the ducts through a split. Fig. 17 shows the corroded steel strands in segmental bridge tendons on the Mid Bay Bridge.

**Fig. 17.** Corroded tendons found on the Mid Bay Bridge.

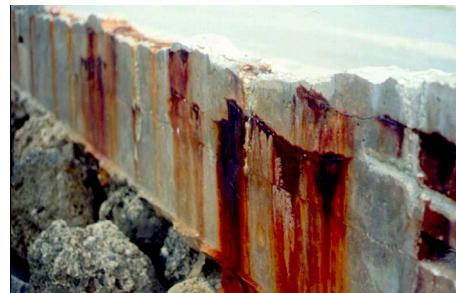
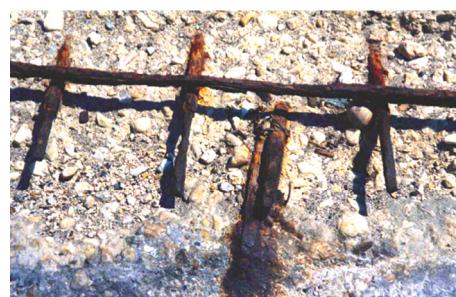
corrosion will become apparent as a result of surface spalling, delamination and staining (Fig. 18). When concrete corrosion has been identified, instigation of remedial work will be required to ensure continued integrity of the structure.

**Fig. 18.** Corrision staining of concrete sea wall (a); spalling concrete as a direct result of corrodng rebar on a bridge deck (b).

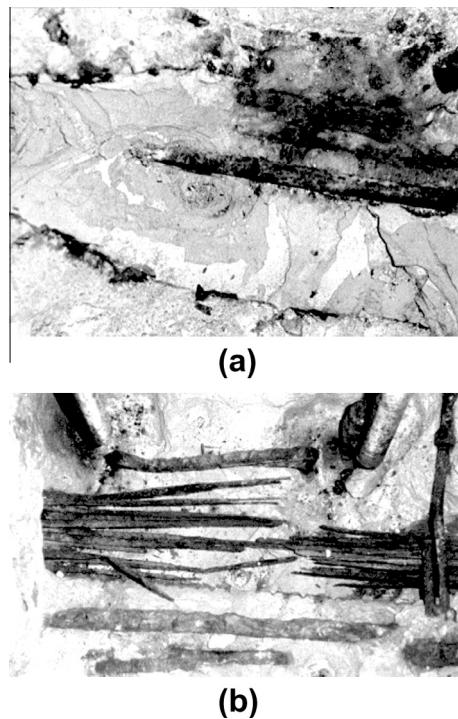
Pre-stressed tendons of the deck slab located below the crane rail gutters were in a badly corroded condition. The steel ducts were almost all destroyed by corrosion and in many cases stress corrosion cracking of the wires had occurred, as shown in Fig. 19(a). This failure mode will progress with little or no loss of cross-section. Sudden failure of the structural elements may occur with no visible warning of tendons deterioration.

In some instances, ducts were found to be totally un-grouted as a result of poor workmanship. In these situations the pre-stressed wires were not protected by the alkaline environment of the grout and a drastic degradation was found, as shown in Fig. 19(b).

In summary, extreme deterioration of the pre-stressing tendons was caused by an aggressive micro-environment, present in the rail gutters, that was linked to both poor materials and workmanship. Lack of drainage of the gutters had led to the accumulation of salt water on the concrete surface. Water evaporation deposited salts that lead to localised chloride concentrations. These conditions had lead to a high penetration rate of chlorides into concrete and therefore to the early development of the corrosion mechanism that overtook the tendons.

**Fig. 19.** Stress corrosion cracking found in pre-stressed wharf tendons (a); drastic degradation of wire tendons (b).

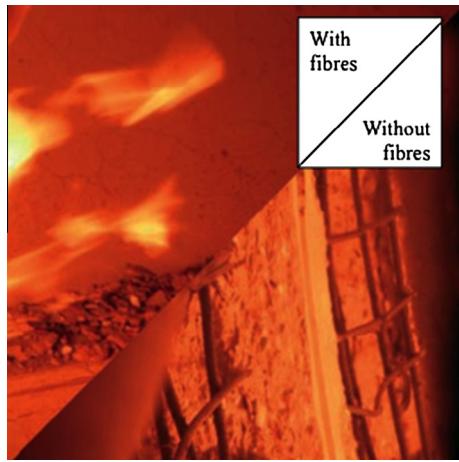
An accepted theory [25] is that by melting at a relatively low temperature of 170 °C, the polypropylene fibres create “channels” for the steam pressure in concrete to escape, thus preventing the small “explosions” that cause spalling. The study showed that the amount of polypropylene fibres needed to minimize spalling is about 0.1–0.25% (by volume). Further research is being carried out to determine the optimum fibre content for different types of concrete. The effect of polypropylene fibres on spalling is illustrated in Fig. 20, which shows HSC concrete blocks after two hours of fire exposure [26].

**Fig. 20.** The effect of polypropylene fibres on concrete spalling. The sample with fibre reinforcement stayed intact to a large extent; spalling of the sample without polymer fibre reinforcement exposes the steel rebar.

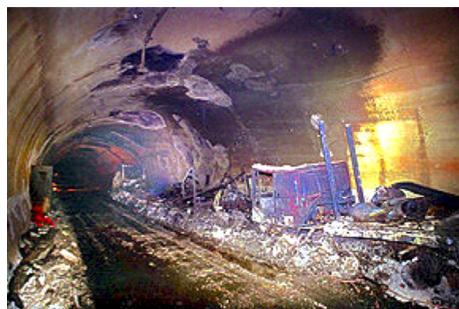
**Fig. 21.** Two examples of fire spalling of concrete: the channel tunnel (a); the Mont Blanc tunnel after the fire (b). In both cases, damage sustained by the concrete is clearly visible.

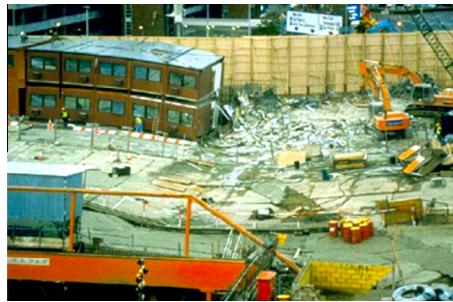
**Fig. 23.** Express rail tunnel collapse at Heathrow airport 1994.

lished a report on the safety of NATM which revealed that over 100 incidents had occurred during tunnel construction in the 30 years that the technique has been used, with more collapses known to have occurred but not to have been reported. When analysing the background of these collapses, the most important fact to emerge is that the large majority of NATM tunnel collapses have occurred during construction. Moreover, the principle collapse in NATM is the face failure, i.e. collapses have occurred only at the face where the lining is still weak and cantilevered. Completed, correctly constructed NATM linings have almost never failed. However, the design of NATM tunnels relies heavily on the available data of the soil conditions [31,32]. It has been claimed, that designers of NATM tunnels often had insufficient data to work with, and in fact, most NATM collapses are connected with 'unexpected ground conditions'.

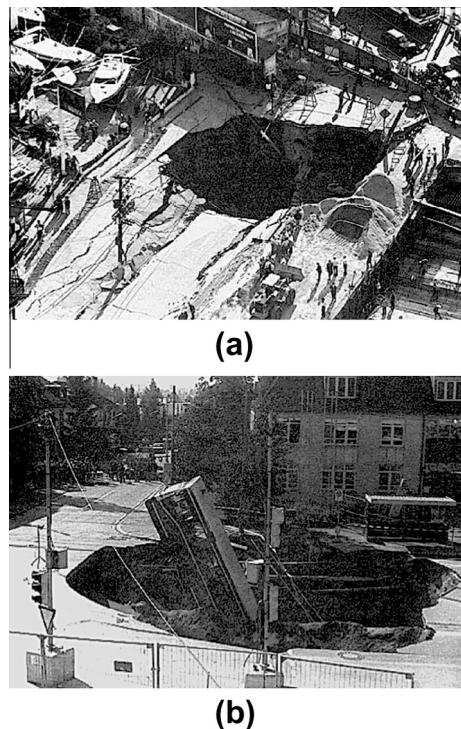
**Fig. 24.** Tunnel collapse in São Paulo Brazil 1993 (a) and Munich Germany 1994 (b).

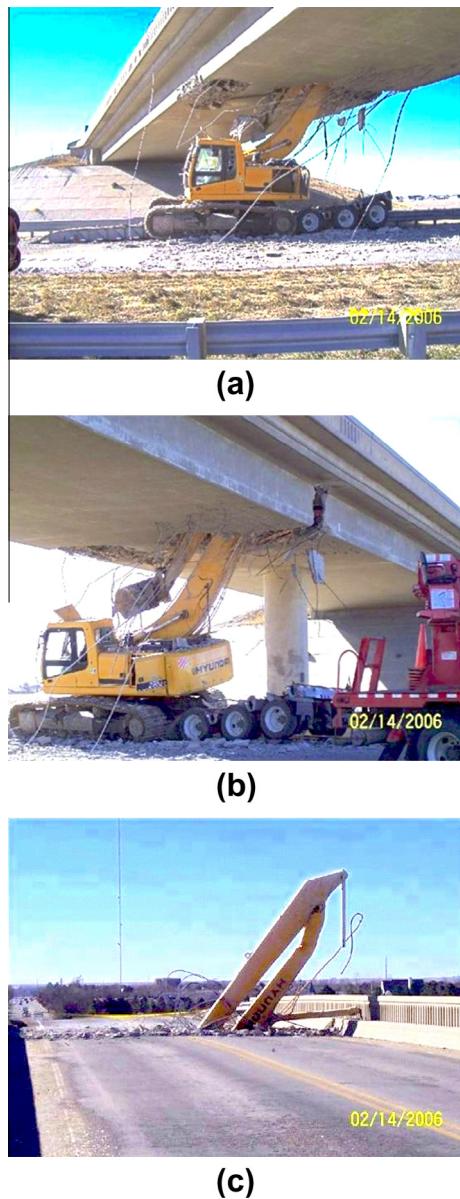
**Fig. 26.** It is impossible to design for every eventuality !!.

As a parting thought, it may be impossible to design for every eventuality. A backhoe weighing 8 tons was being transported on top of a flatbed trailer. The combination was heading east on Interstate 70 near Hays, Kansas, USA. When the shovel arm hit the overpass, it sliced almost halfway through the reinforced deck (Fig. 26). The overpass deck was constructed from commercial-grade concrete, reinforced with 37 mm diameter steel rebar spaced at 15 cm intervals in a criss-cross pattern layered in 30 cm vertical spacing. Strong enough to support the passage of a tank regiment, but not the cutting action of a backhoe.
