Evacuation of Students to Dining Hall/Dormitory and Construction of Walls to Separate Classes

Abstract

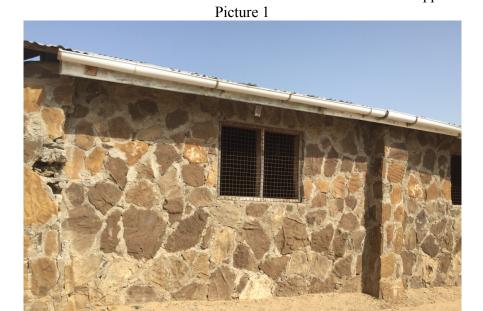
The collapsing corridor, seen in appendix 1, pictures 1-7, is noticeably structurally unsound. It was made from concrete with large aggregates of sandstone. The cement separating these aggregates is greatly cracking. Large aggregates are crumbling out from the wall; there are very large cracks in the concrete going from the bottom of the wall to the top. The concentration of the largest cracks is outside classroom 5, shown in picture 1.

2.2 – **Assessment of Existing Facilities/Services**: The corridor may collapse at any moment. It is imperative to move the students immediately out of classroom 4 and 5.

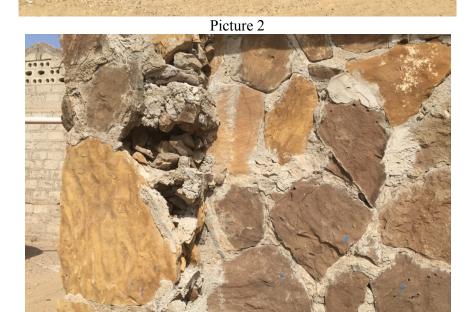
Classroom 5 is the most structurally unstable classroom. The column has a large chunk of cement missing (picture 2). The side of the classroom has rocks missing from the concrete (picture 4). The columns for classroom 4 and 5 are bowing outwards. The column for classroom 4 is shown in picture 3, and for classroom 5 picture 6. The columns for classroom 4 and 5 are cracking off the wall (picture 7). The columns do not support the ceiling weight at all. For classrooms1, 2, and 3, the columns are still attached to the wall and are not bowing outwards. The largest cracks for classrooms 1 and 2 are at the bottom of the wall, as seen with picture 5.

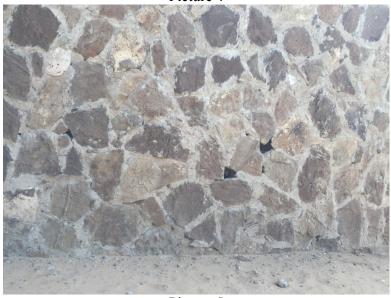
Picture 5

to the wall and are not bowing outwards. The largest cracks for classrooms 1 and 2 are at the bottom of the wall, as seen with picture 5.

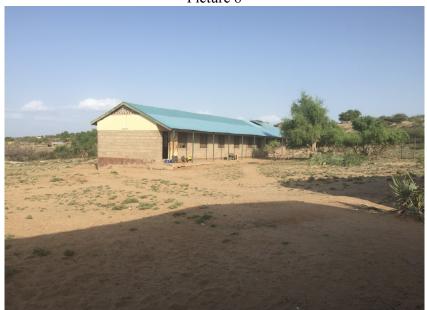
Picture 8

Both the dormitory and the dining hall are made from the same concrete, and the aggregate is finer than of the corridor. They are shown starting with picture 8.
