# Flight below minimum altitude involving Boeing 737, PK-LDK

19 km south of Canberra Airport, New South Wales on 14 June 2024

Aviation Occurrence Investigation (Defined)

AO-2024-035

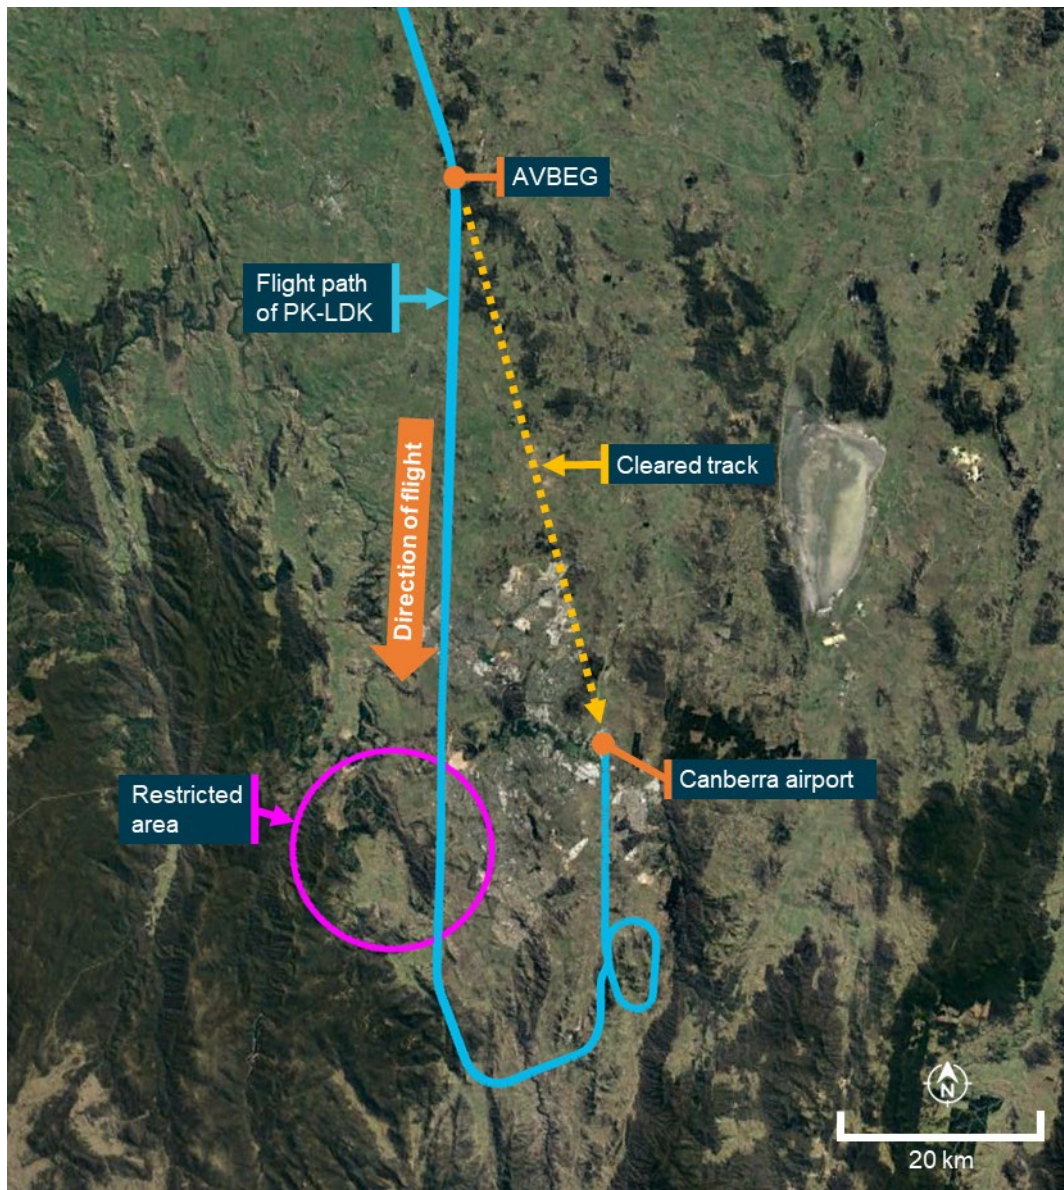
**Figure 1: Overview of the descent**

At 0543, the controller managing the airspace handed over management of the airspace to a controller commencing work. This oncoming controller identified that the Batik Air flight was deviating from the cleared track (direct to Canberra) presented in the ATC system while still in controlled airspace. The oncoming controller was unsure if the aircraft was deviating from its clearance or if it had been provided the clearance by the outgoing controller and that clearance had not been entered into the ATC system. The controller also noted that the aircraft was descending toward an active restricted area (Figure 1).

The controller did not query the crew's deviation or provide a safety alert (see the section titled *Safety alerts*) but instead asked the crew if they were going to remain clear of the restricted area 17 NM to the south of their position. The crew advised the controller that they were tracking via the AVBEG 5A STAR. The controller acknowledged the tracking advice and instructed the crew to maintain 10,000 ft above mean sea level (AMSL) to remain above the restricted area. After receiving this instruction, the crew became
