# Engine failure involving Boeing 737, VH-VYH

Sydney Airport, New South Wales, on 8 November 2024

## **ATSB Transport Safety Report**

AO-2024-057

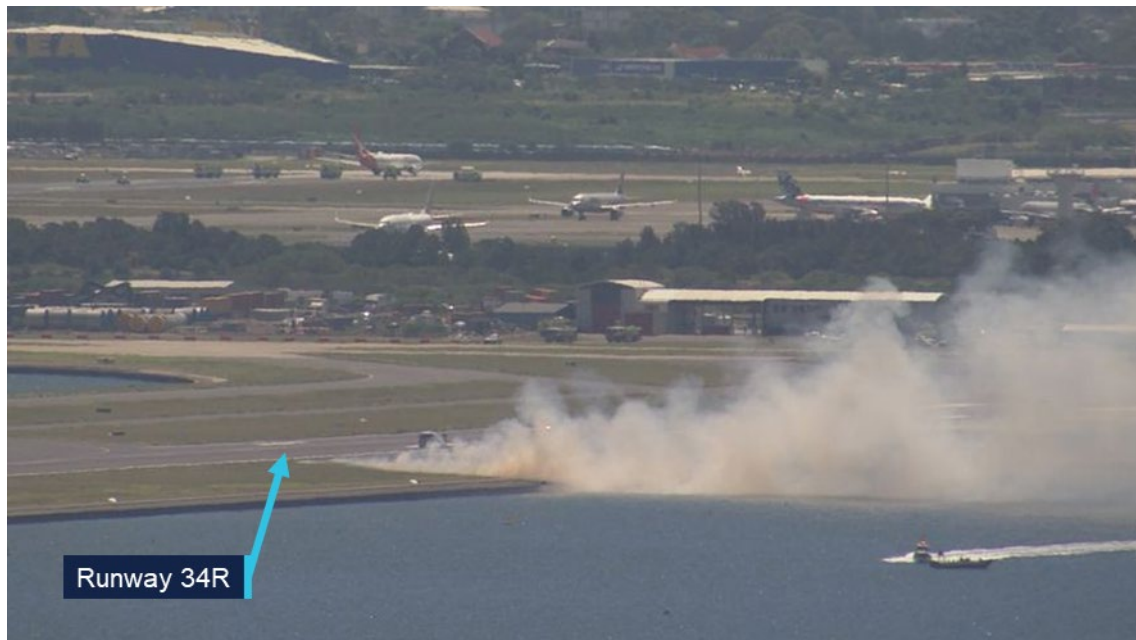
**Figure 1: Grass fire next to runway 34R**

The flight crew requested a return to Sydney Airport and ATC directed the flight accordingly. The aircraft was slightly over its maximum landing weight due to unspent fuel, and the expected landing distance was higher for a single engine landing. The flight crew therefore planned to land on runway 34L, which was longer than runway 34R (3,962 m vs. 2,438 m). In addition, ATC closed runway 34R, due to fragments from the engine, which ignited a grass fire next to the runway (Figure 1).

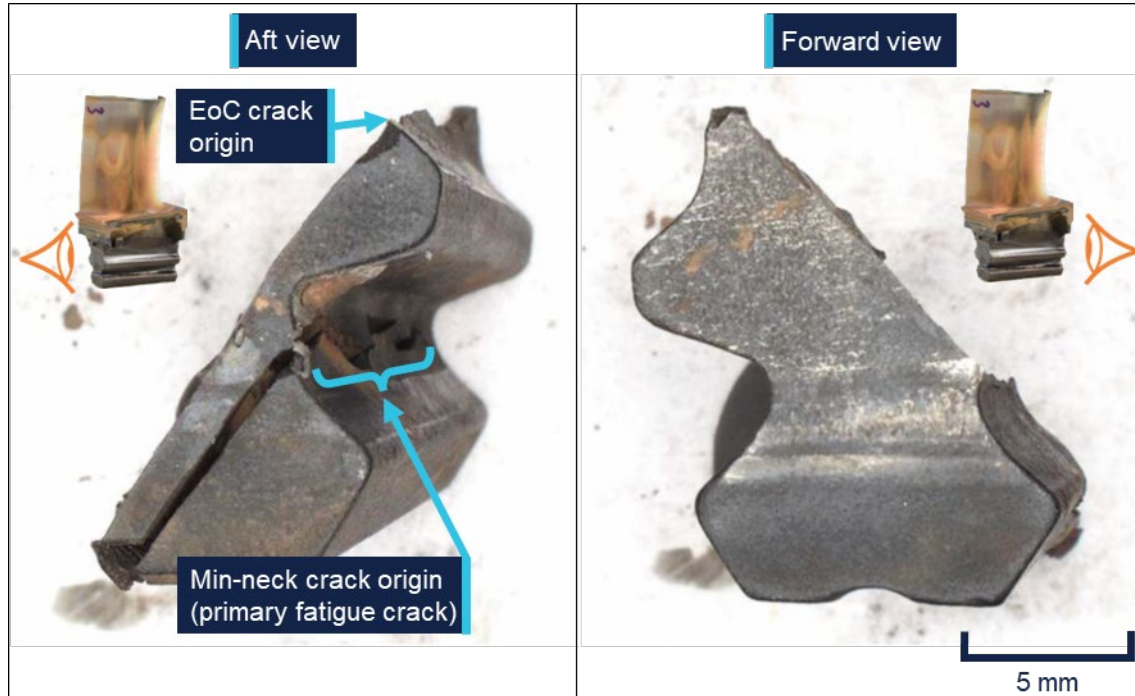
**Figure 6: Dovetail of blade 50 recovered from the HPT disc**

Blade number 50 was one of the 2 blades that experienced a below-platform failure. It exhibited the most extensive fatigue cracking. Conversely, the other blade with a below-platform failure, blade 51, exhibited no evidence of fatigue, failing purely due to tensile overstress. The manufacturer noted that there had been previous occurrences involving a below-platform fatigue failure where the adjacent blade failed in the dovetail due to tensile overstress resulting from contact with the liberated blade. The remaining 74 blades failed due to overstress fractures at the base of each aerofoil.

The fracture morphology of blade number 50 was examined to determine how the cracking progressed. The dovetail recovered from the HPT disc is shown in Figure 6.

*The edge-of-contact (EoC) crack originated where the blade made contact with the HPT disc during normal operation. The min-neck crack originated where the dovetail's cross-section was at its thinnest.*  
Source: CFM International, annotated by the ATSB
