# Structural Redesign of the Steering System for Team Falcon E Formula Student Car

## Reason for Redesign — Previous Steering Column Bearing Mount

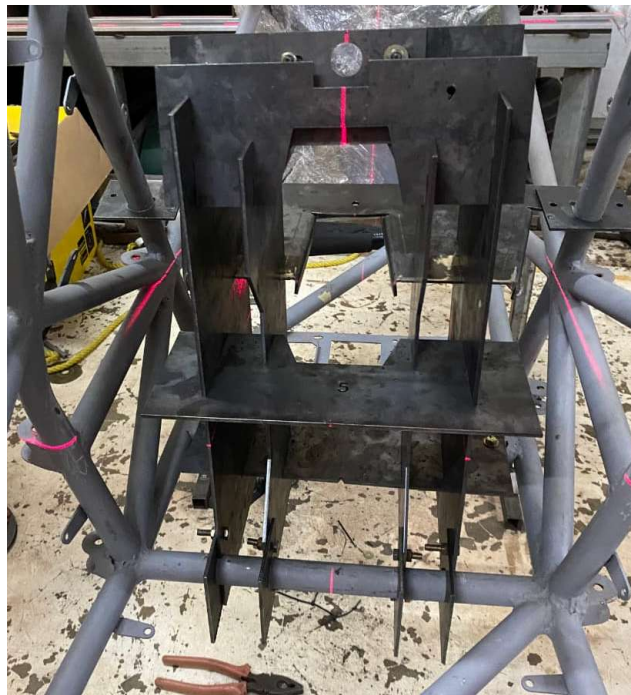
*Figure 4 -Alignment using laser*

Following the completion of the design phase, the steering column bearing mount was fabricated and assembled using the dedicated alignment jig. Prior to welding, the jig was precisely aligned using a laser alignment tool, ensuring that both bearing collars were held in perfect coaxial alignment with the steering shaft axis. Once the laser alignment was confirmed, the components were secured within the jig and the mount was welded in position. The use of laser alignment eliminated any manual positioning error and guaranteed that the final welded assembly maintained the exact bearing collar positions defined in the CAD model. This process ensured a binding-free, low-friction steering shaft installation with minimal steering play in the finished assembly.

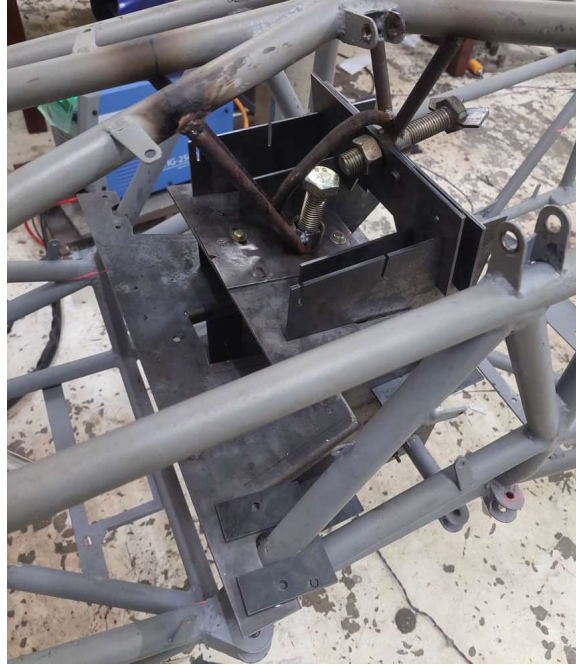
*Figure 5 - Welding Process*

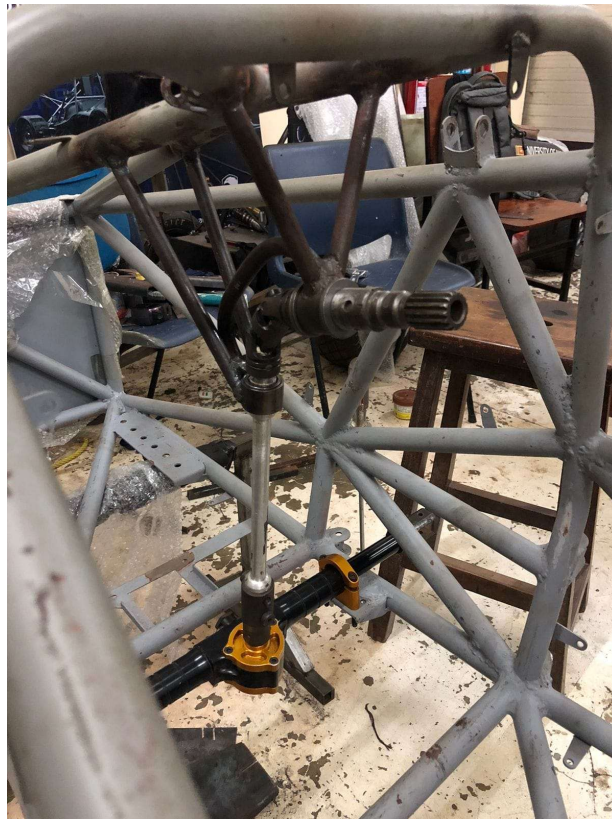
*Figure 6 -Steering system after fabrication*
