MSE 1031 Project Report

Failure Analysis of the Kaohsiung Gas Explosion (2014)

Root Cause Investigation and Liability Assessment

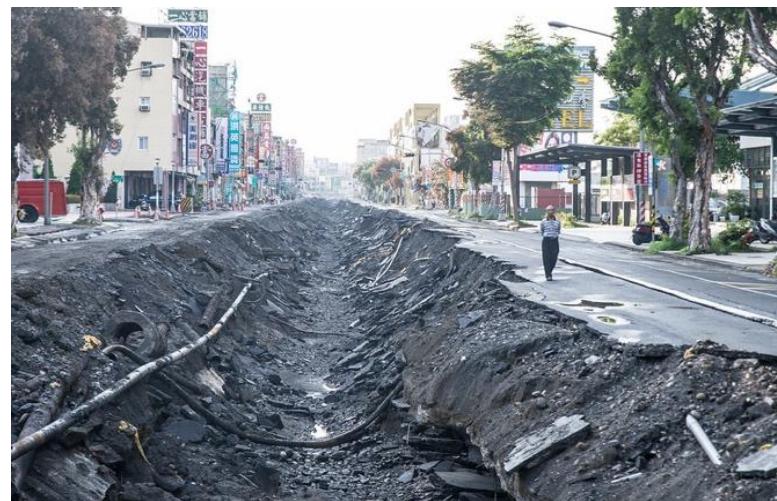
Figure 2. Aftermath of the Kaohsiung Gas Explosion [3]
