## TECHNICAL REPORT

### Regarding Grazing of Cattle Guard of Train No. 64582 (DLI–HRF MEMU) with Unloaded Rail Panel at Km 1298/15 in HRS–HRF Section

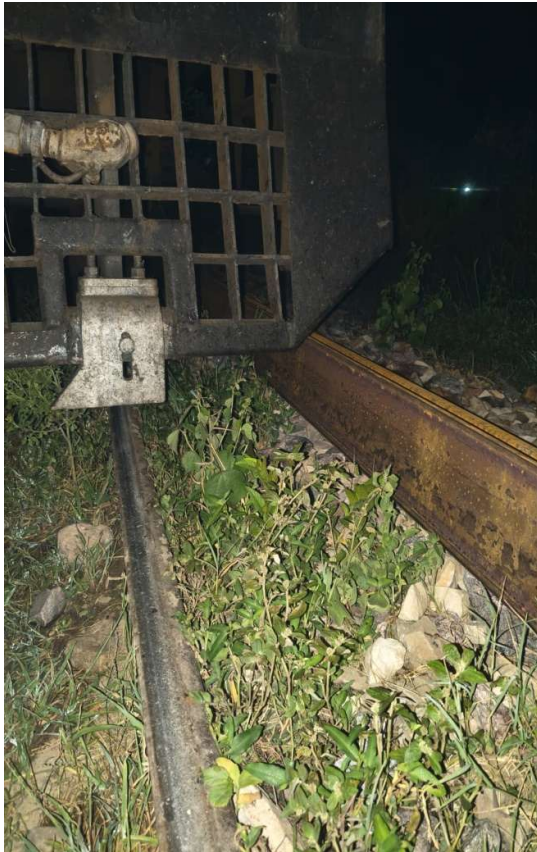
**Cattle guard (No mark found)**

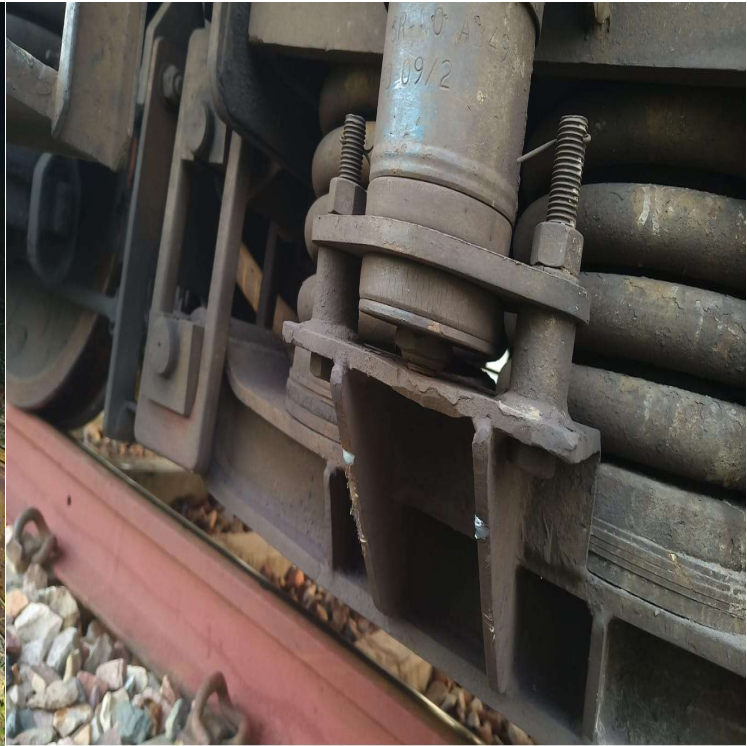
During passage of Train No. 64582, the cattle guard consequently came into contact/grazed the unloaded rail panel, producing the sound noticed by the Loco Pilot.

**Vertical damper with mark**
