Invoice Number : INV29453 **Date** : 22/01/2026

Site Name : Menkind Worcester **Site Code**

Work Type : Electrical **Description** : Lamp changing

Call Slip

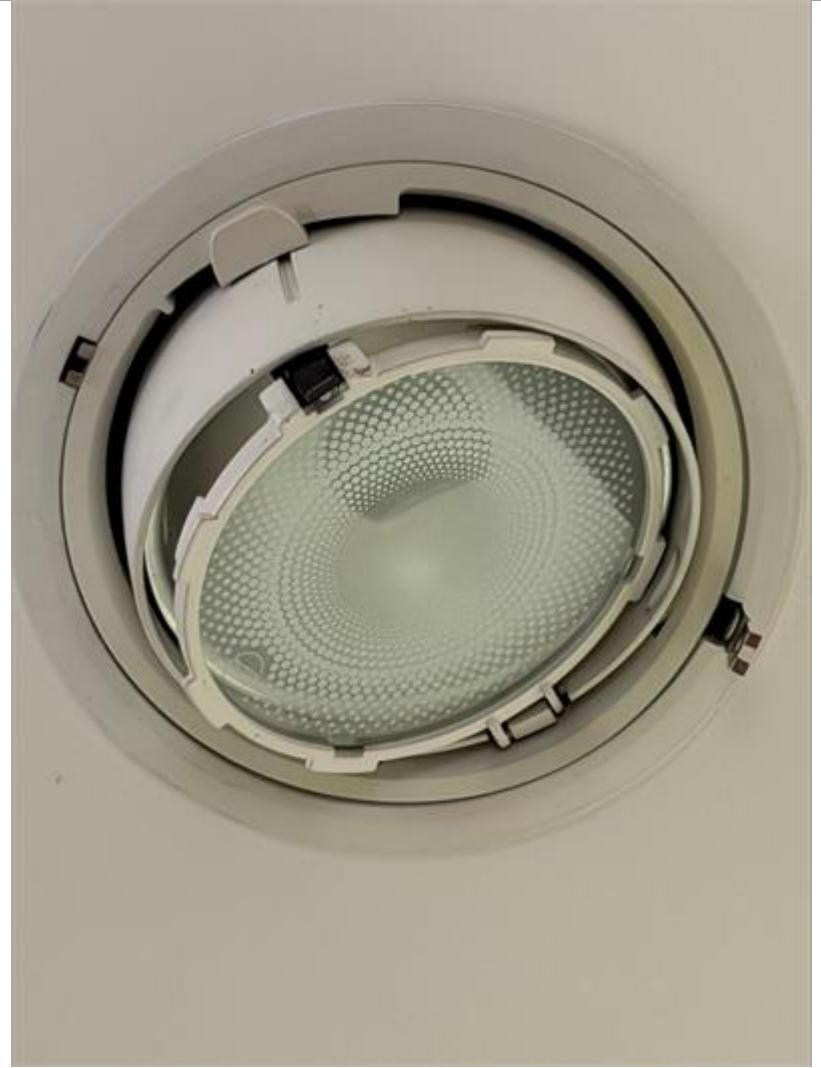
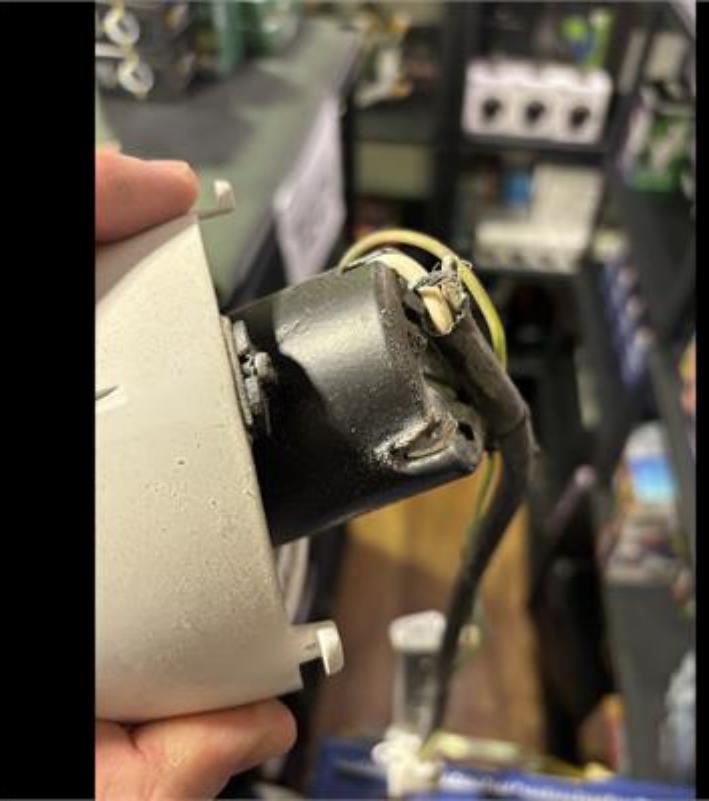
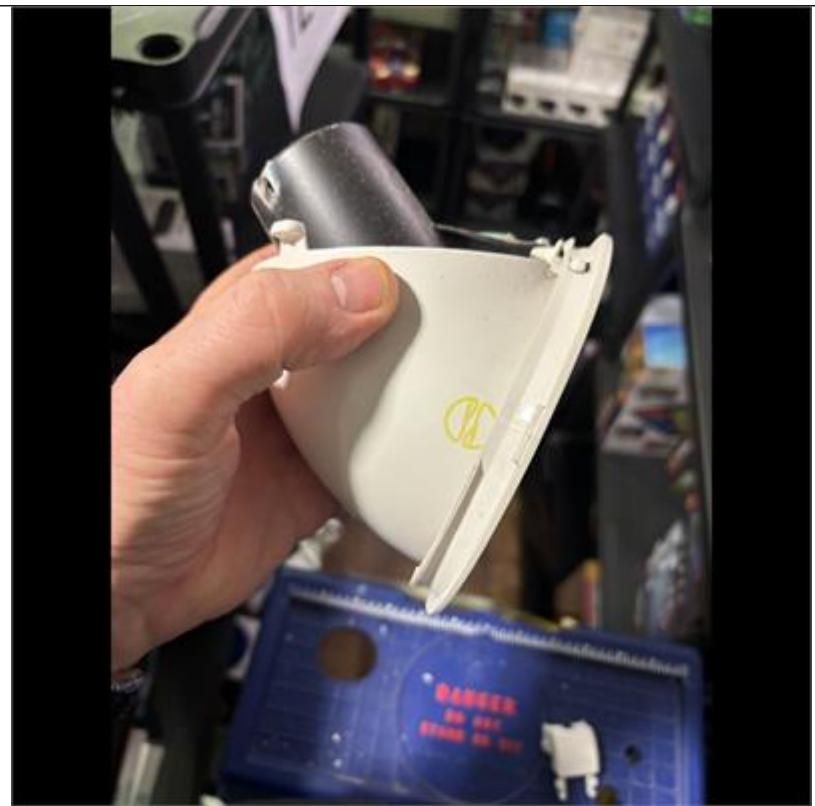
Attachments

Work Started	Comments	Quantity	Unit Cost	Nett	VAT Rate	VAT	Total
14/01/2026 13:45	Electrician attended site to investigate report of failed lighting to the shop floor which is showing sparks as instructed. On inspection found cabling to the back of the lighting brittle & worn away causing it to arc. Undertook necessary repairs to make safe & isolate. All left in good safe order.	1.00	£132.30	£132.30	20.00%	£26.46	£158.76
Job Totals				£132.30		£26.46	£158.76

Engineer Comments: One of the cables in the back of the light had become brittle and worn away causing it to arc on the metal on the back of the light. I have disconnected the light now and everything is safe. Cut out size is 150mm.
Store has many lights of various cut out sizes which aren't working at the moment but Manager Lewis had told me that after a recent visit from an area manager these are all in hand and in progress of being replaced. Job complete
