Rail Accident Investigation Branch

# Rail Accident Report

## **Unsafe events at Heathrow Tunnel Junction 27 and 28 December 2014**

Report 20/2015  
December 2015

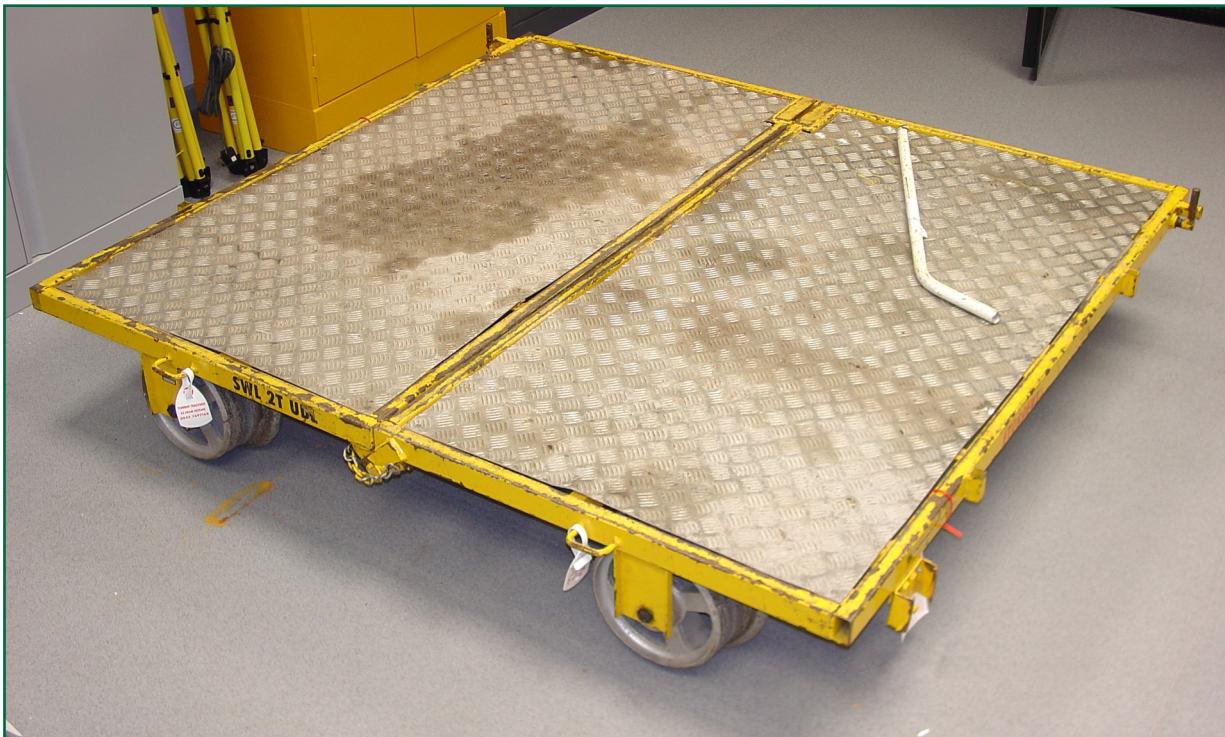
*Figure 11: Example of a hand trolley, similar to the trolley involved in the incident on 28 December 2014*

- 84 COSS B and the site supervisor then attended a task-specific briefing given at the construction site compound by the site manager. It is uncertain whether they received this task briefing at the same time, but they were both informed that, in addition to the planned handrail installation work, their workgroup was to transfer materials from the site compound to the trackside (figure 10). It was possible for the workgroup to undertake this additional task without updating their SSoW paperwork because similar material transfer was also necessary for the handrail installation. During the briefing, the site supervisor suggested to the site manager that the workgroup might use a rail mounted hand trolley (figure 11) to aid this task. The site manager raised no objection to its use, nor did he comment on the associated railway related safety provisions (paragraph 19). Ensuring compliance with these railway related procedures was not part of the site manager's role and there is no evidence that he was told anything suggesting the intended use of the trolley could be unsafe.

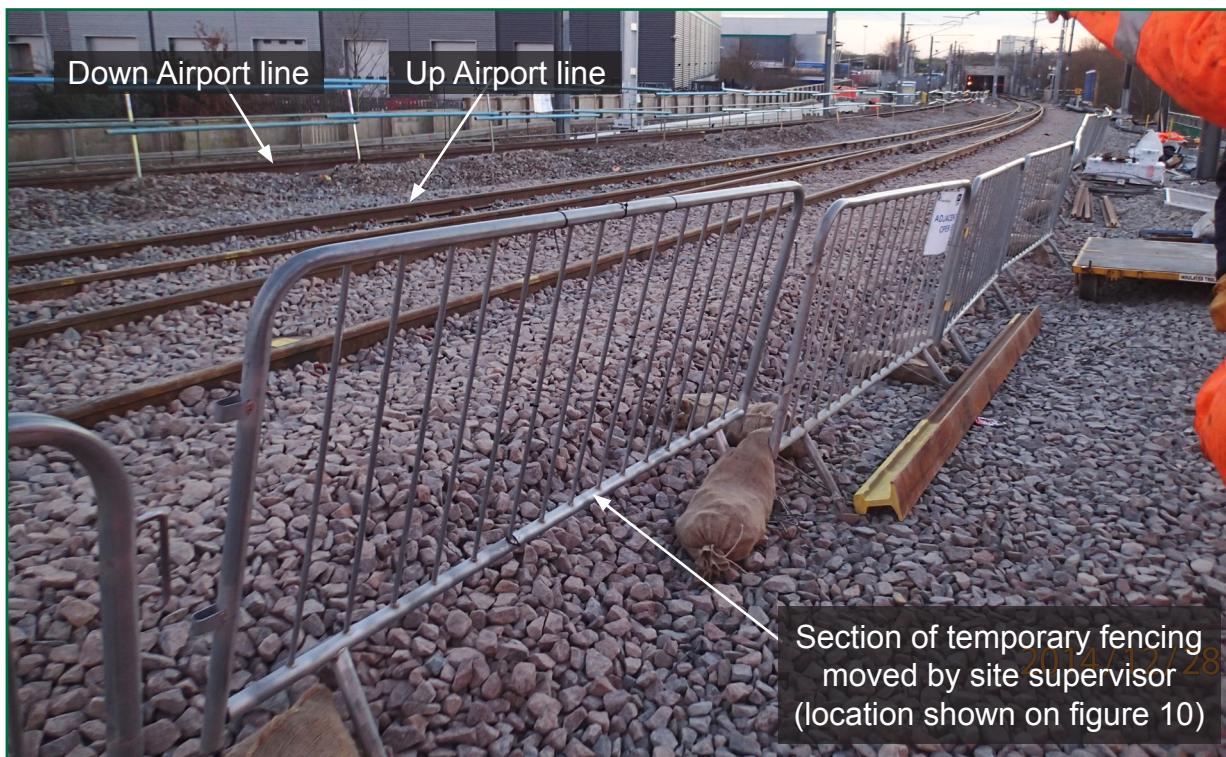
Figure 12: Section of temporary fencing moved to gain access to railway

- 91 After ending the telephone conversation with the engineering supervisor, COSS B called up to the site supervisor and gave permission to place the trolley on the track. The line name was not included in this communication; COSS B did not do so because he believed this had been established when the site supervisor requested consent to use the trolley (paragraph 89). The absence of a line name in this conversation meant that the site supervisor incorrectly believed he had permission to place the trolley on the Up Airport line which, unknown to him, was open to regular train services. The site supervisor and trackworker A then picked up the hand trolley from beside the Up Airport Relief line, carried it through a section of temporary fencing which had been moved aside by the site supervisor, and began to place it on the Up Airport line (figure 12).
