Rail Accident Investigation Branch

Rail Accident Report

**Freight train derailment at Angerstein Junction
2 April 2014**

Report 11/2015
August 2015

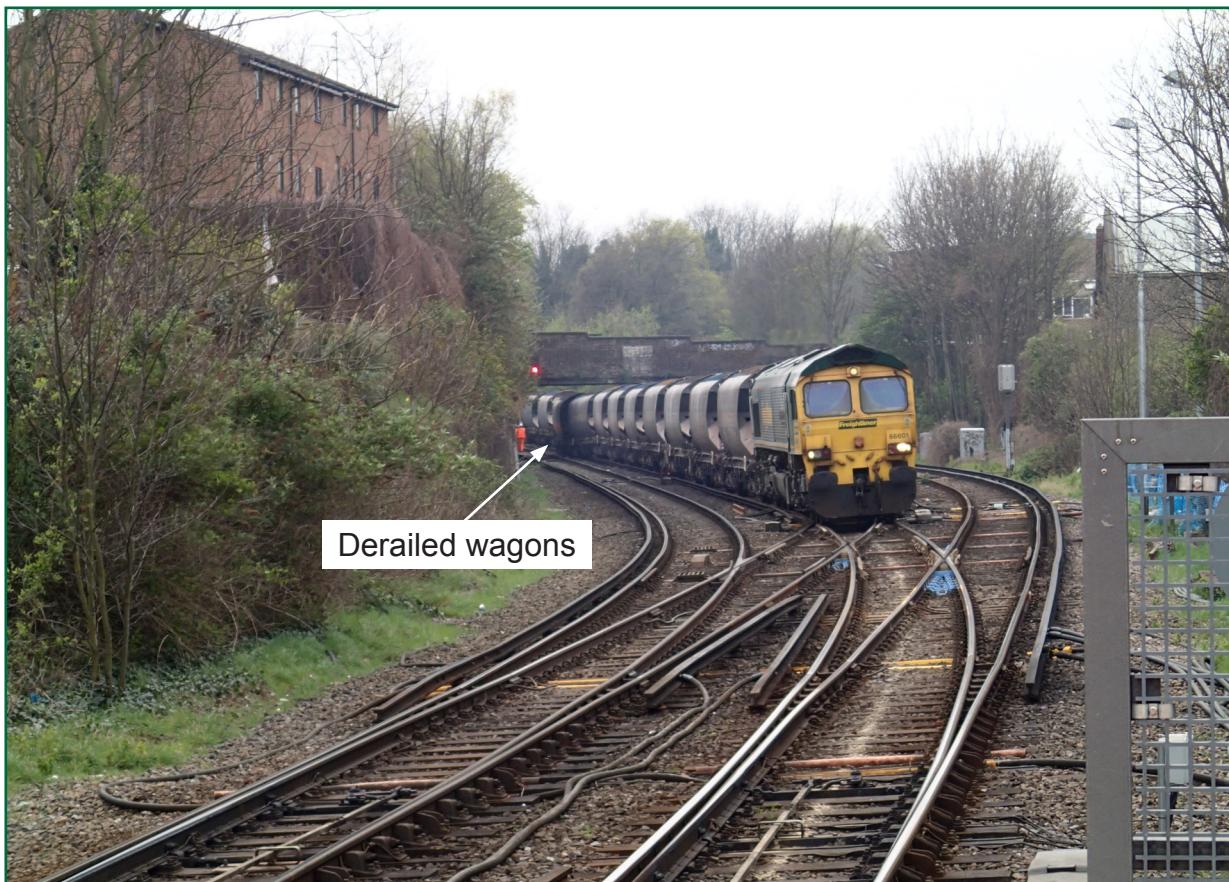
Figure 2: Derailed train after stopping, showing derailed wagons at the bridge

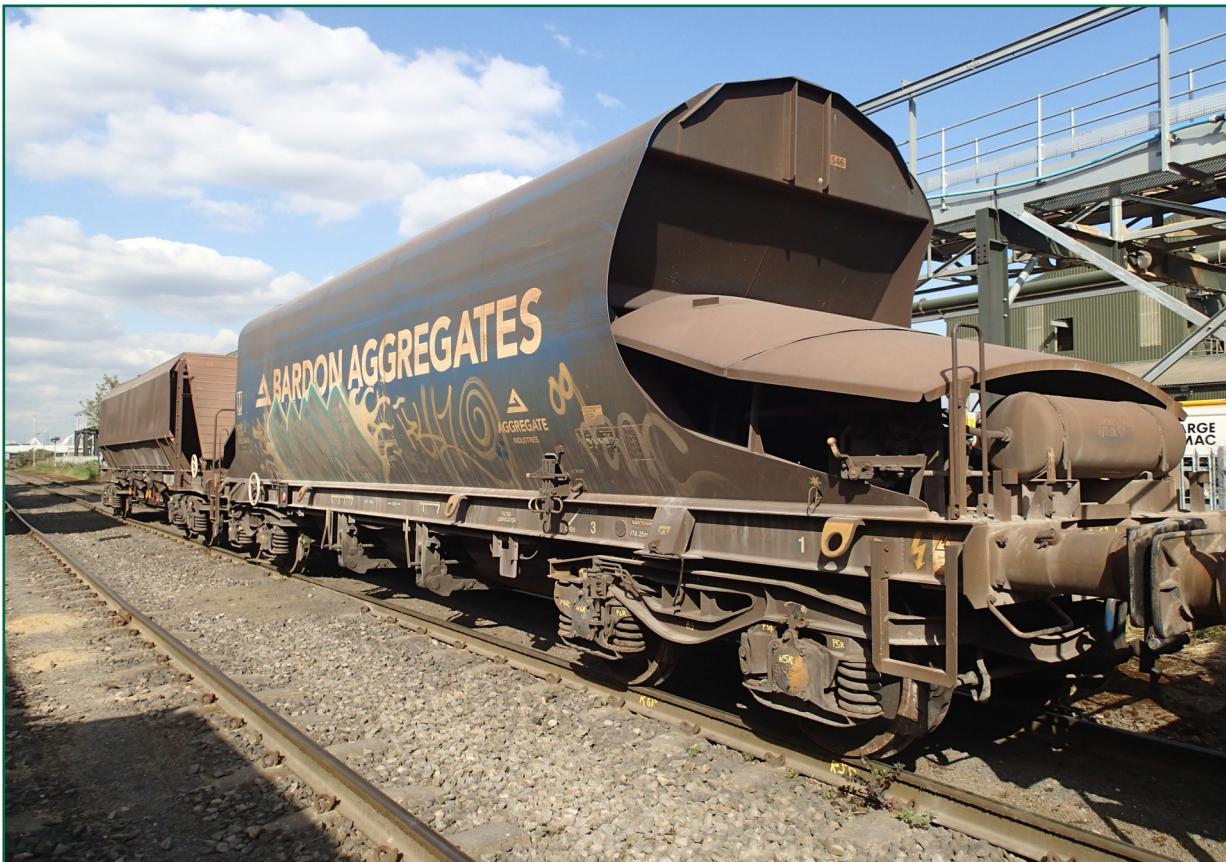
Figure 4: JRA hopper wagon 546, with JGA wagon behind it

- 17 The train involved in the accident was 6M79, the 11:56 hrs service from Angerstein Wharf sidings to Bardon Hill quarry, in Leicestershire. It consisted of a Class 66 locomotive hauling 20 aggregate *hopper wagons* (a mixture of types JRA and JGA - figure 4).
- 18 The two wagons that derailed were both JRA hopper wagons which were built in France in 1990.

- 39 The body of wagon 546 consists of a three compartment hopper supported on an underframe. The underframe is mounted on two bogies, each of which is supported on two wheelsets (figure 4).

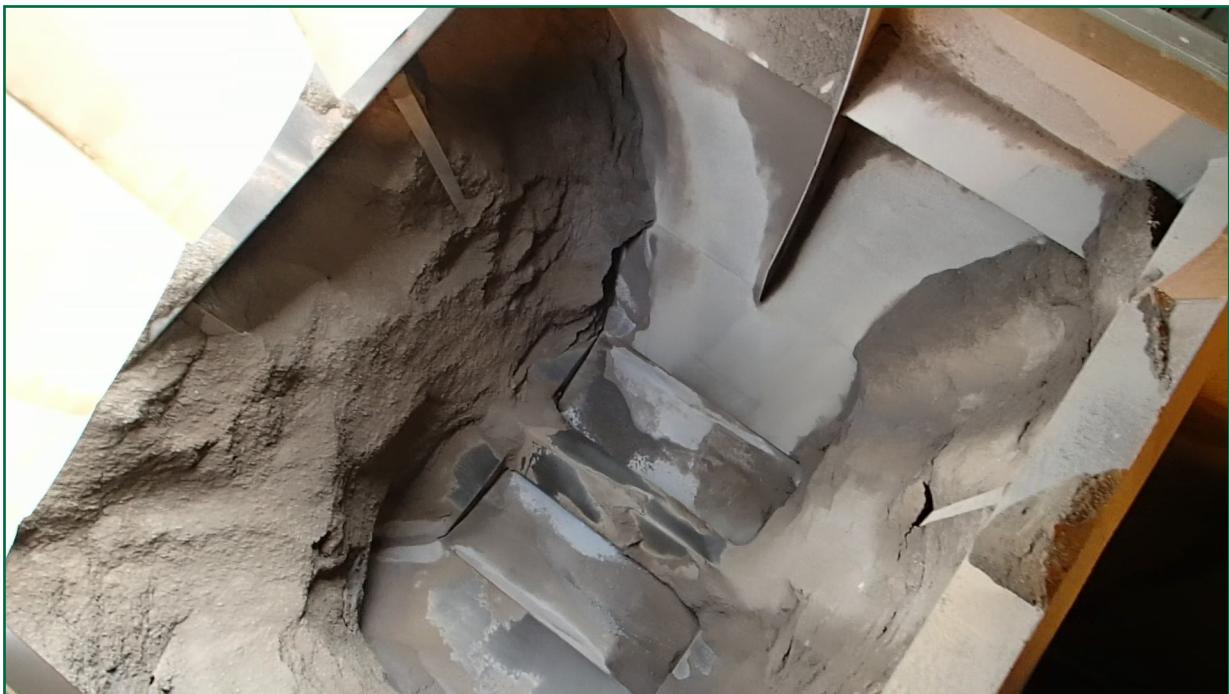
Figure 16: Crushed rock fines hanging up in a similar hopper wagon

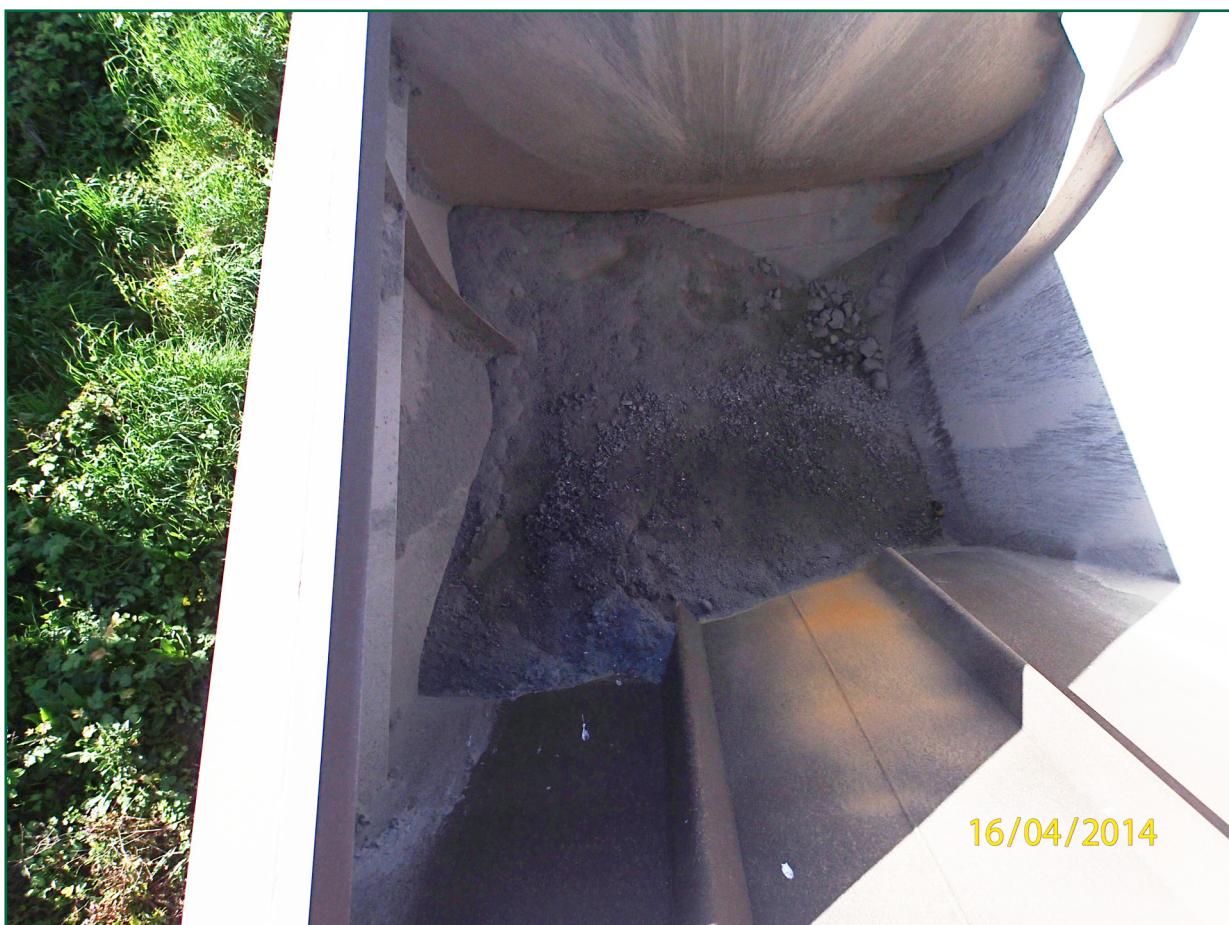
- 97 The actual distribution of the retained payload of 11.7 tonnes of crushed rock fines (paragraph 94) at the time of derailment is not known, as it was displaced during the derailment (paragraph 95). In the absence of better information, the RAIB has assumed that the load distribution at the time of the derailment was similar to the distribution of the 13.3 tonnes of material recorded by WheelChex when the wagon passed Thur maston on 1 April 2014. The wheel loadings at the time of derailment, with the residual load, are estimated to have been as shown in appendix E.

Figure 17: Retained material in the wagon (after derailment)

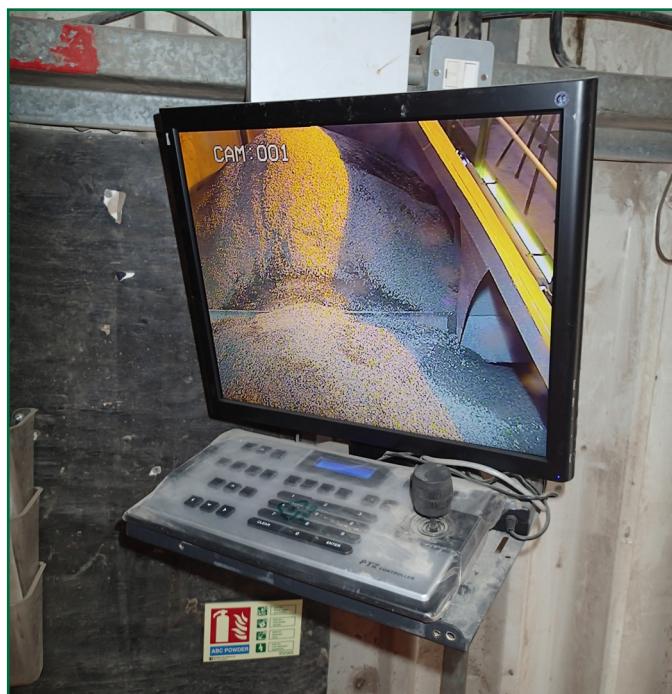
Figure 19: Operators view of wagon interior on CCTV screen

- 115 Aggregate Industries had a procedure in place at the Angerstein terminal that involved use of a CCTV camera, positioned above the unloading pit, to check the inside of wagons that were being emptied to identify if the load had been fully discharged (figure 19). If load was seen to hang up, the operator was required to use a sledgehammer to strike the side of the wagon in order to release it. If the material was not released after a reasonable amount of hammering, the procedure required this to be recorded and the wagon returned with the retained load in situ. The RAIB has seen no evidence to indicate that the presence of retained loads was being recorded.

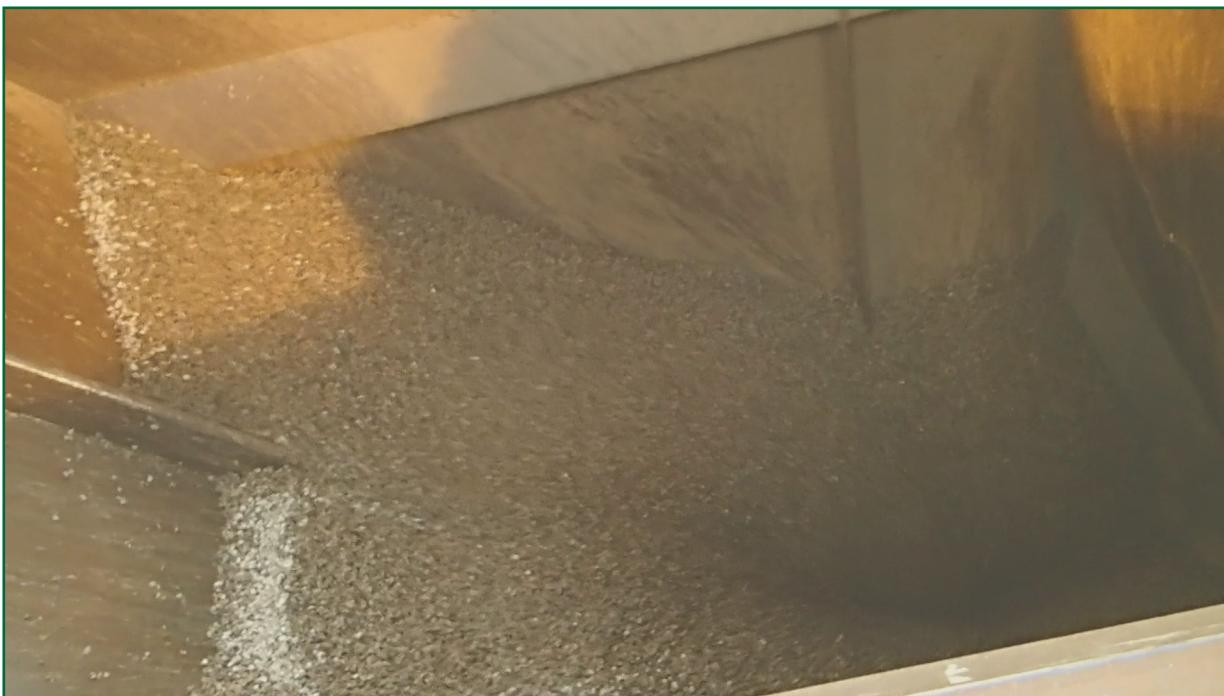
Figure 20: Larger particle rock freely discharging from a hopper wagon

- 116 When travelling to Angerstein, immediately before the derailment, the load in the wagon was 10 mm stone particles. The RAIB noted, while observing unloading of a similar train, that this material does not hang up in wagons, and flows freely from the hopper when the bottom doors are opened (figure 20). It is not known whether the operator checked to see if there was a retained load in wagon 546 after the 10 mm stone had been discharged at Angerstein, shortly before the derailment, or attempted to release the retained load that was hanging up on its sides.
