Rail Accident Investigation Branch

Rail Accident Report

**Train driver receiving a severe electric shock at
Sutton Weaver, Cheshire
23 September 2014**

Report 07/2015
June 2015

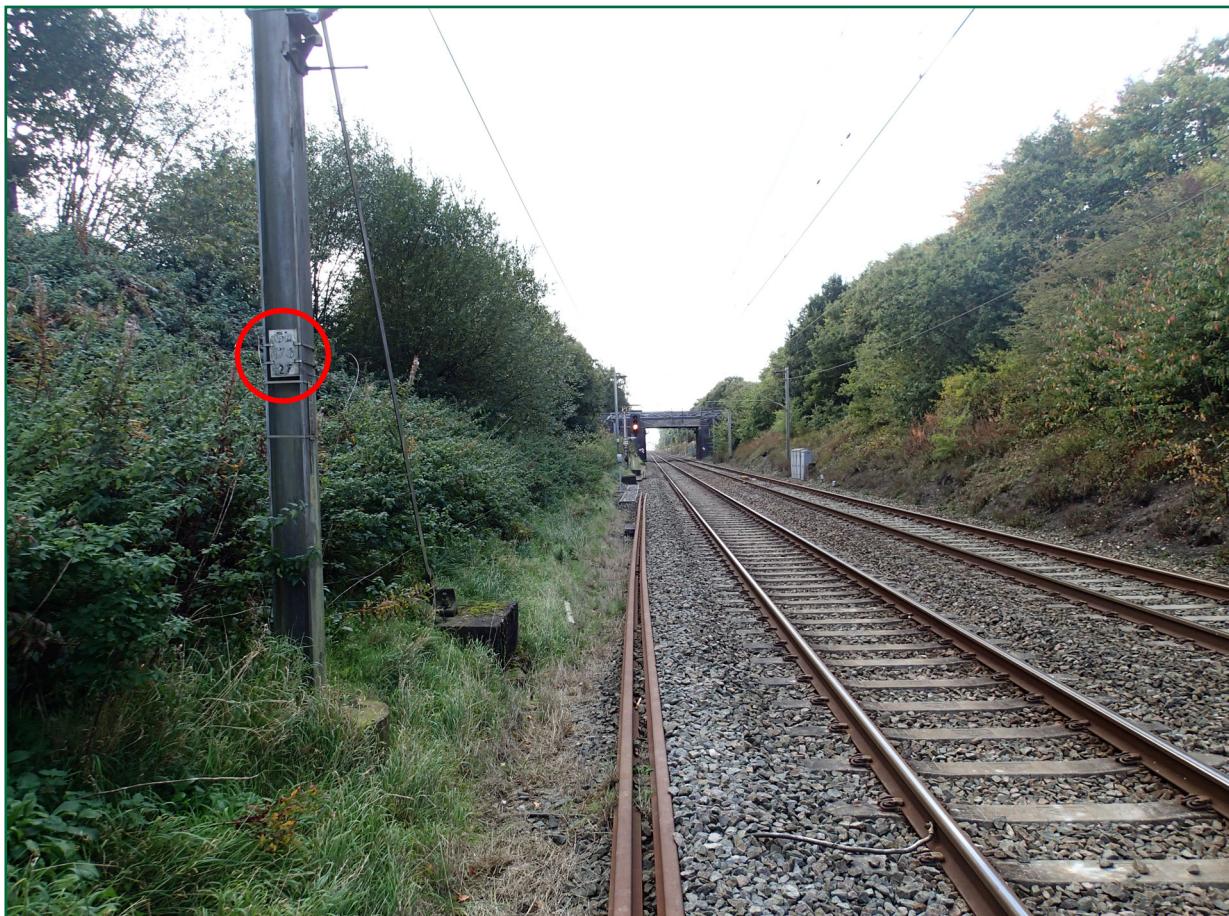
Figure 2: Location of the accident as viewed in the direction of travel of train 1F22 on the approach to HN103 signal, visible in the centre of the picture, and the OLE mast identification plate (ringed)

- 72 The RAIB has observed that the letters and numbers on the OLE structure number plate closest to the train were in a worn condition (figure 2). The RAIB consider that even if in a better condition, it would have been difficult to read them from a distance 18 metres through a wet train windscreen and with the light conditions present at the time.

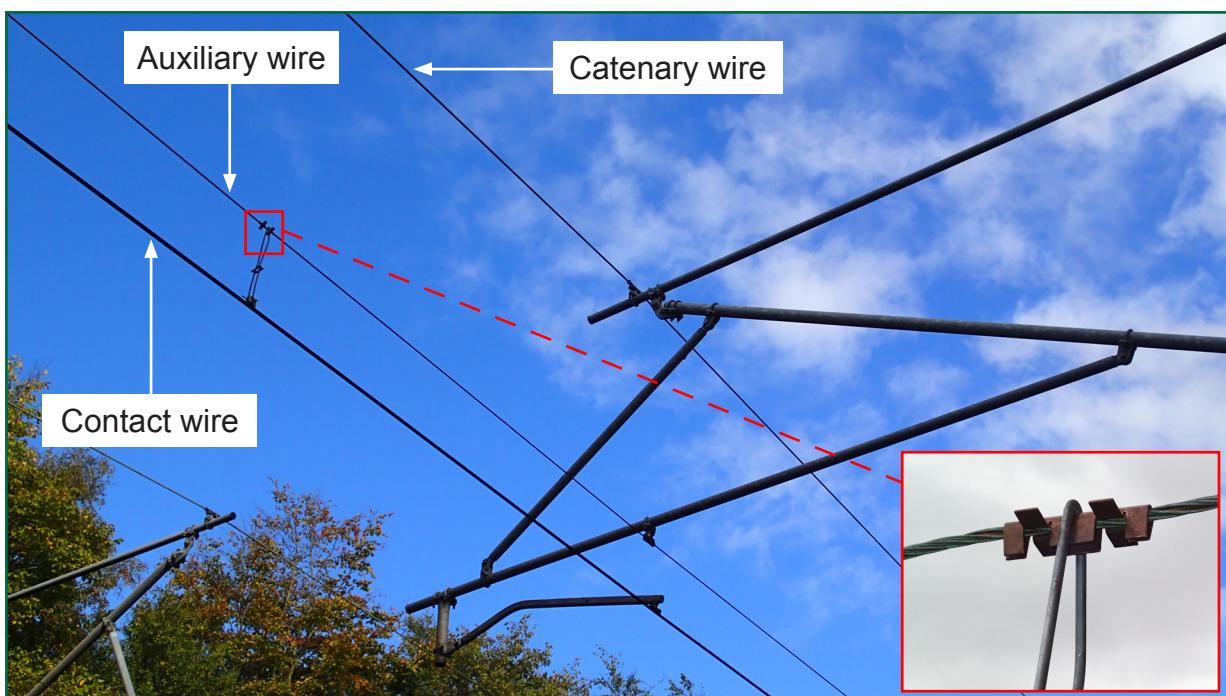
Figure 3: Mk 1 compound catenary with the three wires labelled. Inset shows auxiliary wire protective sleeve on the auxiliary wire.

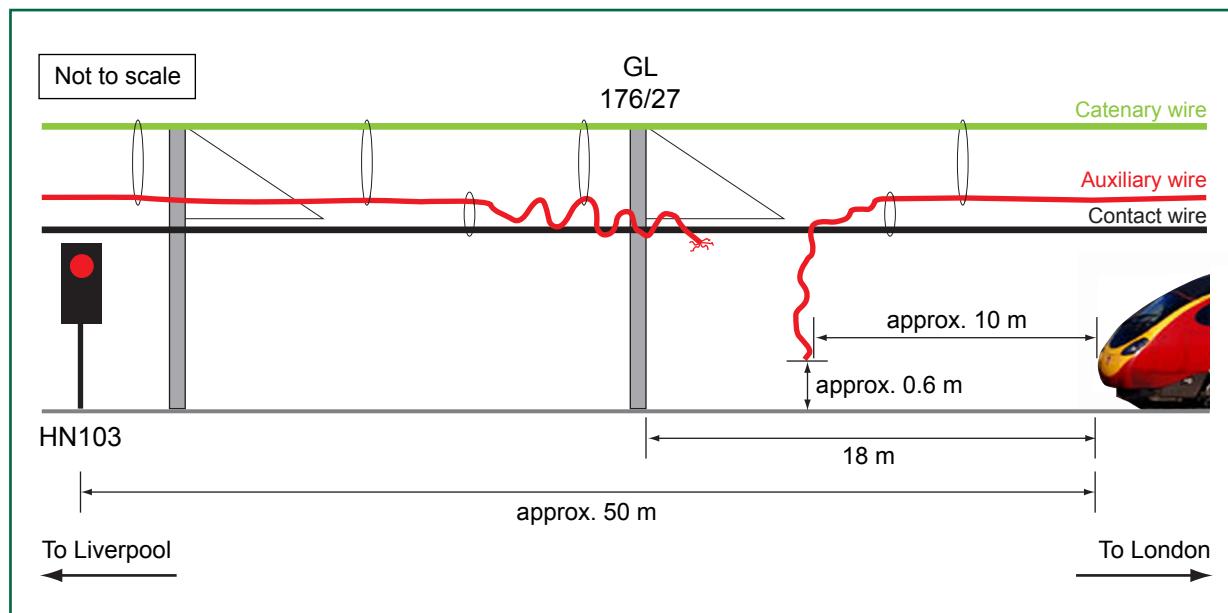
57 The approximate positions of the two ends of the broken auxiliary wire following the accident are shown in figure 4. The end closest to London was hanging low to the ground, and the end closest to Liverpool remained close to the catenary and contact wires.

Figure 4: Approximate positions of the ends of the broken auxiliary wire, the train, HN103 signal and the nearest OLE mast

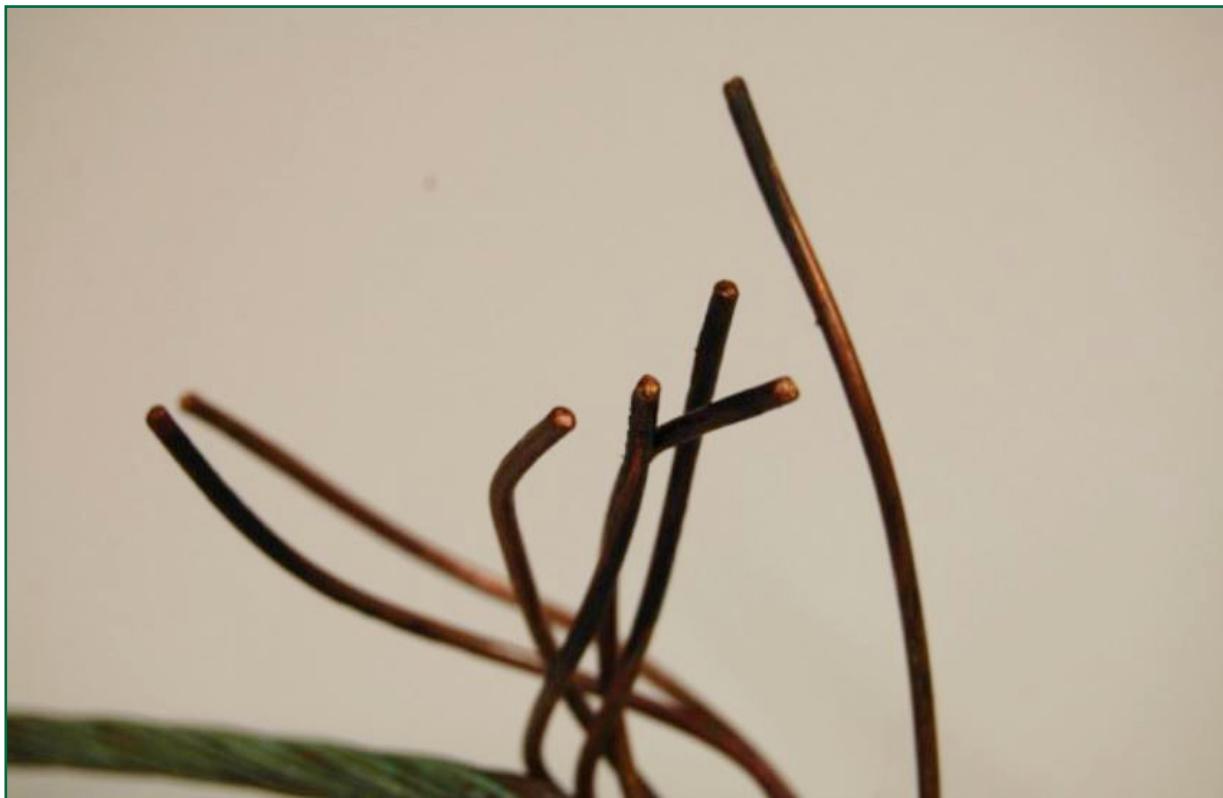
- 58 Examination of the recovered sections of the auxiliary wire showed that the broken end closest to Liverpool had signs of mechanical damage in the form of unwound strands at various angles, together with fused copper deposits on the strand ends (figure 5). Some areas on the section closest to London showed signs of electrical arcing and mechanical damage (figure 6). This damage and the reported flashes are indicative of the broken wire making contact with the two trains preceding train 1F22. Examination of train 1F52, found arcing damage to parts of its pantograph.

Figure 5: Splayed wire strands on the Liverpool section of the broken auxiliary wire

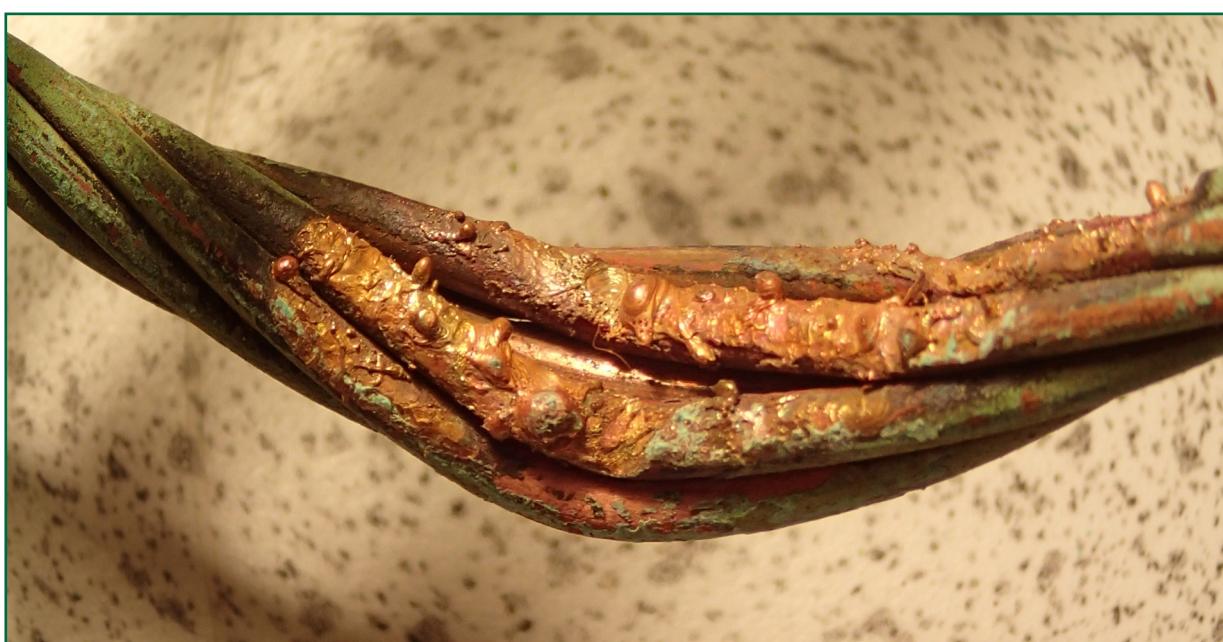
Figure 6: Electrical arcing damage on the London section of the broken auxiliary wire

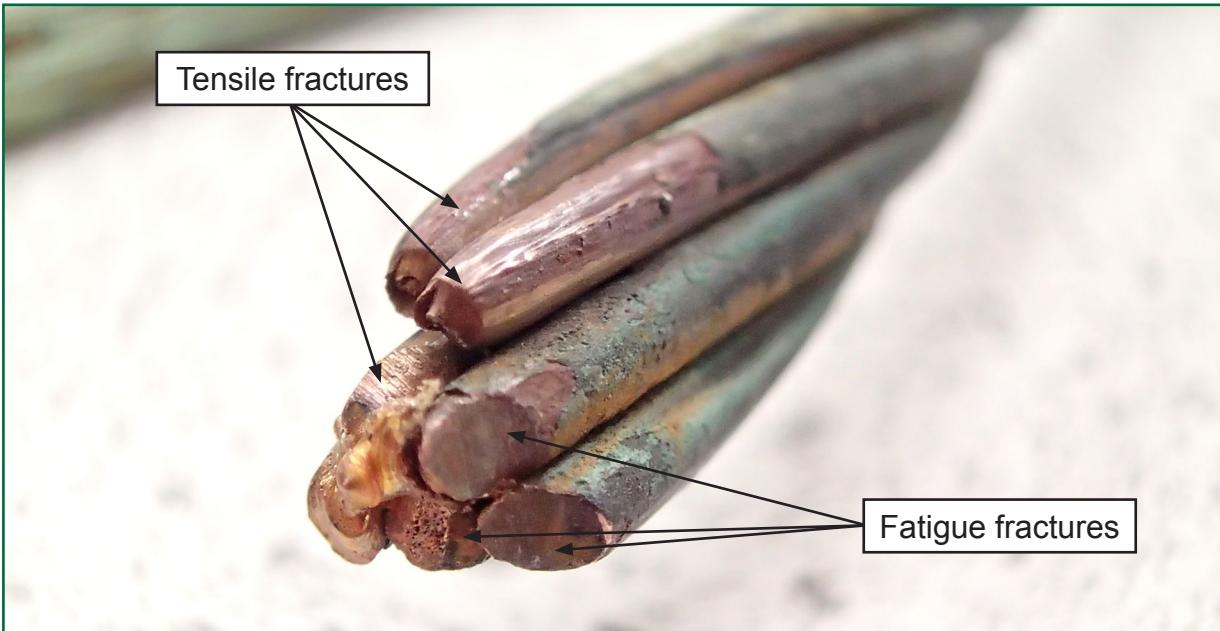
- 59 Metallurgical examination of the strand ends of the wire section closest to London showed that it had failed by two distinct mechanisms (figure 7). The angled fracture faces on at least three of the seven strands are fatigue fractures⁵ which had developed following many load cycles and not just a few overloading events. The remaining three or four strands then failed in tension as they were no longer able to carry the normal tensile load applied to them in supporting the contact wire below. The wire was also examined for possible overheating damage caused by electrical arcing. None was found, discounting this as a possible contributor to the failure.

Figure 7: End of the London section of the broken auxiliary wire

Network Rail should revise its work instructions so that inspection staff are aware of what to look for, including possible fatigue damage precursors as found during the metallurgical examinations of this investigation, and during the inspections Network Rail has already carried out (paragraph 99a).

It should produce a plan for the extension of its current detailed examinations of auxiliary wires close to, and within, protective sleeves to identify and rectify broken and damaged wire strands and protective sleeves on all of its Mk 1 compound catenary. Following this, its routine inspections should include this additional examination.

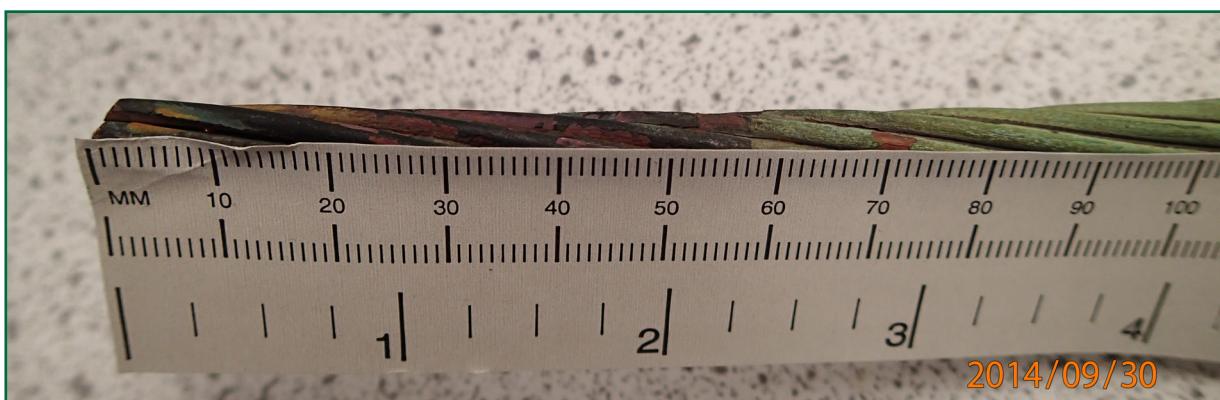
- 60 The wire had developed a green coating (known as verdigris) on the exposed surfaces of the strands. However a short length of the wire at the broken end of the section closest to London was discoloured black rather than green. This suggests that the failure took place within a section of wire within a protective sleeve (figure 8).

Figure 8: End of the London section of the broken auxiliary wire showing dark discolouration where it has been within the protective sleeve

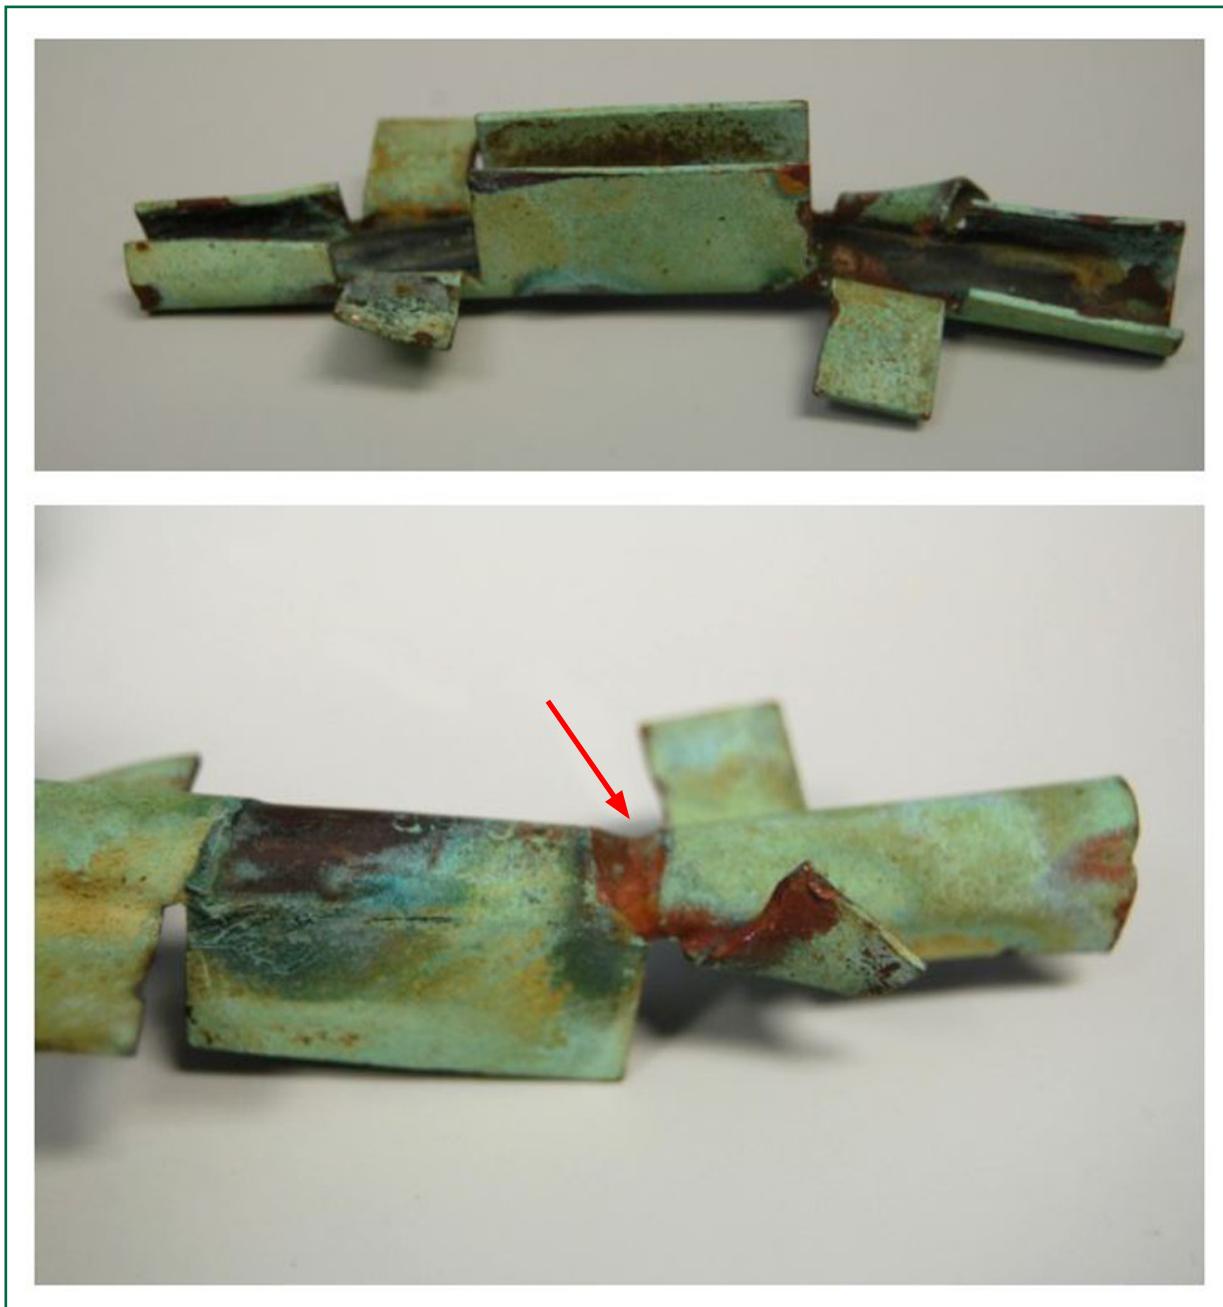
- 61 Several days after the accident, a damaged protective sleeve was found adjacent to the auxiliary wire failure point (figure 9). When the broken end of the wire was placed in the position in the sleeve indicated by the discolouration, the break was found to be coincident with an area of the sleeve that had been subjected to localised loading by the upper loop of the dropper wire impacting on it. This has led the RAIB to conclude that the recovered sleeve is likely to have been the one present prior to the auxiliary wire breaking.

Figure 9: Protective sleeve found at the scene of the accident. Red arrow indicates the groove created from contact with the loop of the auxiliary wire dropper.

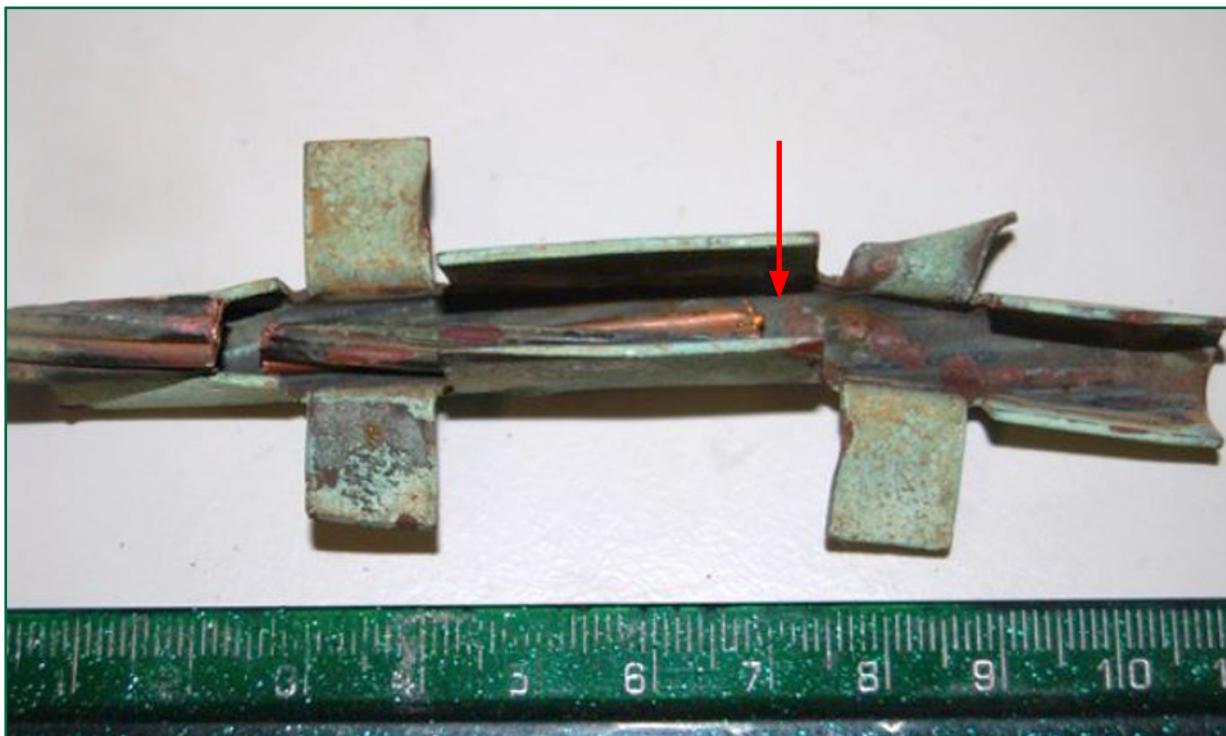
Figure 10: Position of the London end of the broken auxiliary wire relative to the protective sleeve. Red arrow indicates line of wire breakage coincident with the sleeve inner protrusion, which is coincident with the groove shown in figure 9.

62 The localised loading had caused a groove on its upper surface and an associated inner protrusion (figure 10). It is likely that this protrusion caused a local high stress area on the wire which contributed to the initiation and propagation of the fatigue fracture. Network Rail provided the RAIB with two other sections of broken and partially frayed auxiliary wires and protective sleeves. The broken wire section was associated with a circuit breaker trip at another location in June 2014, and the partially frayed wire section was found during a routine inspection. The regions of the completely broken and partially frayed strands on the respective samples were also related to their positions within protective sleeves. The breakage line of the completely broken wire coincided with the end of the sleeve and some of its strands showed signs of fatigue fracture. The ends of the sleeve are other likely positions at which the stress in the wire may be increased (as there is a localised change in stiffness) promoting the initiation and development of fatigue fractures.
