Rail Accident Investigation Branch

Rail Accident Report

**Derailment at Ely Dock junction
22 June 2007**

Report 02/2009
January 2009

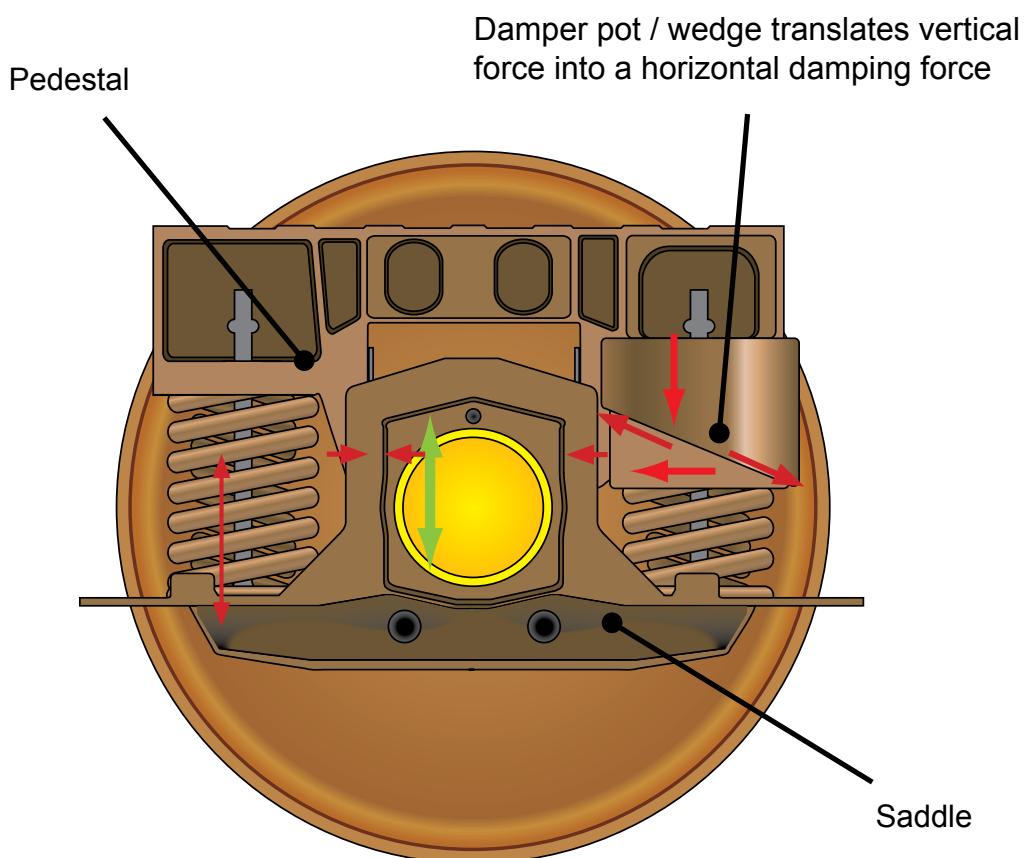
Figures 7: GFA suspension showing damping forces of pedestal and saddle

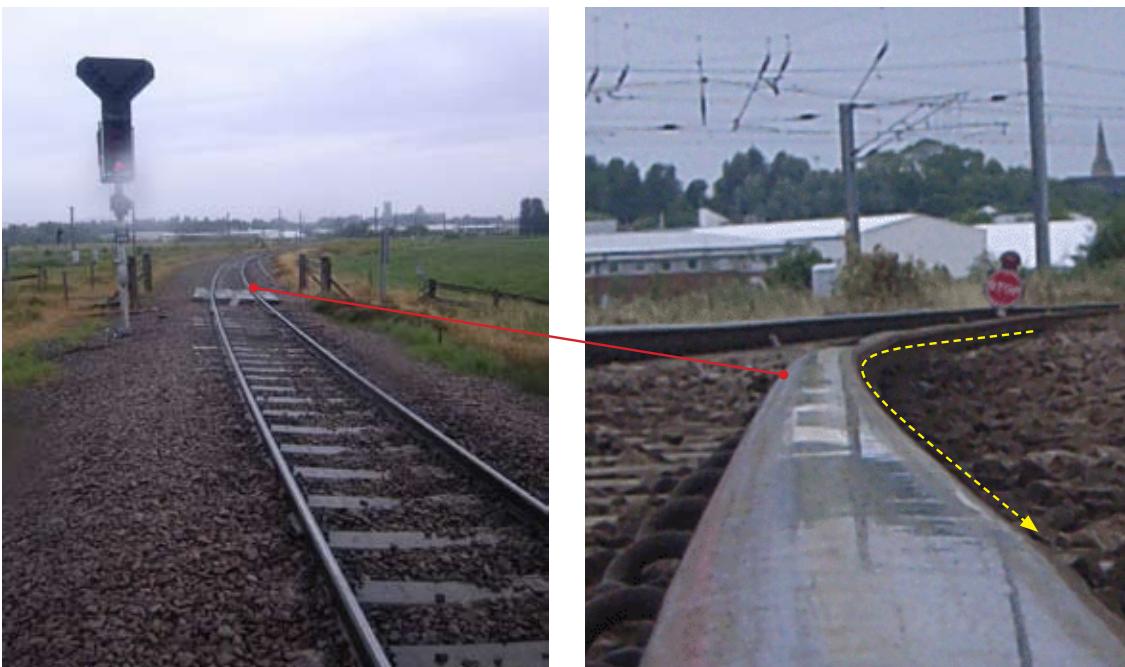
- 52 As the train climbed the gradient the leading right hand wheel of the 15th wagon, REDA 16002, derailed by climbing over the right hand (high) rail at 12 miles 19 chains. This took place shortly before 01:59 hrs. The reasons why it is clear that wagon REDA 16002 was first to derail are explained in paragraph 146.

Figures 8 (left) showing view of track towards Ely with right high rail on left and low left rail on right. Figure 9 (right) view of track towards Ely showing low left rail (foreground) and high right rail (background) at the point of derailment

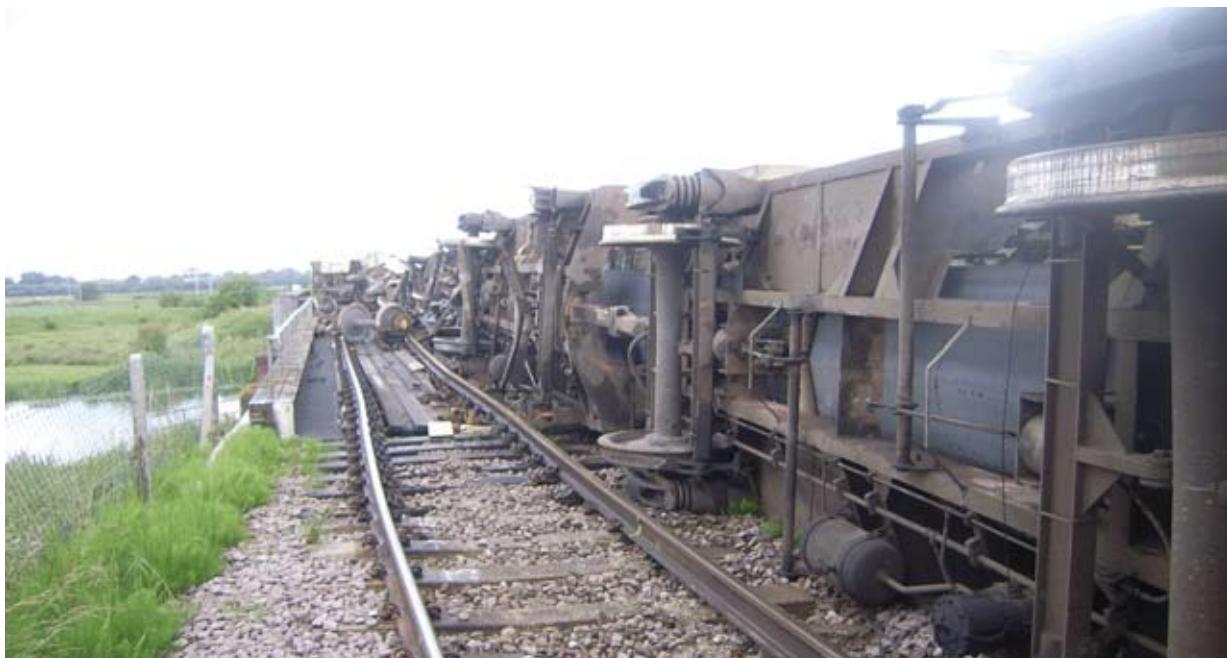
Figure 11: View in direction of Ely showing 6L58 on bridge 2235

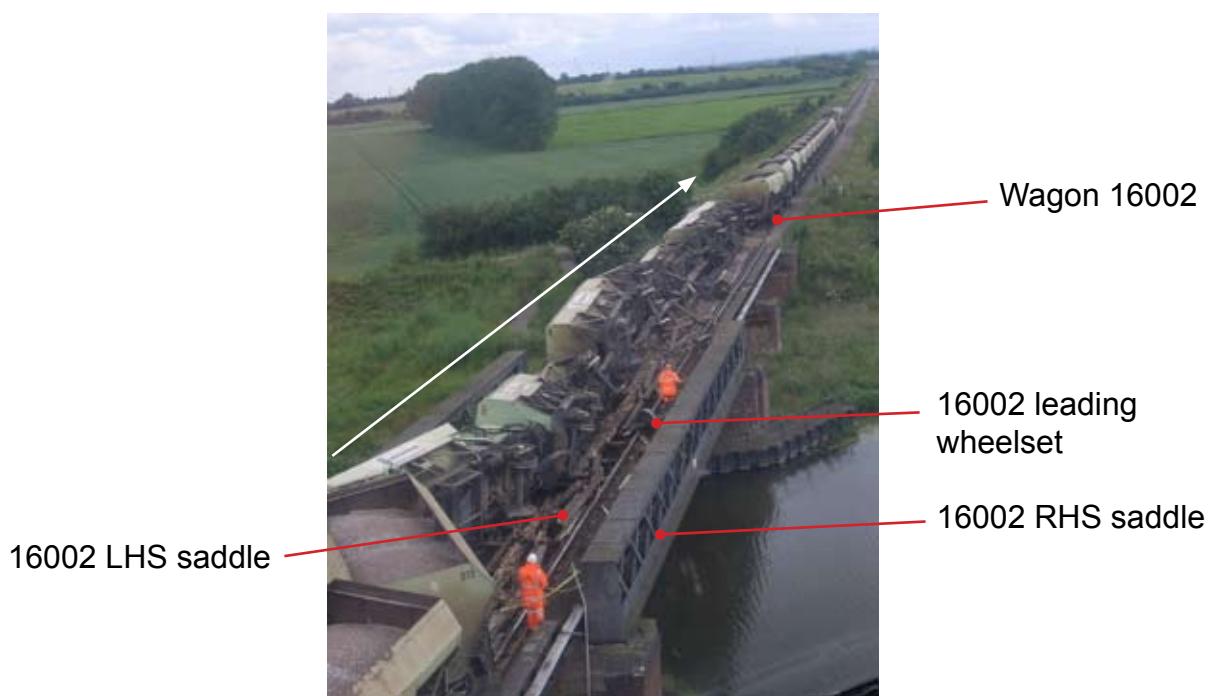
- 57 The weight of the 15th wagon running derailed caused the 14th wagon, REDA 16001, to topple onto its left side and the 13th wagon to derail its trailing wheel set. The 16th to 21st wagons also toppled over onto their left side in the same direction as wagon REDA 16002 as they reached the damaged bridge. They continued to slide, losing their payload, wheel sets and suspension components in the process. The derailment and wagon trajectories resulted in the bridge being catastrophically damaged.

Figure 12: View of derailed wagons on bridge 2235

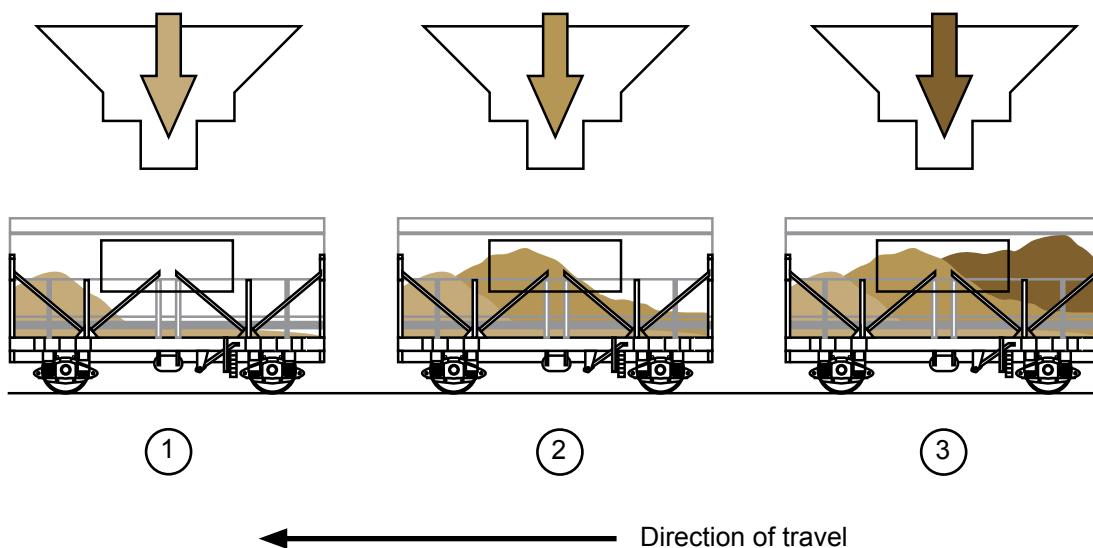
Figure 18: Diagram showing loading procedure and propensity to load wagons rear-axle-heavy

- 78 As the wagon travels, the third load is deposited at the rear of the wagon. The dividers within the wagon are only partially effective as their purpose is to provide framework rigidity, so when the third slug enters the wagon part of the first and second slug has already spread towards the rear (Figure 18). This makes the wagon rear-axle-heavy unless the operator compensates for this as the load is dropped into the wagon or the peak loads are moved by hand by the English Welsh & Scottish Railway ground staff during their formal train preparation duties. There is no means of adjusting the position of the discharge to the left or right of the wagon, hence a load bias can exist to either side of the wagon (paragraphs 270 to 276).

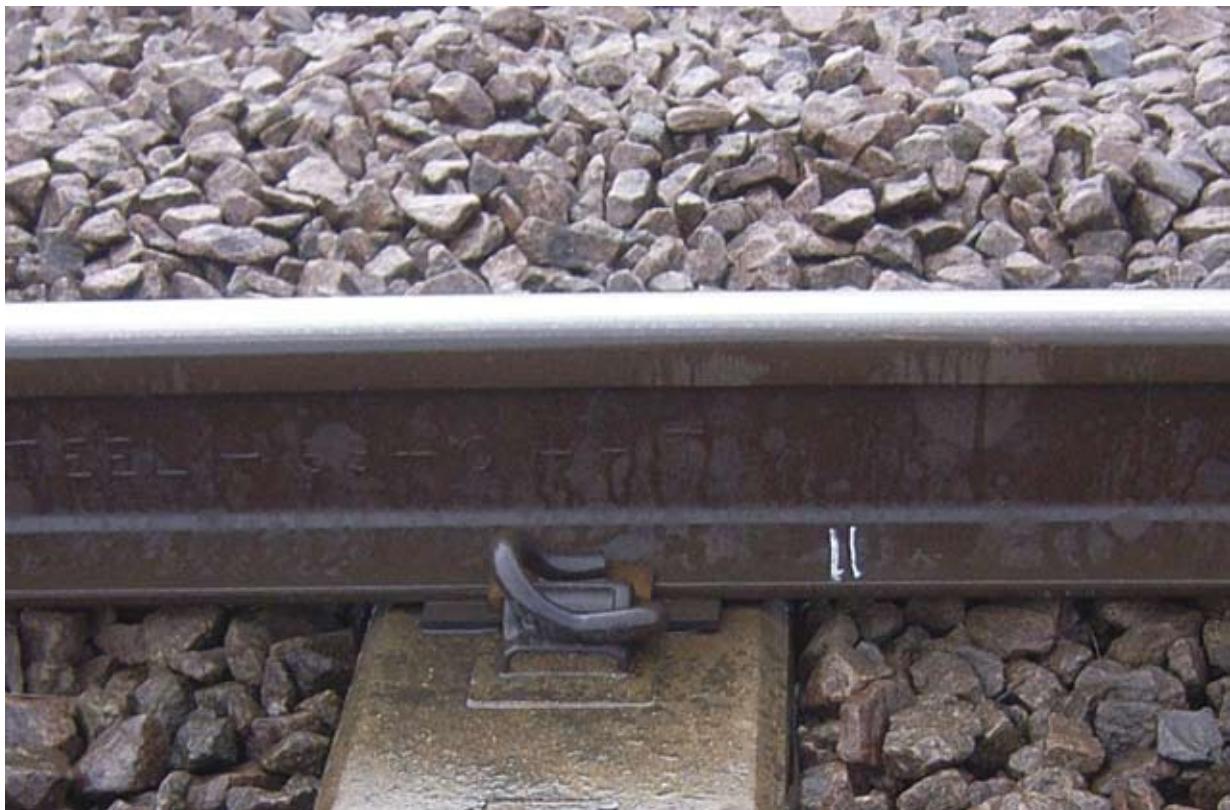
Figure 24a: Lower left-hand rail (drop off)

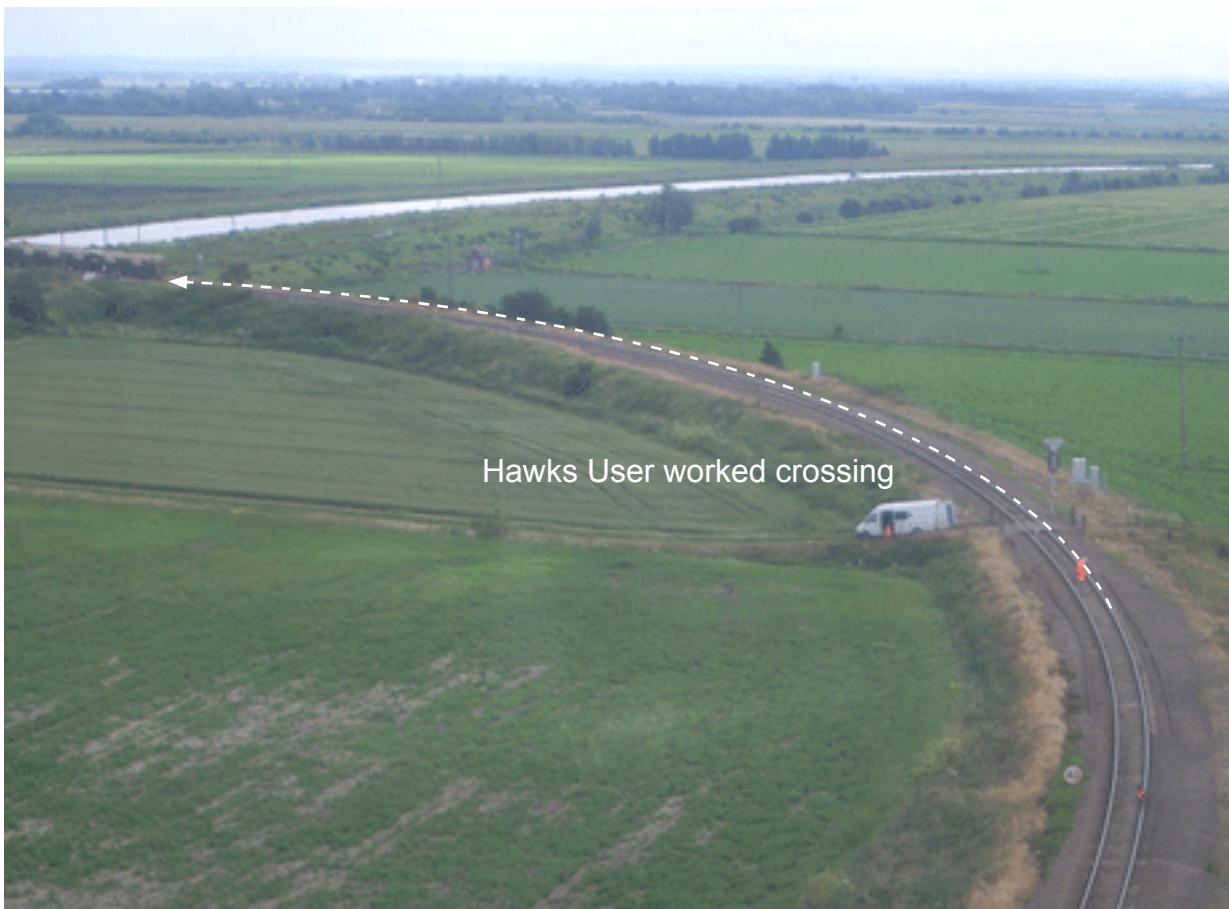
112 The average curve radius was 450 metres, with the tightest curve being 329 metres between sleeper +12 to +2, just before the point of derailment. The alignment was as designed, and it was permissible for the wagons to negotiate a curve of this radius (paragraph 37) (Figure 26).

Figure 26: Aerial image showing the area from the point of derailment to bridge 2235

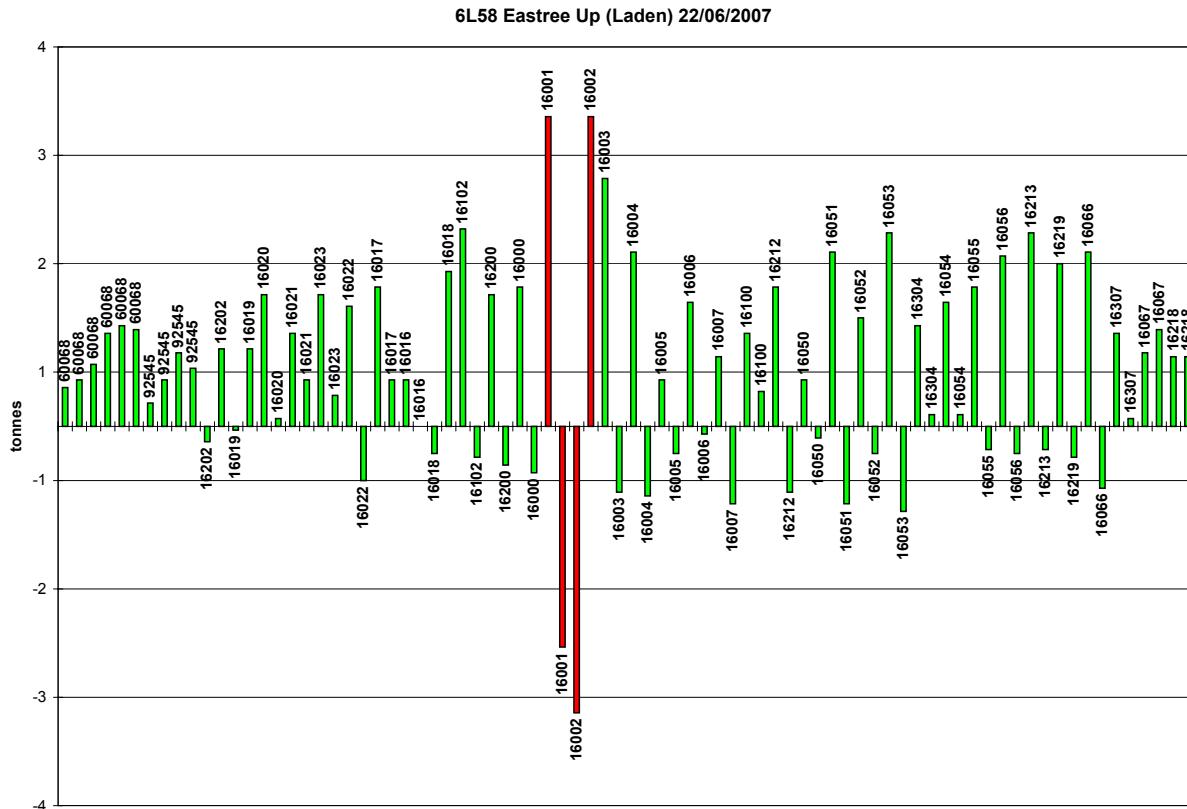
Figure 29: Train consist diagram from the Eastrea Wheelchex site showing incident wagons REDA 16001 and REDA 16002 (both shown in red) and non incident wagons (green)

- 131 Train 6L58 passed over the Eastrea wheelchex site. The system recorded high diagonal wheel imbalance loads on wagon REDA 16001 and REDA 16002 (Figures 28 - 29) but did not highlight this data or trigger an alarm.
 - 132 The maintenance schedule specifies that each site must be calibrated and maintained every six months, and following any repairs or nearby track maintenance. Eastrea was calibrated in January 2006 and was scheduled for further calibration in June 2006 (and January and June 2007). This was not done, and neither was the omission identified by Network Rail or its sub contractor.
 - 133 The post accident calibration of the system at Eastrea showed that it was still within specification and working correctly.

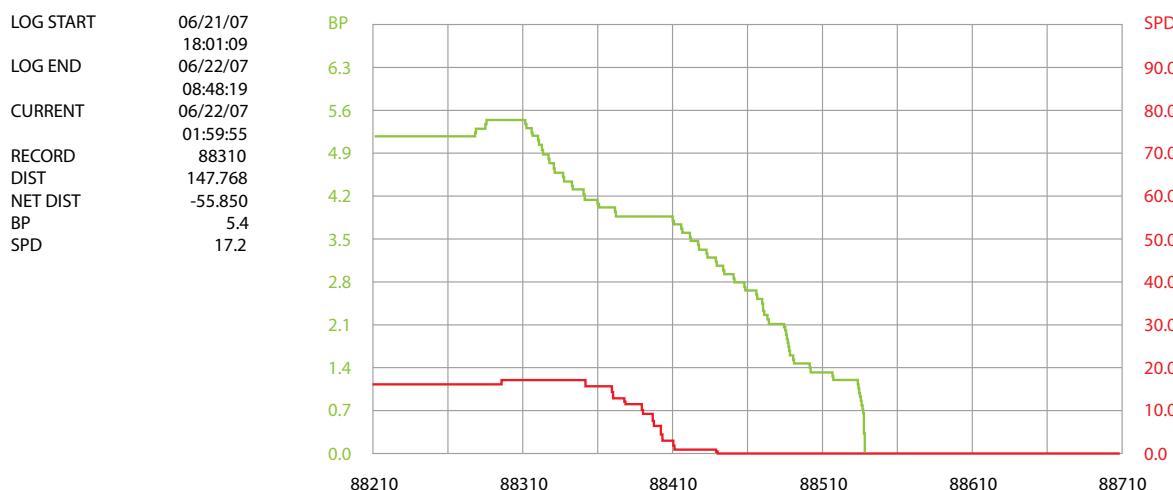
- that no sand had been applied by the train driver;
- that during the journey from Mountsorrel the train had reached a maximum speed of 56 mph (90 km/h), within the permitted 60 mph (96 km/h);
- the speed of the train as it ran through Ely and up to the derailment did not exceed any speed limit (Figure 30); and
- that no irregularities in brake pressure were recorded during the journey from Mountsorrel.

Figure 30: Locomotive 60068 OTDR reading of speed (red trace) and brakepipe pressure (green trace) at 01:59:55 seconds 22 June 2007

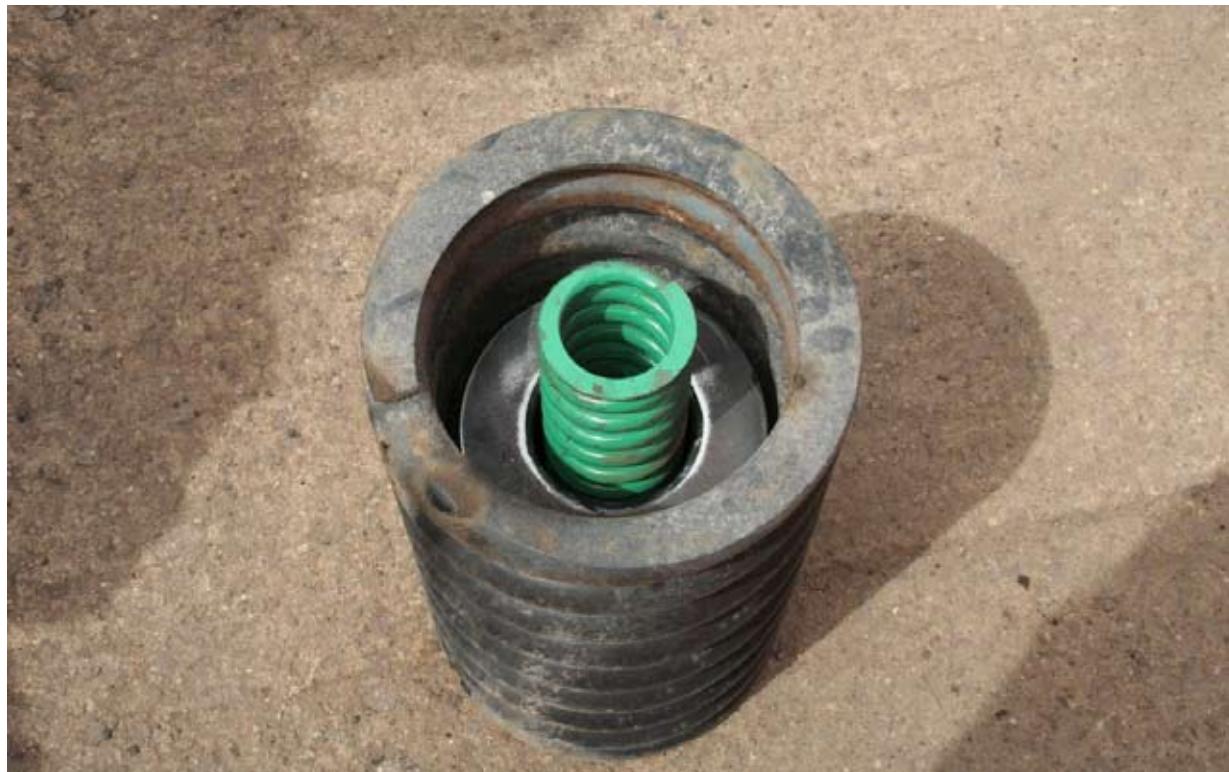
- 143 Springs that were recovered were compliant with the manufacturer's material and dimensional specifications, and free of corrosion.
- 144 In close proximity to the derailment site and on the Soham side of Hawks UWC a single green painted anti rattle or 'cup' spring was recovered (Figures 26 and 40). This spring is housed inside the 'top hat' which sits within the primary and secondary spring assembly as shown in Figure 31. The spring was found on the left-hand embankment in the vegetation (paragraph 328).

Figure 31: Spring assembly showing primary, secondary and inner 'cup' spring sitting within the 'top hat' component. Inner cup spring is identical that found at Hawks user worked crossing

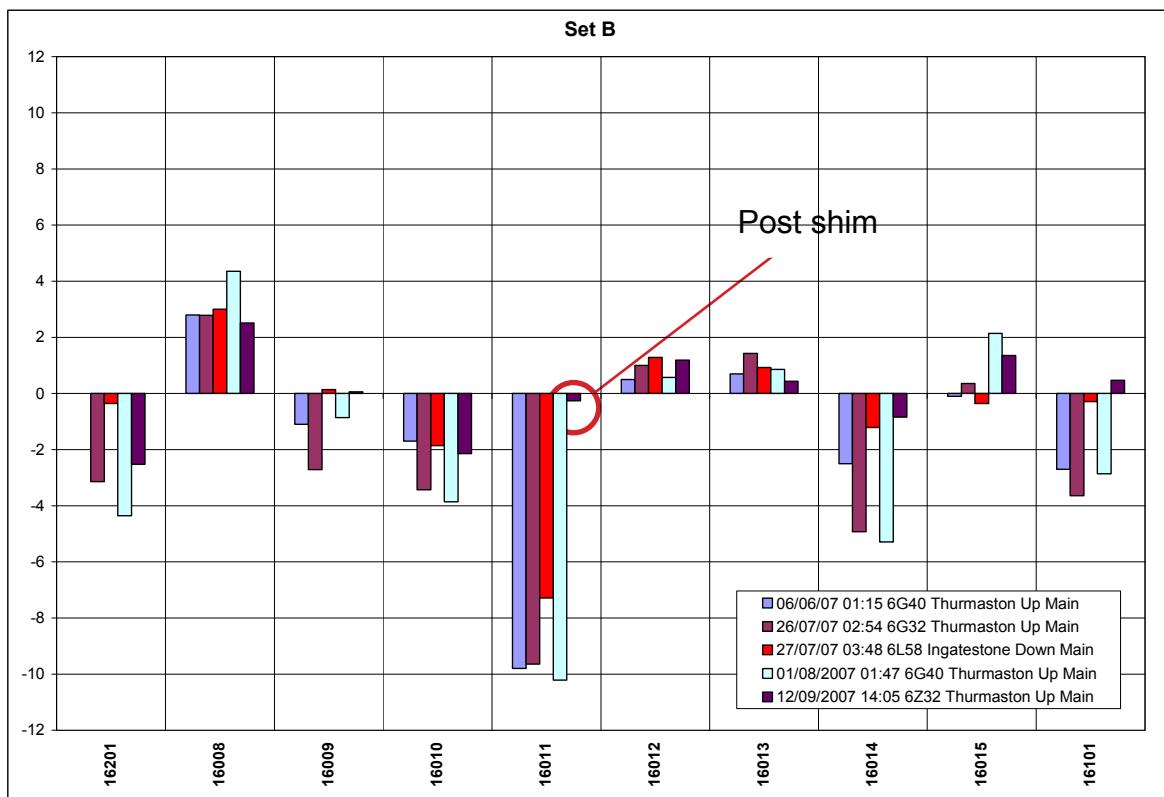
Figure 39: Graph showing analysis of raw Wheelchex data of pre and post frame twist on REDA 16011

169 Following the fitment of 18 mm frame twist compensation shims in diagonally opposite corners, Network Rail's Private Wagons Registration Agreement department authorised Lafarge to return the wagon to operational use (Figure 39).

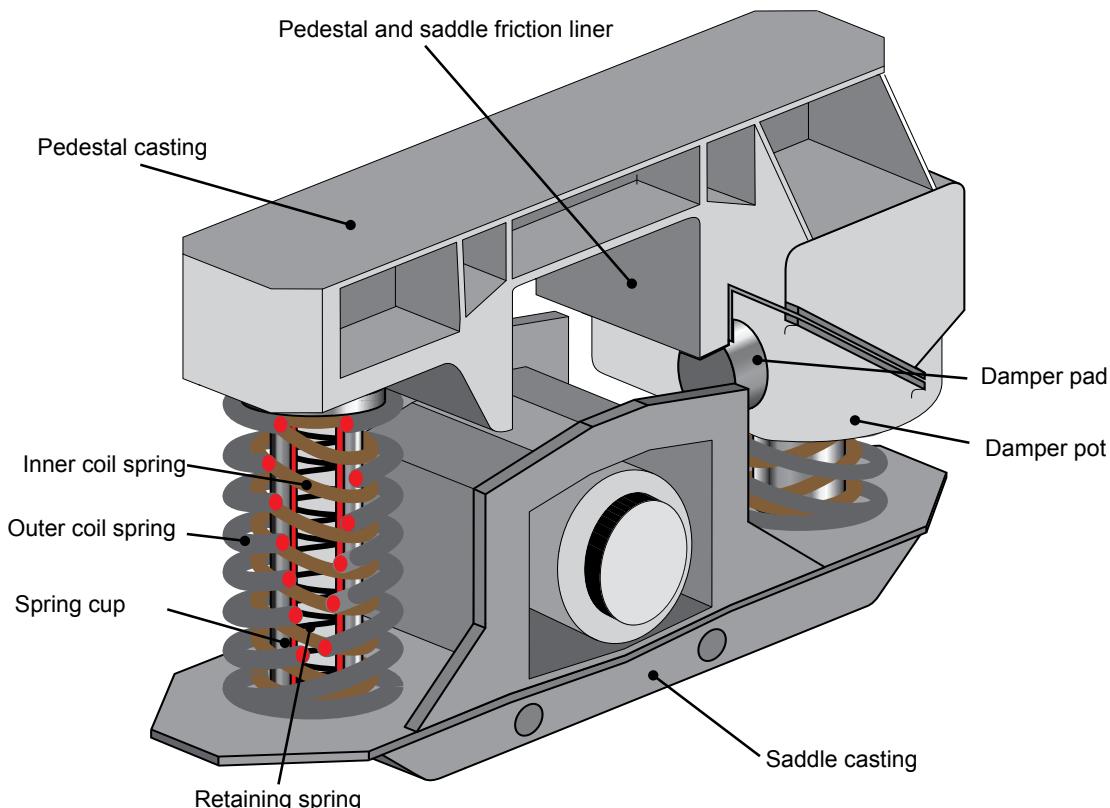
- 92 The payload of the wagon produces a vertical downward force on the GFA suspension which is transmitted into a horizontal force by the damper pot and wedge on one side of the suspension acting on the mating surfaces of the axle and pedestal. The downward and horizontal force on the wedge and mating surfaces can be affected either individually or by a combination of payload distribution, contamination or condition of the track causing the suspension to momentarily stick or lock during service. A frictional lock-up prevents the suspension damping performing as designed and can generate a risk of derailment if the lock-up occurs whilst the springs within the suspension are in compression, causing the wheel to become unloaded (Figure 40).

Figure 40: Diagram of GFA suspension and components

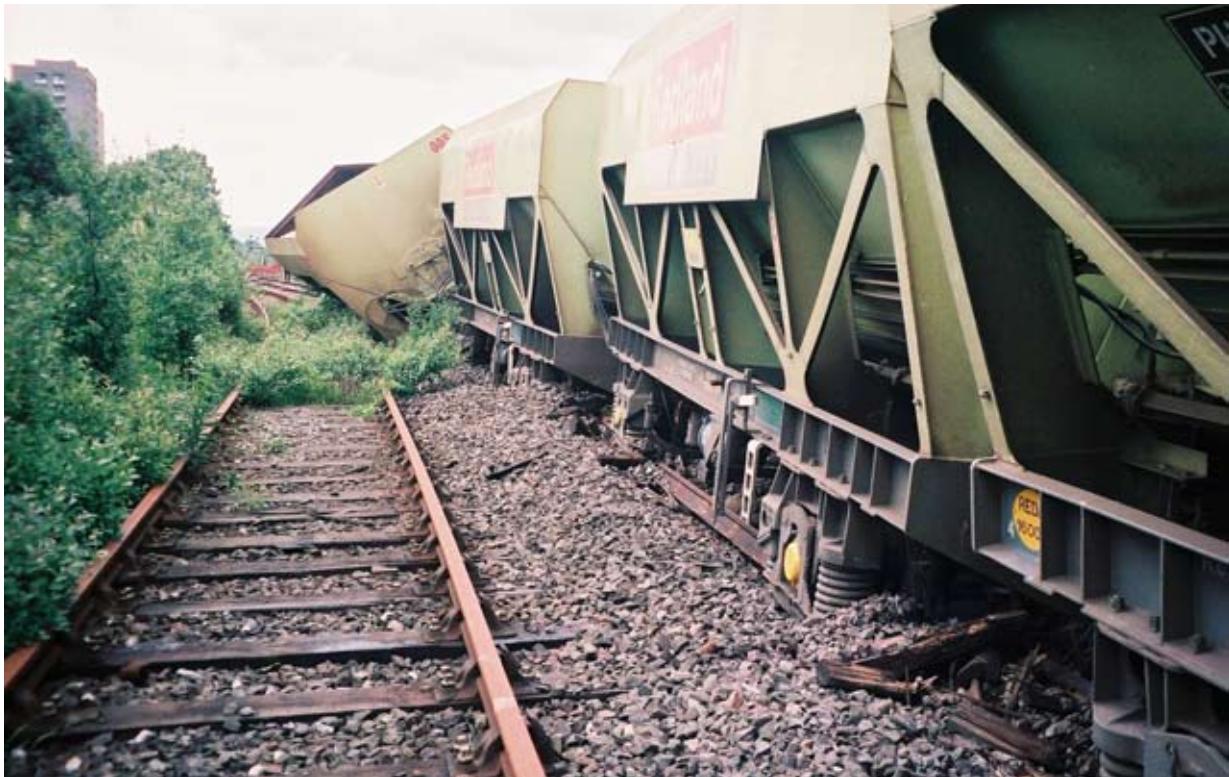
- 240 At 09:30 hrs train 6P54, the self-discharge train, 08:09 hrs Peak Forest to Ashburys, derailed at Baguley Fold Junction. Among the derailed wagons were REDA 16001 to REDA 16007. The cause of the derailment was gauge spread due to rotten sleepers.
- 241 Wagon REDA 16002 was derailed and collided with wagon REDA16003. The body work on 16002 was damaged. The wagon had no compensatory shims in place in corners 2 (rear right hand corner) and 4 (front left hand corner) and no welding work on its bodywork at the time of this derailment (Figures 42 - 44).
- 242 The wagons were transferred to Marcroft in Stoke for repair. There are no records of the wagons or a repair ever being undertaken at Marcroft as the archive data was destroyed when the maintenance system was changed from a paper process to a software system.

Figure 43: Image showing derailed wagon REDA 16003

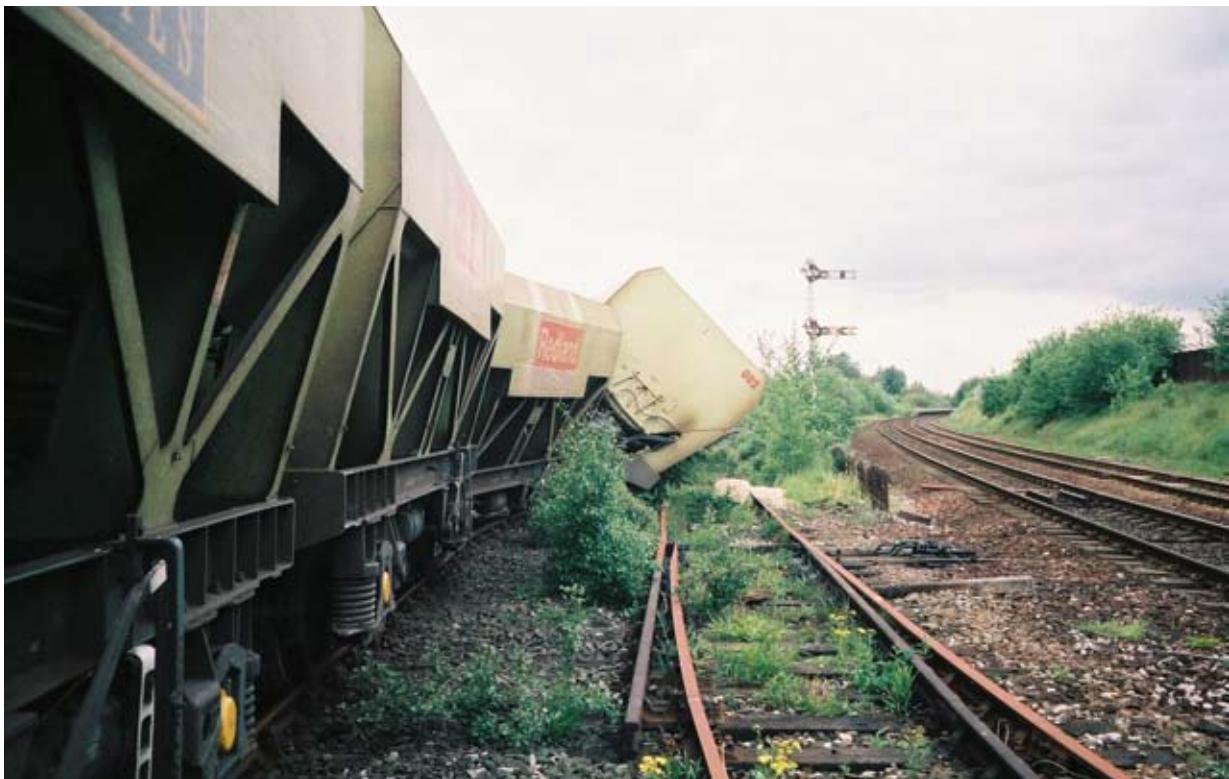
Figure 44: Image showing derailed wagon REDA 16002

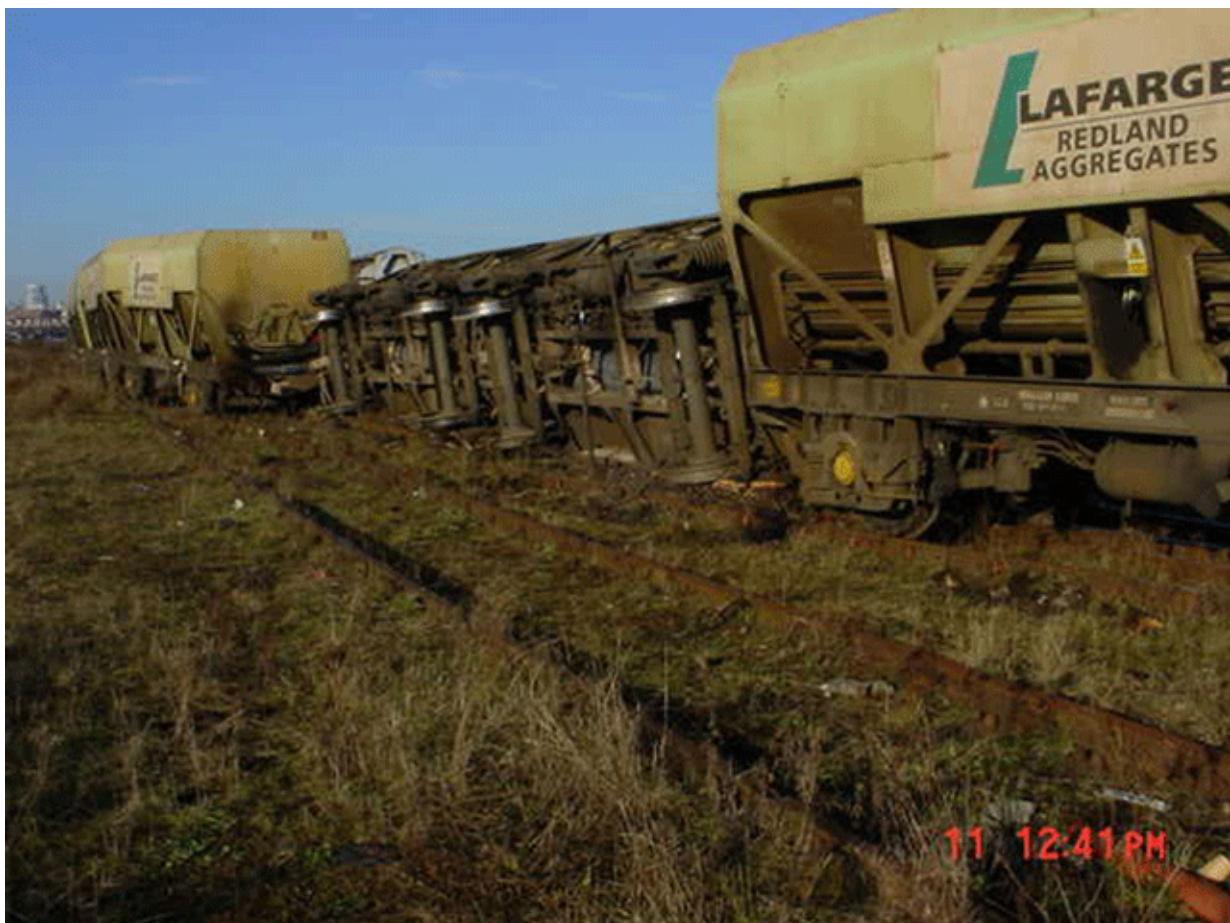
- 244 At 14:50 hrs train 6D38 the 13:12 hrs Small Heath to Mountsorrel Railhead, became derailed at Lafarge Sidings, Small Heath (Figure 45). Five wagons derailed (wagon's REDA16009, REDA16010, REDA16013, REDA16012 and REDA16011). Two wagons were severely damaged and taken out of the ten wagon set. The eight undamaged wagons returned to Mountsorrel where the conveyer belt was repaired and the train was sent to Northampton for offloading.

- 246 The incident is likely to have been the cause of the 36 mm frame twist identified on wagon REDA 16011 by Wheelchex after the Ely incident (paragraph 153 and 188).

Figure 45: Image showing train 6D38 derailed within Small Heath sidings

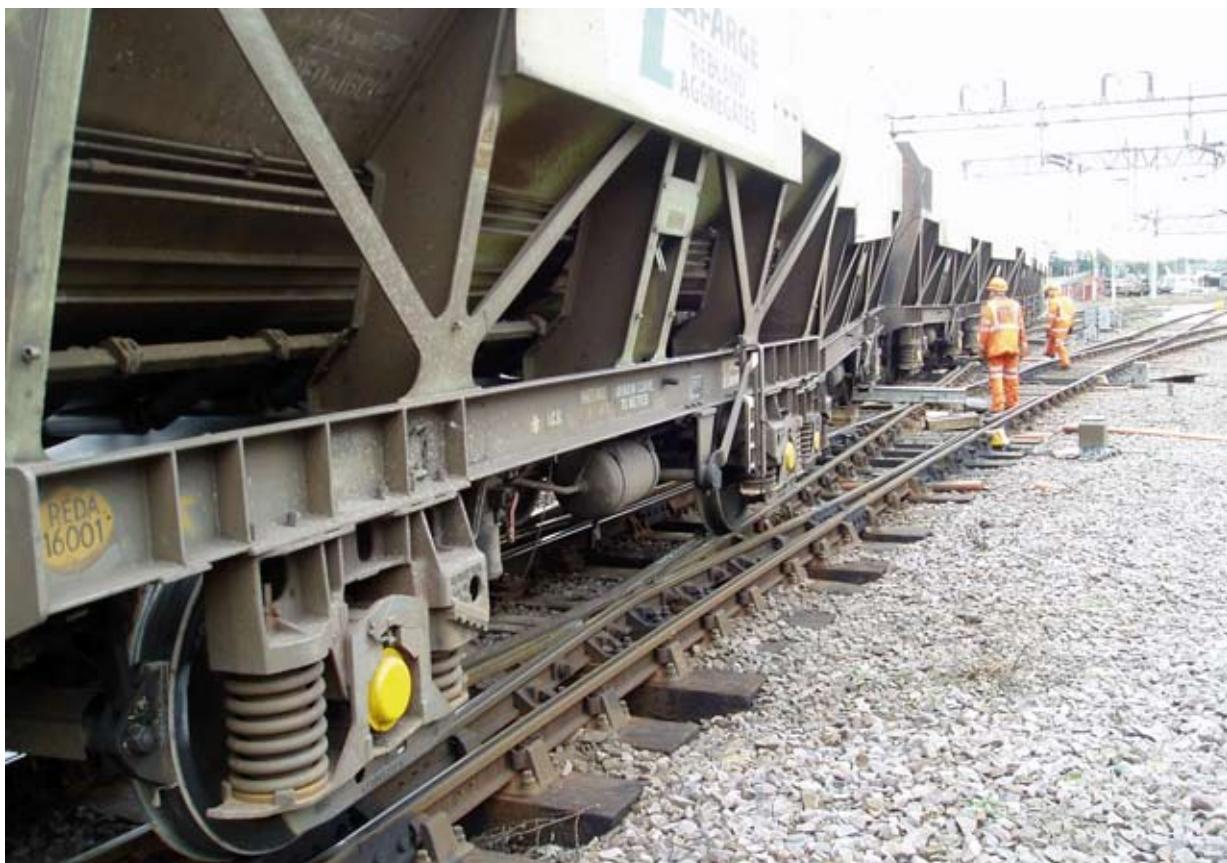
- 249 At 21:00 hrs, five PHA wagons derailed in the English Welsh & Scottish Railway sidings in Northampton while travelling at low speed (Figures 46 & 47). The point of derailment was a track joint with gauge widening to 1457 mm present.

- 251 Under the terms of GO/RT3473 English Welsh & Scottish Railway and Network Rail conducted a track survey. Network Rail made further observations relating to the loading of the vehicles. A static twist fault of 1 in 273 was identified as the cause of the derailment. No other formal correspondence or information was shared between the parties involved to ensure all parties had a clear understanding of the causal factors and that all areas of the investigation had been completed (paragraph 255 to 258).

Figure 46: Image showing derailed wagons REDA 16001, 16002 and 16003

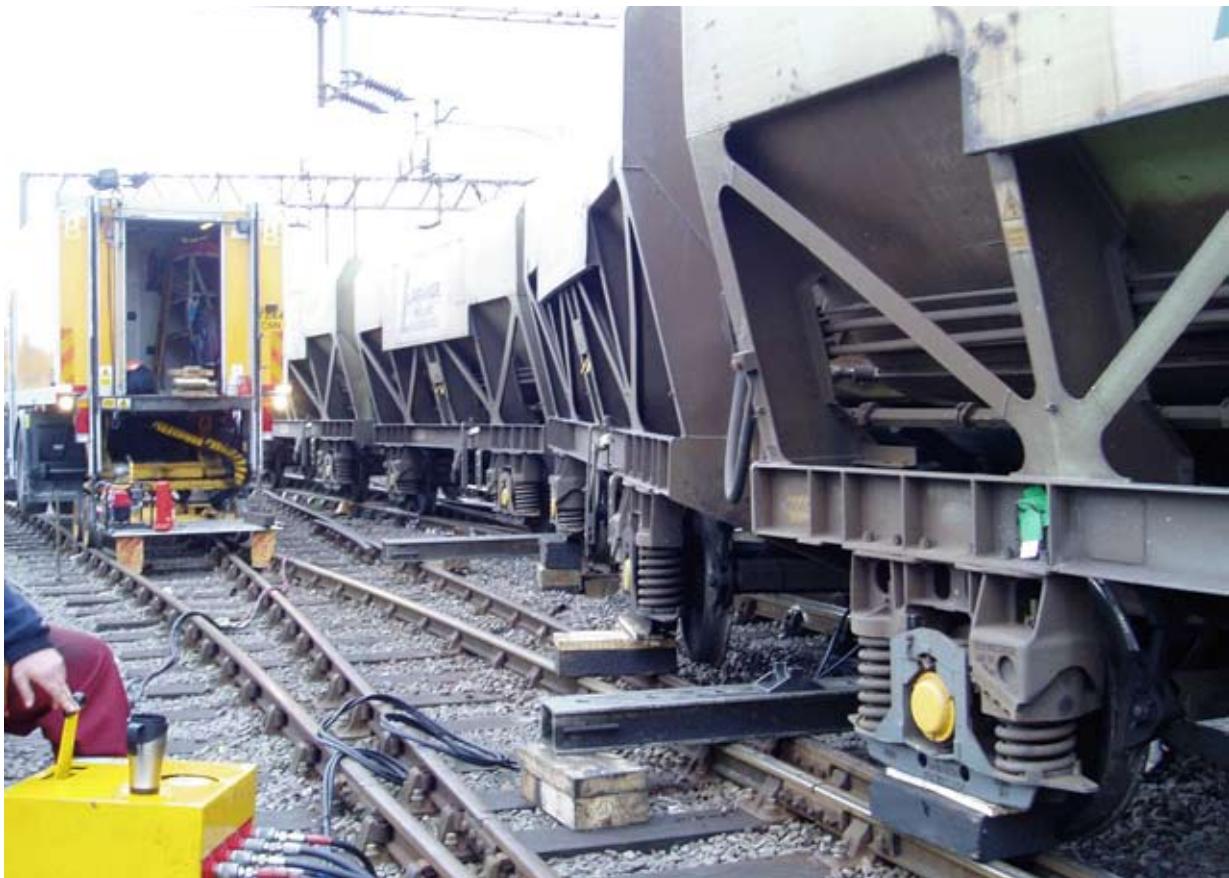
Figure 47: Images of Northampton derailment on 5 October 2006 showing wagons REDA 16001, 16002 and 16003

252 Following the derailment Wabtec undertook a visual inspection of the wagons, but no frame twist check in accordance with POCL 484 was completed, as frame twist was not suspected in any of the derailed wagons. The compensatory shims were not identified and there were no visual markers highlighting the previous packing on 16002. No examination or assessment of the wagons was documented by Wabtec or any other party (paragraph 178 and 188 to 189).

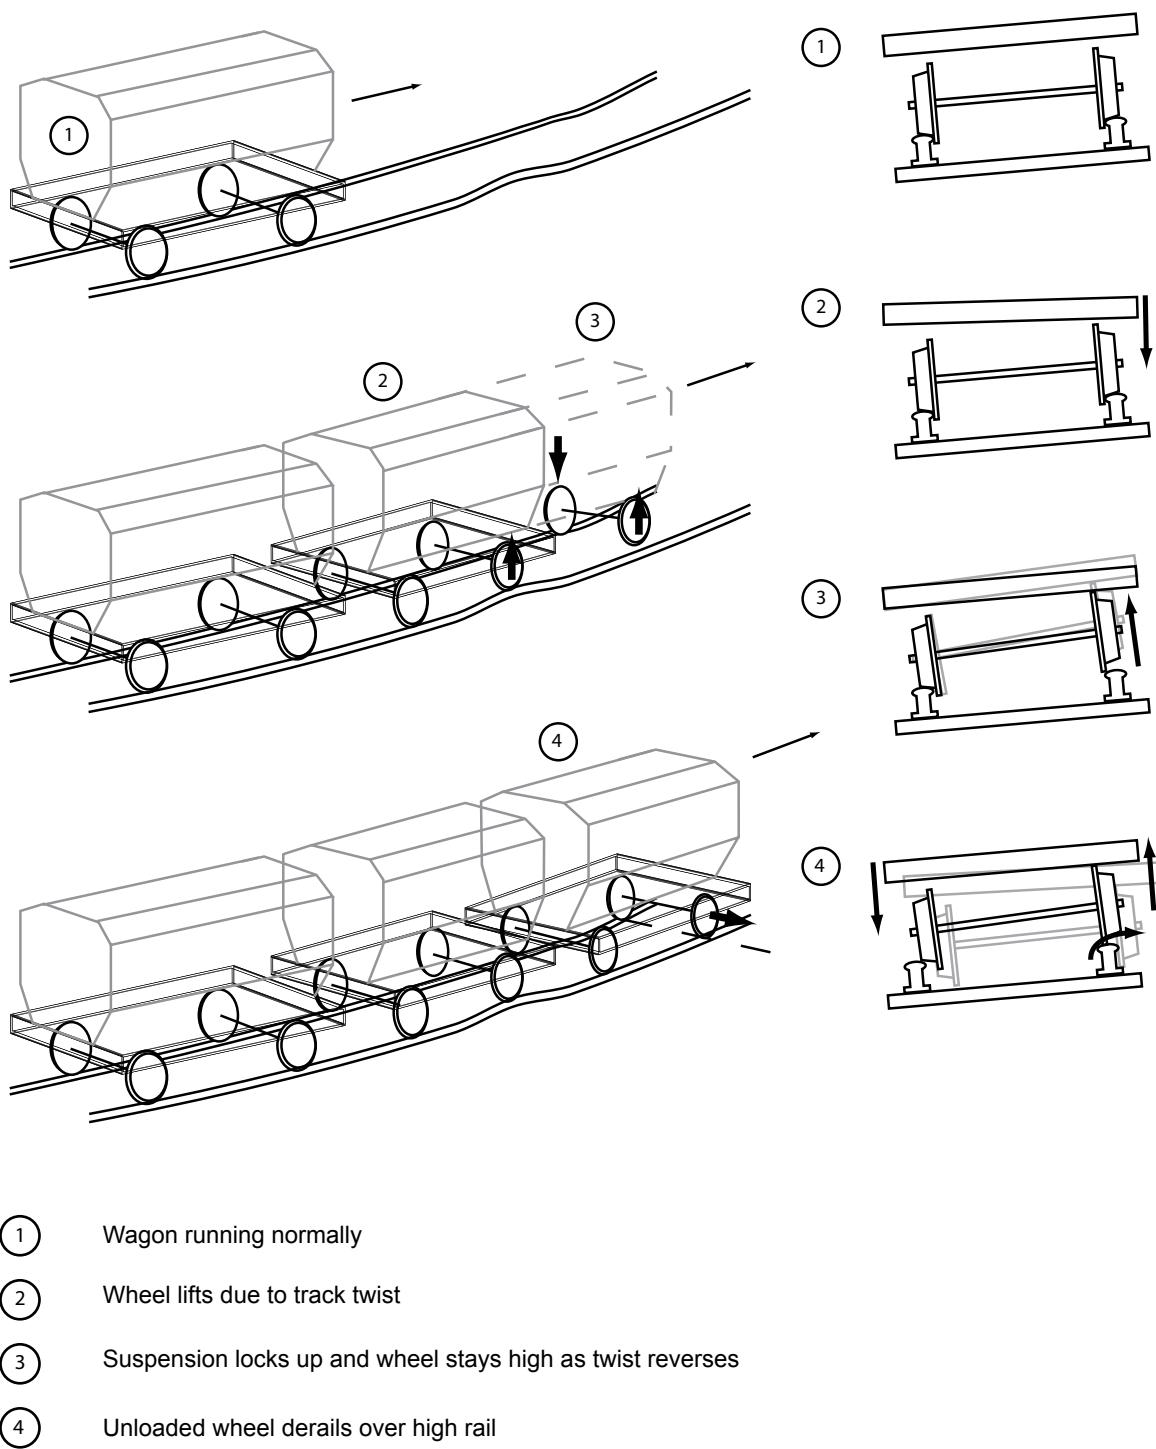
278 The additional compression of the right-hand suspension (Figures 48 (1) and (2)) is believed to have caused the right-hand leading suspension to become locked with the springs highly compressed.

279 The reversal in the twist then caused the wagon to apply an increased load to the front left wheel (Figure 48 (3)) and reduced the load on the front right-hand wheel (Figure 48 (4)). The right-hand wheel remained high and subsequently provided very little contact with the gauge corner of the rail. As the removal of any one feature would have prevented the derailment from occurring, the track twist was causal to the derailment, even though it had not reached the intervention limits (paragraphs 108 to 110).

280 The flange climb mark at the point of derailment was visible on the right-hand gauge corner, indicating the flange of the right wheel had climbed through and onto the rail head, making intermittent contact with it. The derailment mark was 250 - 300 mm in length, extremely light, and barely visible to the eye, indicating very little or no vertical and lateral load had been present on the leading right wheel flange. The flange climb marks of the right-hand leading wheel did not exhibit the expected behaviour of a leading axle on a left hand canted curve with high right rail, where it would normally be expected that heavy and deep score marks would be left by the heavily loaded wheel (paragraph 101). The drop-off mark on the left-hand rail was clearly visible.

Figure 48: Diagram of simplified derailment sequence (1) to (4)

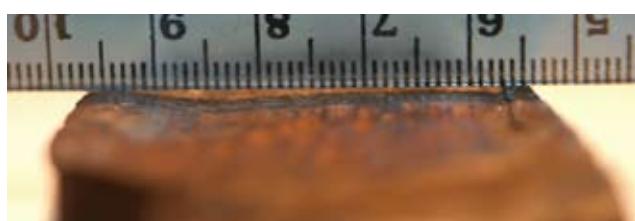
Figure 49: (A) Image of furrowing from front pedestal of REDA 16002. (B) Image of front portion of inner aspect of leading right-hand pedestal. (c) Heat damage and corrosion to pedestal guide

- 318 A section through the heated area of wagon REDA 16002 shows that the surface and microstructure of the casting was heavily deformed, with evidence of re-crystallisation of the material. The temperature colours that arose as a result of the heating indicated that the temperature had risen to between 300 and 700 degrees Celsius. The worn surface area also had areas where oxidisation and corrosion had formed within and under the heated area, indicating that the heating had taken place over an extended period of time and not just at the derailment site (Figure 49 (a) to (c)).

- 320 The irregular surface wear on the manganese friction liners on the pedestal, saddle and weld on the lateral guides of wagon REDA 16002 showed a furrowing effect had occurred between the two components (Figure 49 (a)). This indicates a misalignment had occurred between the mating surfaces of the saddle and guide friction liners, and the welded surfaces on the lateral guides.

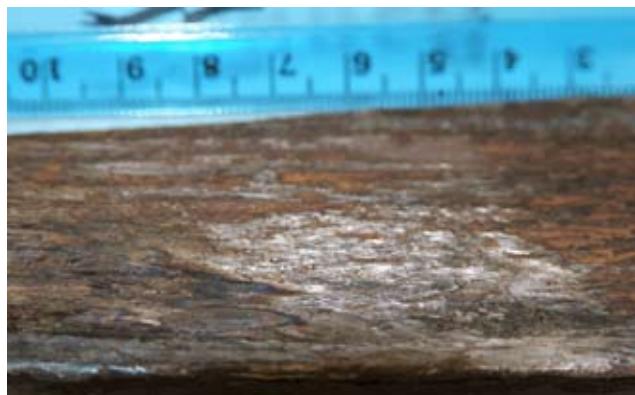
C

- 324 The combination of the frame twist and the frictional characteristics of the suspension caused the normal clearance on the inner surfaces of the right hand pedestal and saddle lateral guides to close, and the surfaces to stick. This caused a variation in the wear rates, a misalignment of the two surfaces and abnormal wear and heat to occur. The frictional characteristics of the suspension were a causal factor in the derailment (paragraphs 194 to 201 Figures 49 (a) to (c)).

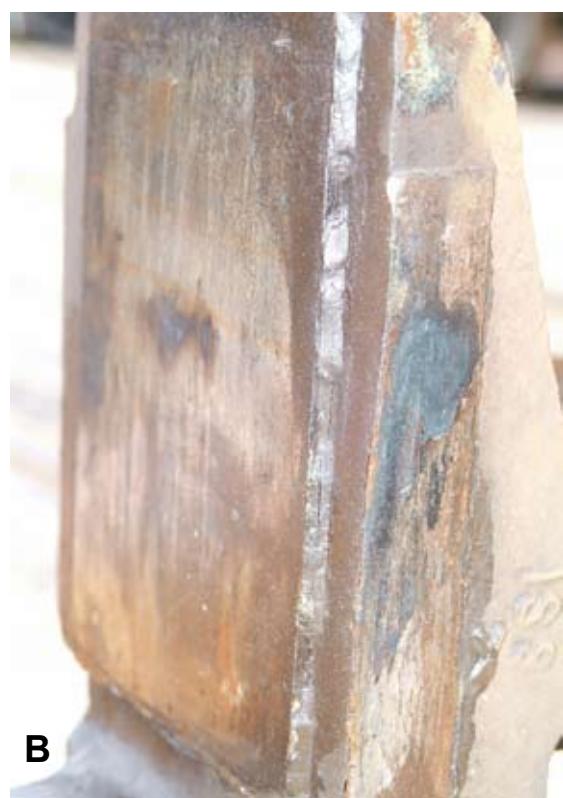
B

- 314 The measurements taken from the external rib surface of the saddle (Figure 49) and internal surface of the pedestal on wagon REDA 16002 showed a variation of 11 mm increasing to 13 mm either side of the saddle. By comparison wagon 16011 had less wear with a clearance of 8 mm increasing to 9 mm (paragraph 160).

- 315 The friction liner on the leading right hand suspension showed signs of abnormal heat on areas of the mating faces of the pedestal and damper pad, as well as the lateral guides of the pedestal (Figures 7, 40, 49 (a) to (c) and 50 (a) to (b)).

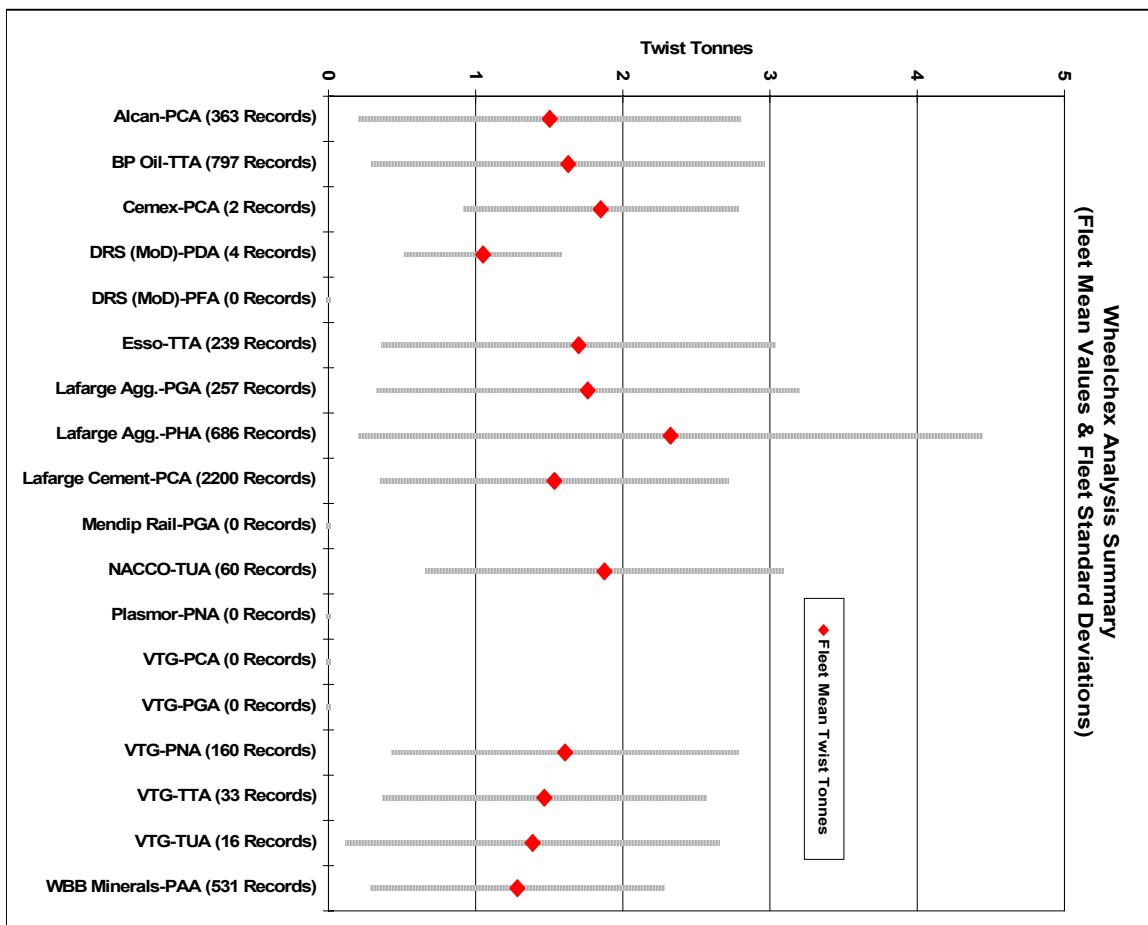
Figure 53: Network Rail review of PWRA companies. Red diamond indicates the mean value and grey horizontal bar indicates deviation from the mean value of wheel imbalance in tonnes. The data highlights the PHA wagons above average wheel imbalance compared to other wagon types
