Rail Accident Investigation Branch

# Rail Accident Report

**Fatal accident at Grimston Lane footpath crossing, Suffolk  
23 February 2016**

Report 23/2016  
November 2016

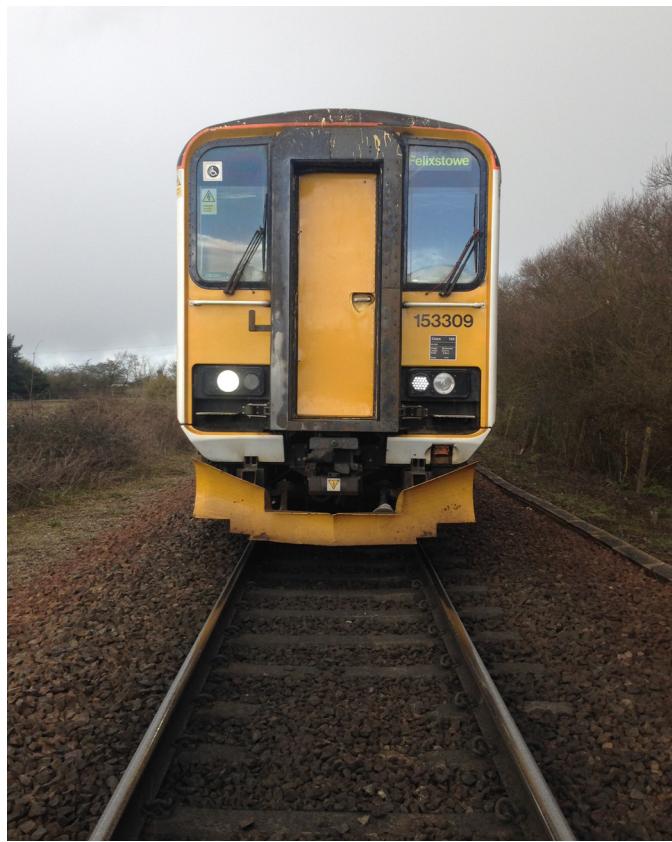
- 13 Train 2R14 was formed of a single-car Class 153 *diesel multiple unit*, number 153309.
- 14 Photographs taken shortly after the accident show that, on the front of the train, the lights were working and there was no obvious degradation of the yellow-coloured areas provided to improve conspicuity (figure 4). Post-accident inspection and testing by Abellio Greater Anglia recorded nothing untoward with the brakes, warning horn operation, or the windscreens wiper and washer.
- 15 The RAIB found no evidence that the condition of the train, or the way it was driven, contributed to the cause of the accident.

Figure 4: Photograph of train 2R14 taken at 13:49 hrs on 23 February 2016 (image courtesy of Network Rail)

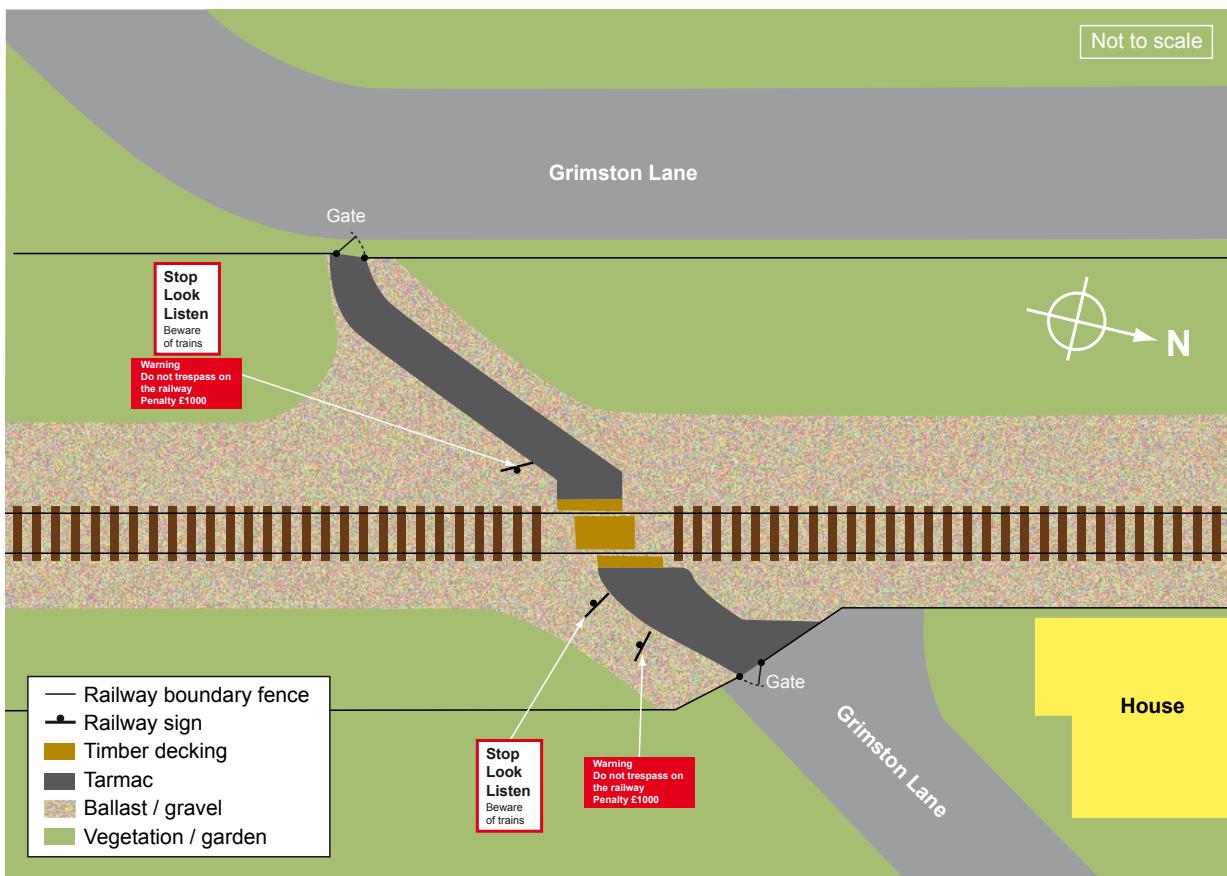
- 17 Figure 5 shows the general layout of Grimston Lane footpath crossing at the time of the accident. The single line railway at this location runs approximately north to south in a relatively wide strip of railway land. Self-closing wooden wicket gates at the railway boundary provide access to an open lineside and broken-edged tarmac footpaths leading to a level timber *crossing deck*. The paths and the crossing deck broadly follow the original line of Grimston Lane, which crossed the railway on a skewed alignment. Inside the railway boundary, signs instruct users to stop, look and listen and beware of trains. The pedestrian was crossing the railway from the east. Figure 6 shows the key features when approaching in this direction.

Figure 5: Layout of Grimston Lane footpath crossing

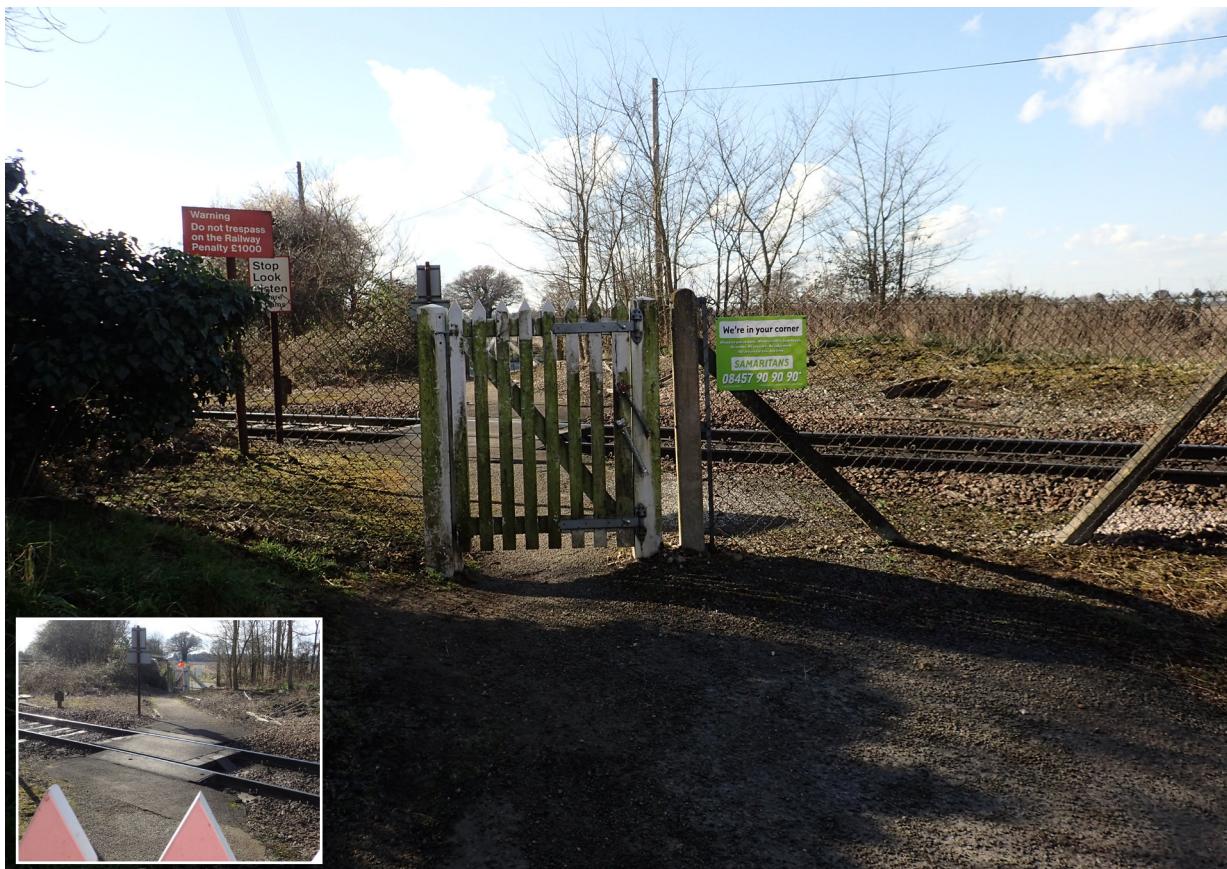
Figure 6: Key features of Grimston Lane footpath crossing when approaching from the east

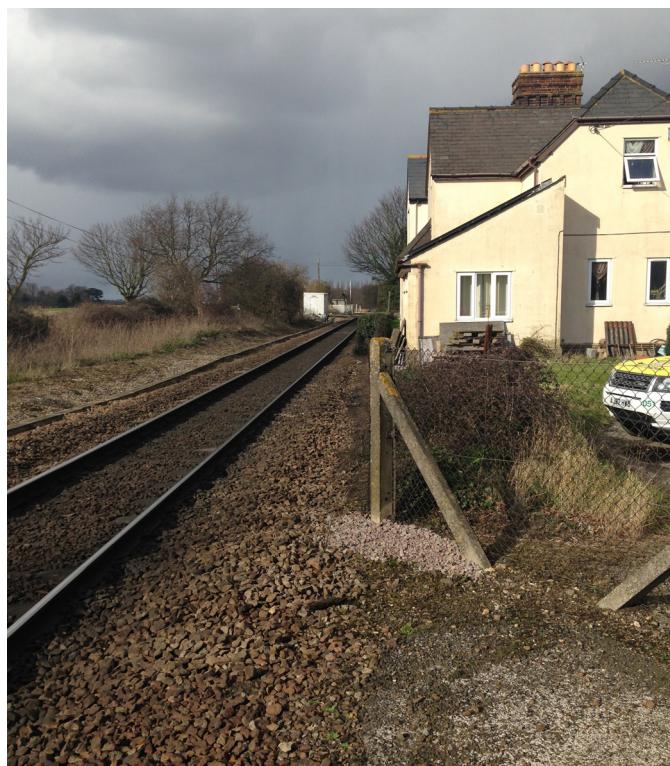
- 22 It was daylight at the time of the accident; the sun was close to due south (facing the approaching train) and almost at its maximum altitude,  $27.98^\circ$ . The weather recorded at Wattisham airfield, 28 km away, was partly cloudy. This is consistent with photographs taken at the crossing shortly after the accident (figure 7). There was no fog or mist.
- 23 A local weather station in Trimley St Martin recorded an air temperature of  $9.4^\circ\text{C}$  and a north-north-westerly wind of 15 km/h. There had been no precipitation over the previous 12 hours.
- 24 The RAIB found no evidence that the above environmental factors contributed to the cause of the accident.

*Figure 7: Photograph of the railway at Grimston Lane footpath crossing in the direction from which the train approached, taken at 13:36 hrs on 23 February 2016 (image courtesy of Network Rail)*

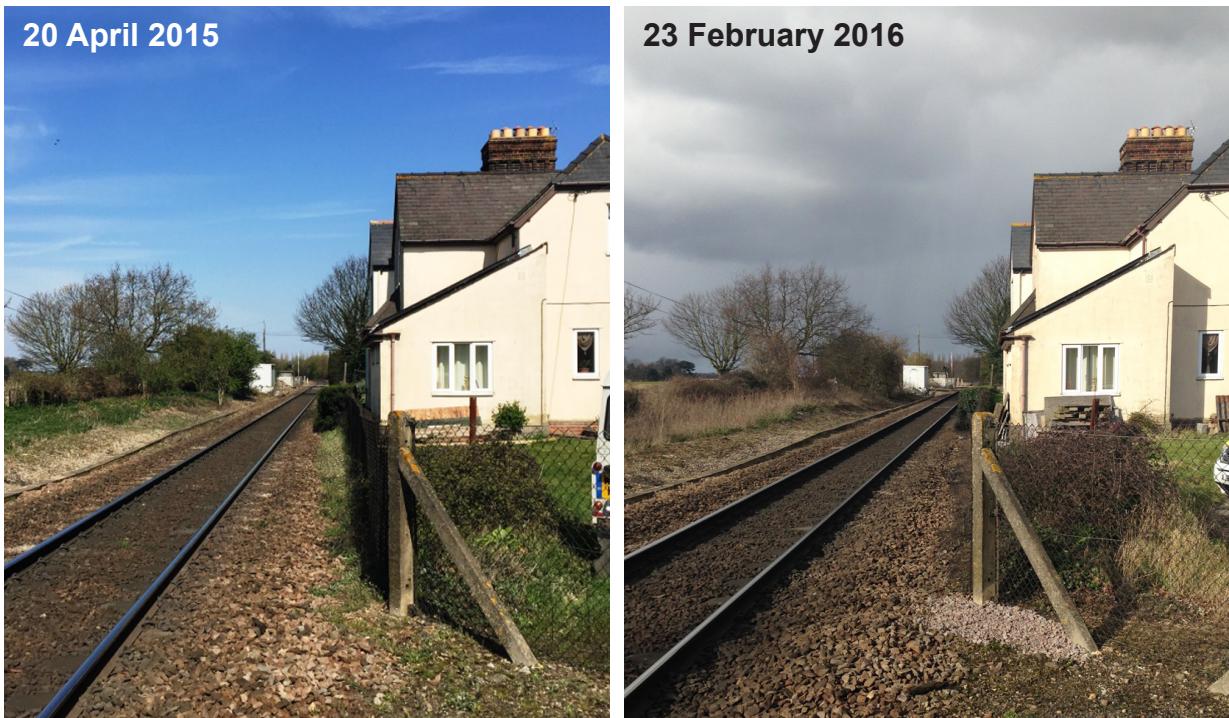
- Changes to the lineside equipment, structures or vegetation since the last risk assessment had not compromised the pedestrian's view of the approaching train. Figure 8 shows photographs of the view taken for the last risk assessment (on 20 April 2015) and the view after the accident (on 23 February 2016).

Figure 8: Photographs taken from the east side of the crossing, in the direction from which the train approached, on 20 April 2015, for the last level crossing risk assessment, and 23 February 2016, after the accident (images courtesy of Network Rail)

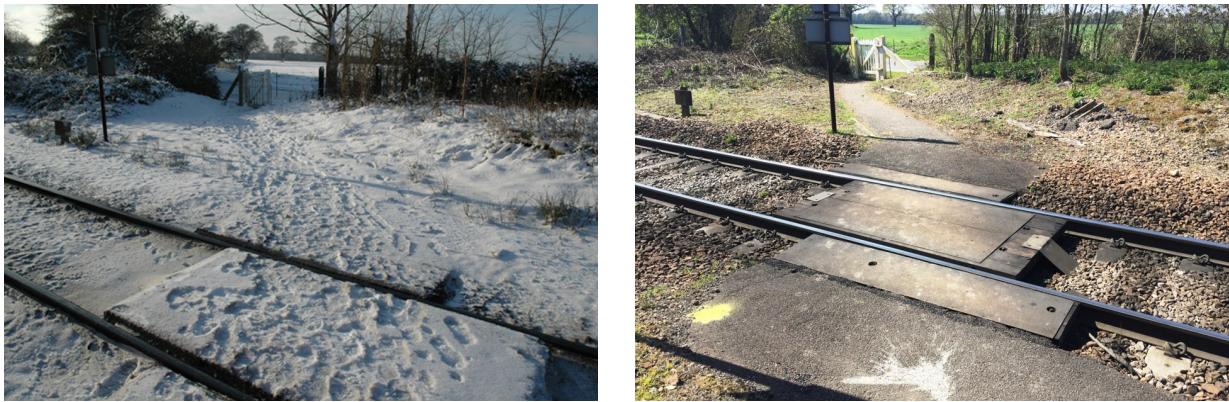
- 61 **It is possible that the skew of the crossing, or another reason, resulted in the pedestrian not looking in the direction of the approaching train.**
- 62 Photographs showing footprints and wear patterns on the crossing deck (figure 9) indicate that users routinely follow the general skewed alignment of the crossing deck (and the tarmac approach paths to and from it) and cross the railway on a diagonal path. The RAIB estimates that a typical path would be at 33° to the direction at right angles to the track, and orientated so that users crossing from the east side naturally tend to face away from trains approaching in the down direction.

*Figure 9: Evidence of footprints and wear marks on the crossing deck (images courtesy of Network Rail)*

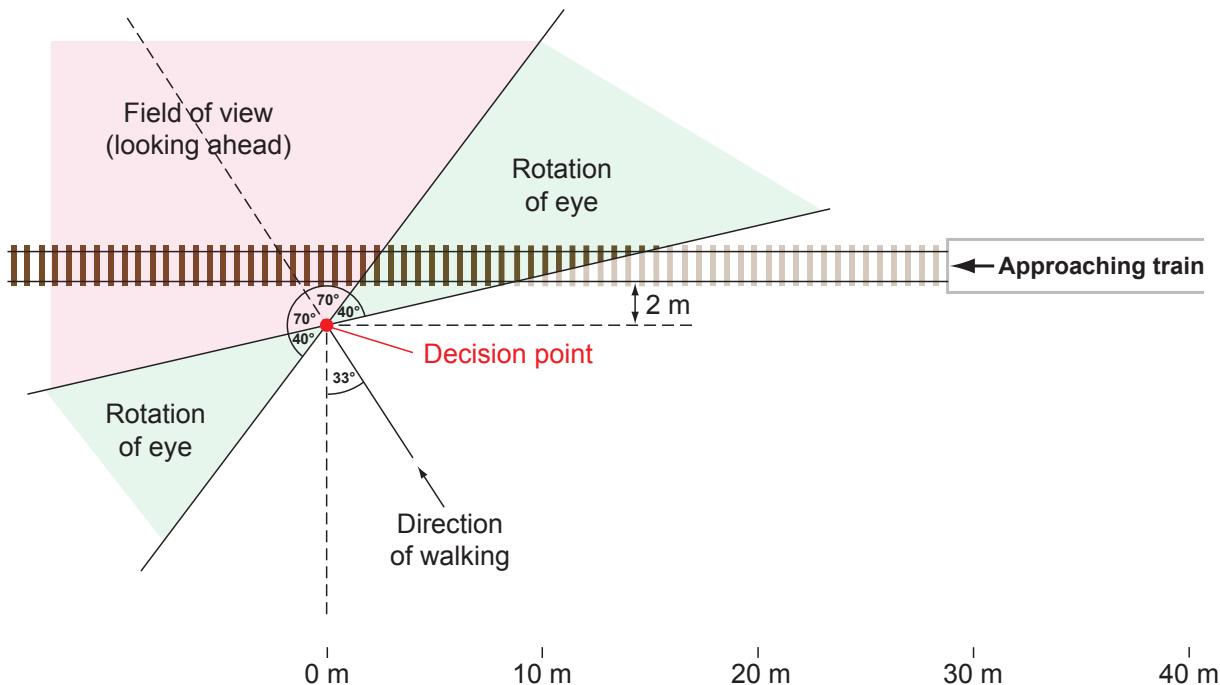
Figure 10: Estimated field of view at a decision point two metres from the track (paragraph 69) when crossing at a skew angle of 33° to the direction at right angles to the track

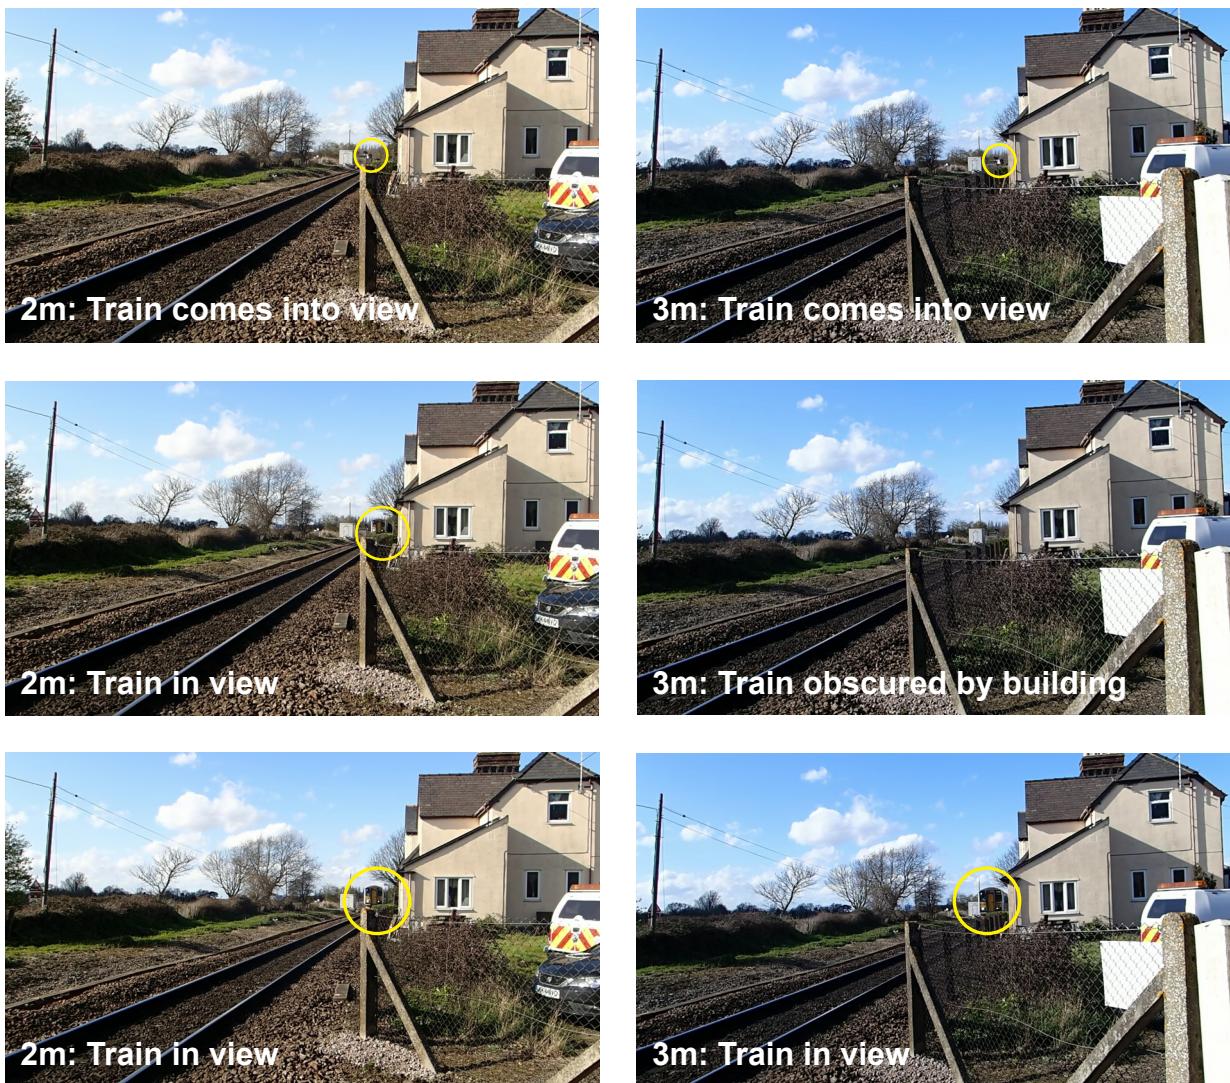
- 70 Trains approach Grimston Lane footpath crossing in the down direction on a right-hand curve (paragraph 26) and, on the east side of the crossing, nearby structures increasingly restrict a pedestrian's view of trains as the selected decision point moves further from the track. The RAIB made video recordings of down-direction trains approaching the crossing with cameras positioned at two metres (the decision point used in the last level crossing risk assessment) and three metres from the track. At two metres, close to the sign instructing users of the need to 'stop, look and listen' (paragraph 17), the train remains in view from when it appears, from behind level crossing equipment at Thorpe Lane, to when it reaches Grimston Lane. However, at three metres, it becomes obscured by a two-storey house shortly after appearing from behind the Thorpe Lane level crossing equipment; it only reappears when it is close to Grimston Lane footpath crossing (figure 11).

Figure 11: Video images of an approaching down-direction passenger train recorded at two metres and three metres from the track, on the east side of Grimston Lane footpath crossing

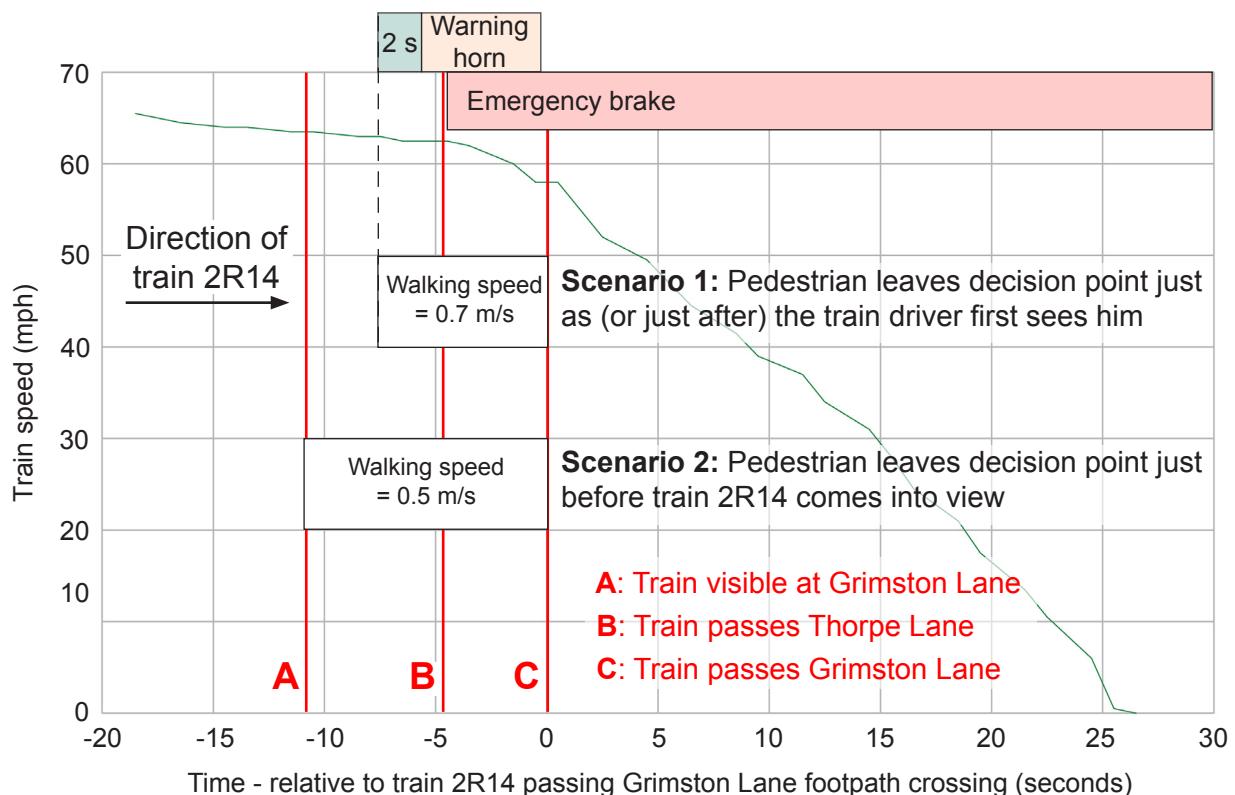
- 79 The RAIB analysed the information from the *on-train data recorder* (OTDR) to estimate the speed at which the pedestrian was crossing. With reference to figure 12, if the pedestrian had decided to cross just as (or just after) the driver had first seen him<sup>23</sup>, and was located at a decision point two metres from the railway (paragraph 70), he would have been walking at a speed of no more than 0.7 m/s (scenario 1). However, if the pedestrian had decided to cross earlier, when he would not have seen an approaching train, but when train 2R14 was about to come into view, he would have been walking much more slowly, probably around 0.5 m/s (scenario 2). A review of studies into road crossing behaviour has observed that older pedestrians may not fully compensate for the decline in their walking speed (paragraph 76).

Figure 12: OTDR analysis showing the possible range of speeds at which the pedestrian was walking. Both scenarios assume: a) the decision point was two metres from the track; and b) the traverse path was aligned at 33° to the direction at right angles with the track

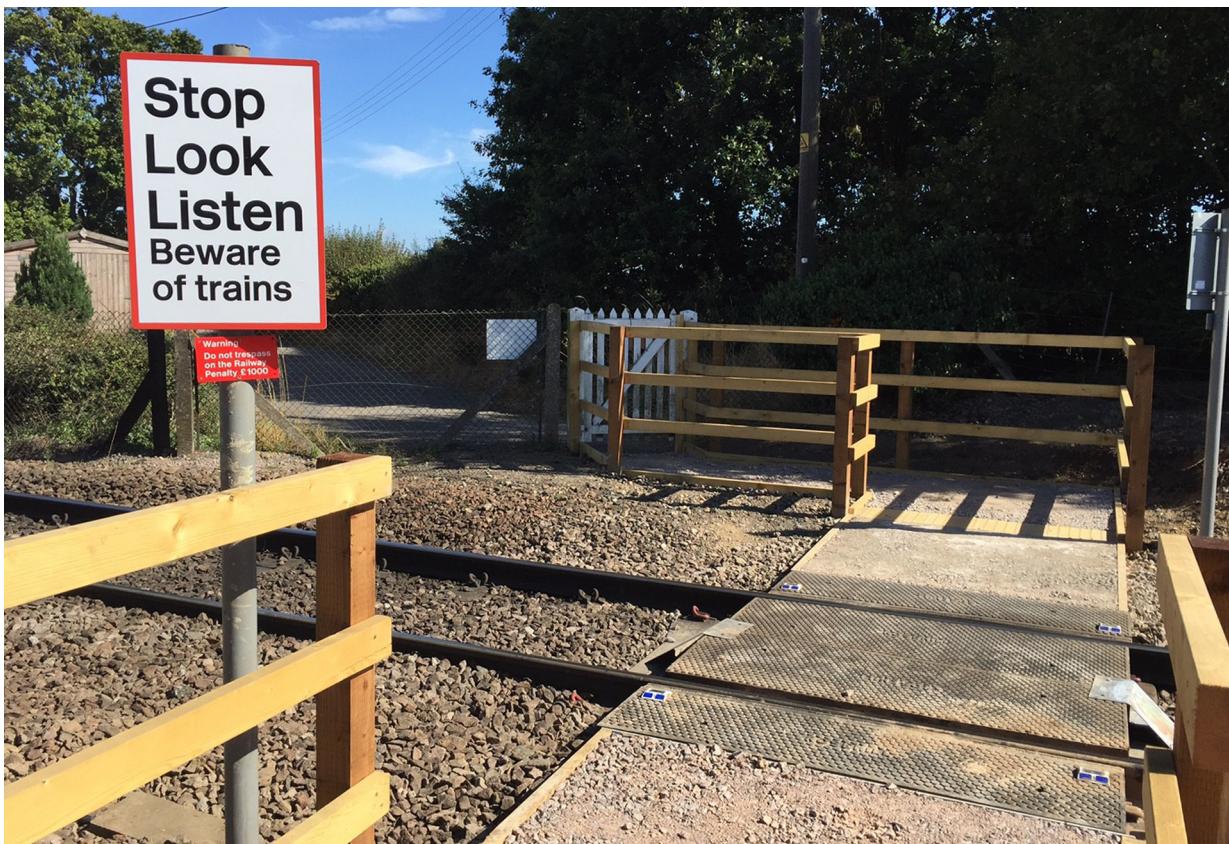
Figure 13: New crossing deck and fenced approach paths at Grimston Lane footpath crossing (image courtesy of Network Rail)

105 Network Rail has advised that it reviewed the sighting from Grimston Lane footpath crossing after the accident and removed vegetation and redundant lineside structures (in the vicinity of the nearby level crossing at Thorpe Lane) to improve the visibility of trains approaching in the down direction. It later advised that it has replaced the skewed timber crossing deck with a rubber crossing deck that is aligned perpendicular to the track, and has fenced the approach paths to it (figure 13).
