# Rail Accident Report

**Unauthorised entry of a train onto a single line  
at Greenford  
20 March 2014**

Report 29/2014  
December 2014

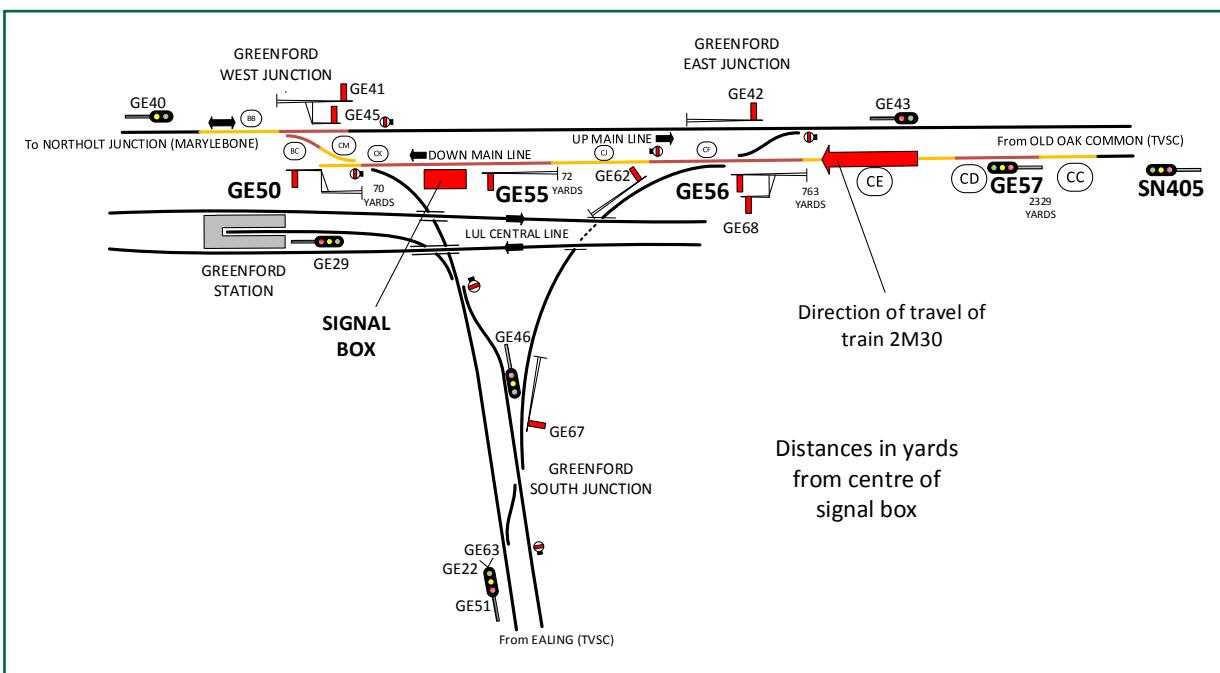
Figure 2: Greenford area, showing track layout and signals

- 6 On Thursday 20 March 2014 train 2M30<sup>1</sup>, the 11:36 hrs Chiltern Railways service from London Paddington to West Ruislip, passed two consecutive signals, GE55 and GE50, at danger near Greenford, Middlesex (figures 1 and 2). It ran onto the single line beyond signal GE50 and continued for about 1 mile (1.6 km) before being stopped. No-one was hurt in the incident.

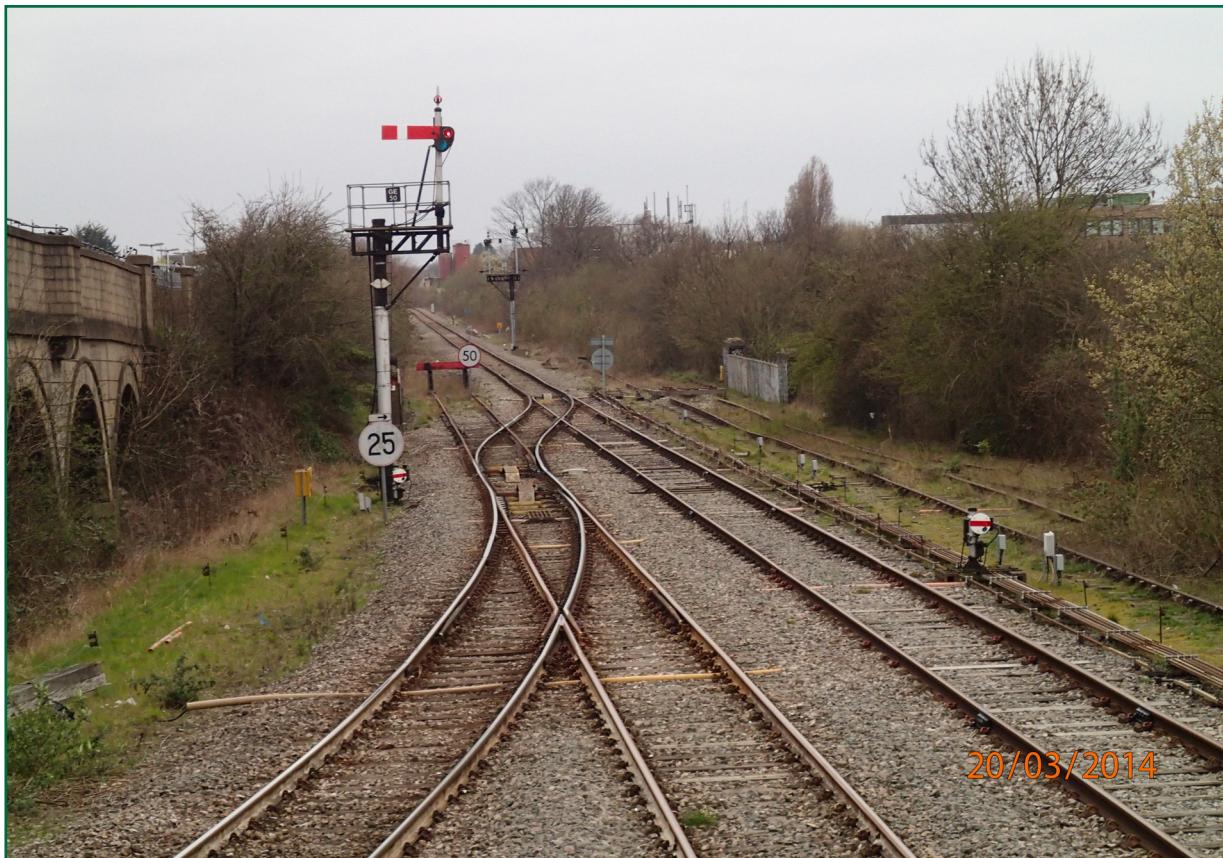
- 25 The signaller knew that signal GE55 was fitted with TPWS. He stated that he expected this equipment to stop the train before it reached signal GE50, which he could clearly see at danger in front of him (figure 3). However, the train did not stop, and continued onto the single line.

Figure 3: Greenford signaller’s view of signal GE50 and the single line towards Northolt Junction (South Ruislip)

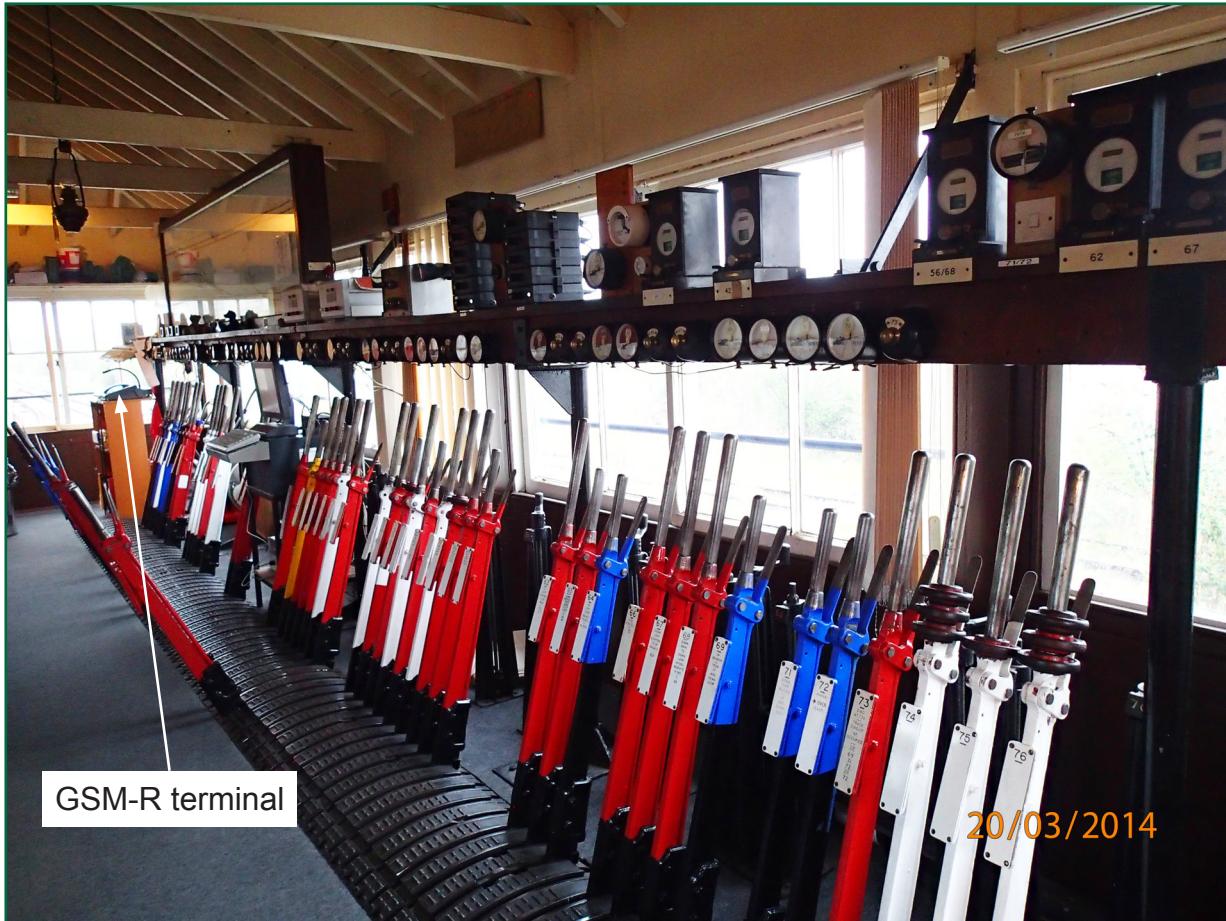
Figure 4: interior of Greenford signal box, showing lever frame.

- 30 Greenford signal box has a mechanical lever frame, which controls both semaphore and colour light signals (figure 4). All the semaphore signals are of the lower quadrant type, in which the arm is horizontal when at 'danger', and moves downwards to between 45° and 60° below the horizontal to indicate 'clear'.

55 The information that the signaller at Greenford has about the position of trains approaching on the down main line is limited. The train's position relative to signal GE56 cannot be established by looking from the signal box, because the signal is 763 yards (698 metres) away, and at the time of the incident it was concealed from the signal box by vegetation (the tree which is visible behind the signal in figure 6). The signaller must rely on the indications on the illuminated diagram in the signal box (visible above the lever frame in figure 4), which show which track circuit the train is occupying (figure 9).

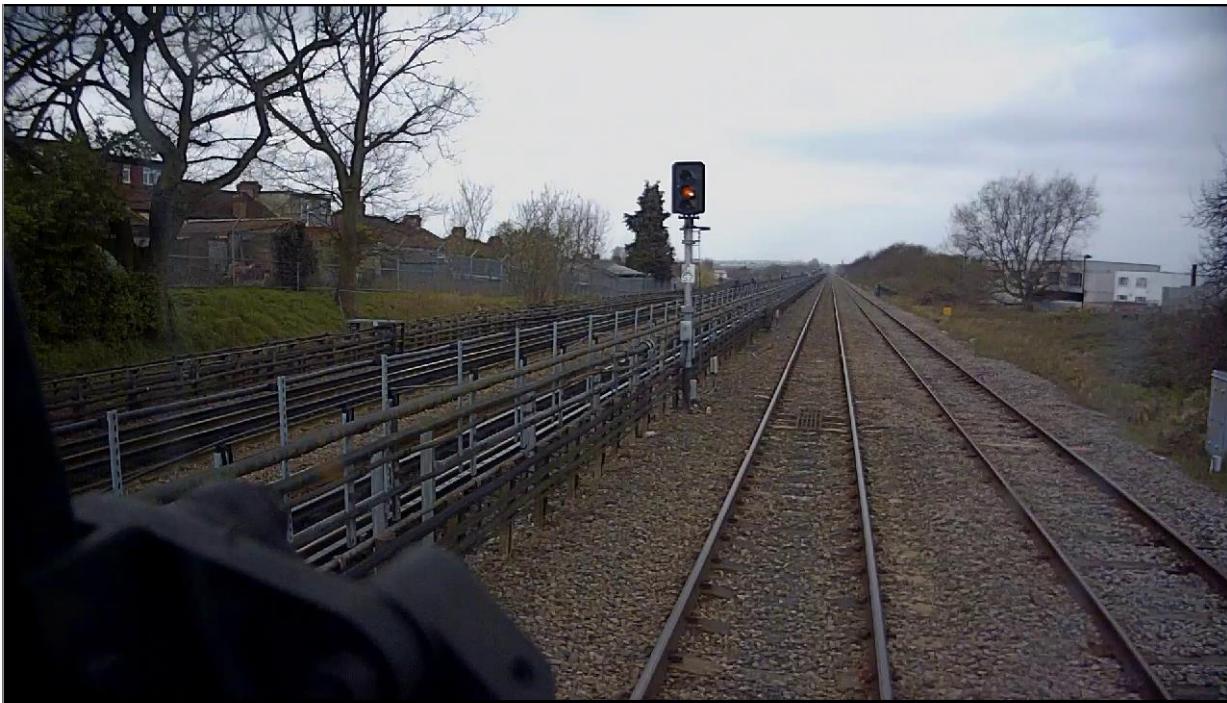
Figure 5: signal GE57 showing yellow (caution). The signal was incorrectly plated G57 at the time of the incident, but this has since been corrected.

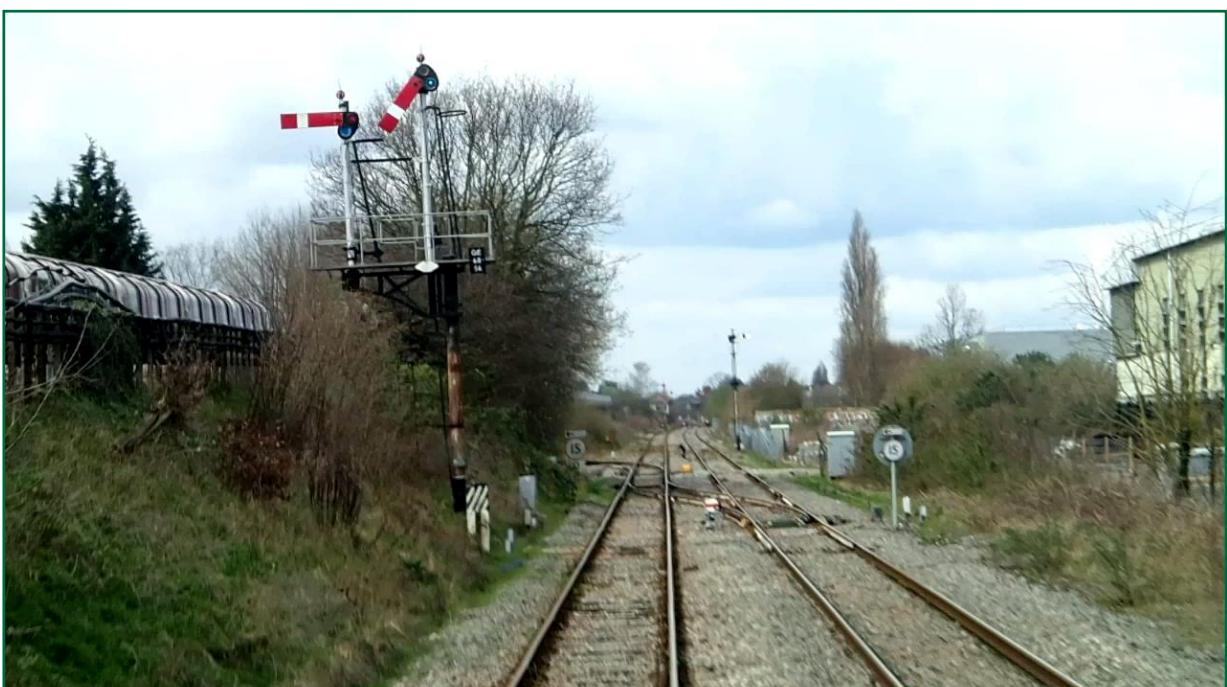
Figure 6: Greenford East Junction, showing signals GE68 (left) and GE56 (right)

- 33 The route to Greenford South Junction and Ealing diverges to the left. The next signal is GE55, visible in the distance in figure 6 and in the foreground of figure 7, which is 72 yards (66 metres) from the signal box. This signal protects the junction with the line from Ealing, which converges from the left beyond the signal box, about 130 yards (119 metres) beyond signal GE55.

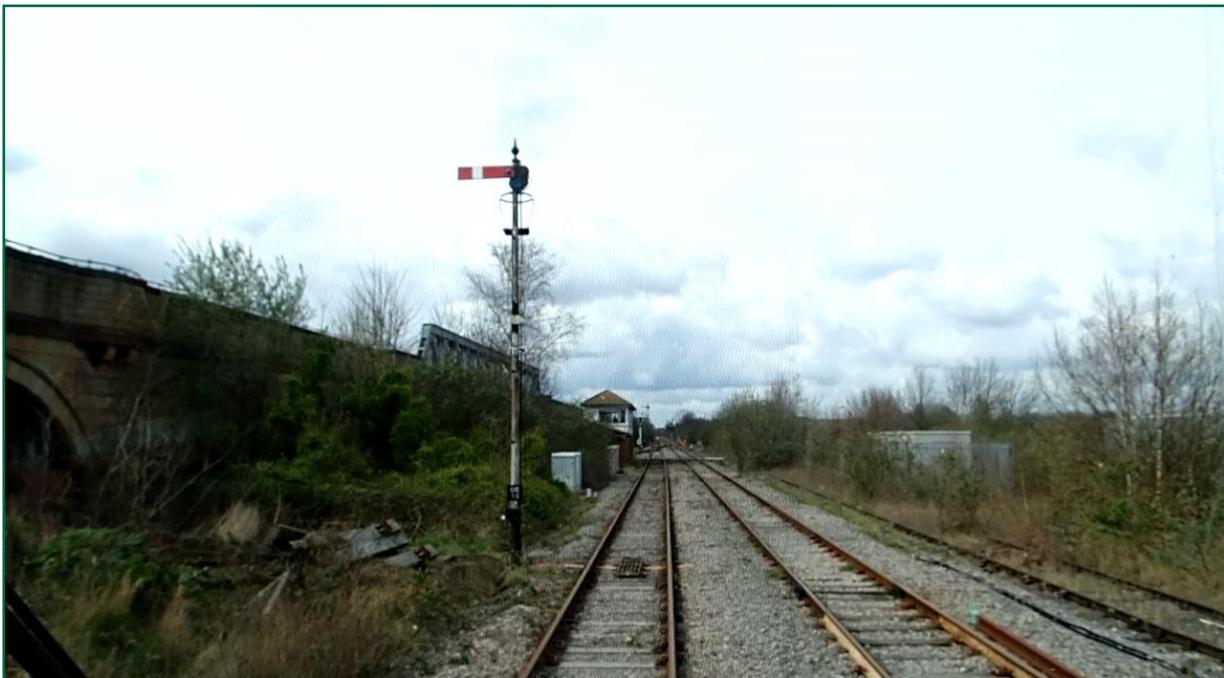
Figure 7: Signal GE55, with Greenford signal box and signal GE50 in the distance

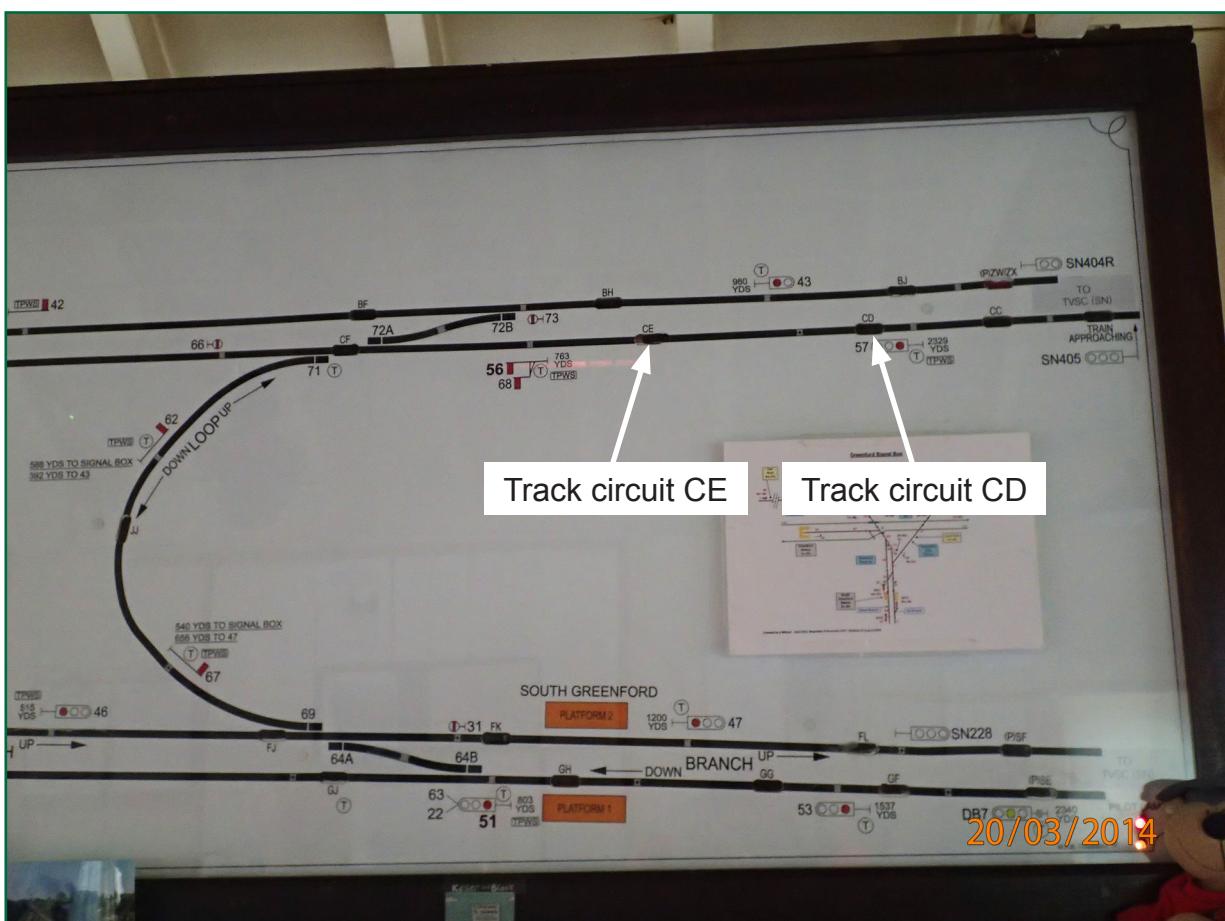
Figure 9: Signal box diagram at Greenford (part), showing down main line approach

- 56 There are two track circuits indicated between signals GE56 and GE57: CD and CE. The two signals are 1566 yards (1432 metres) apart. Track circuit CD extends for 422 yards (386 metres) beyond signal GE57, and track circuit CE covers the remaining 1144 yards (1046 metres).

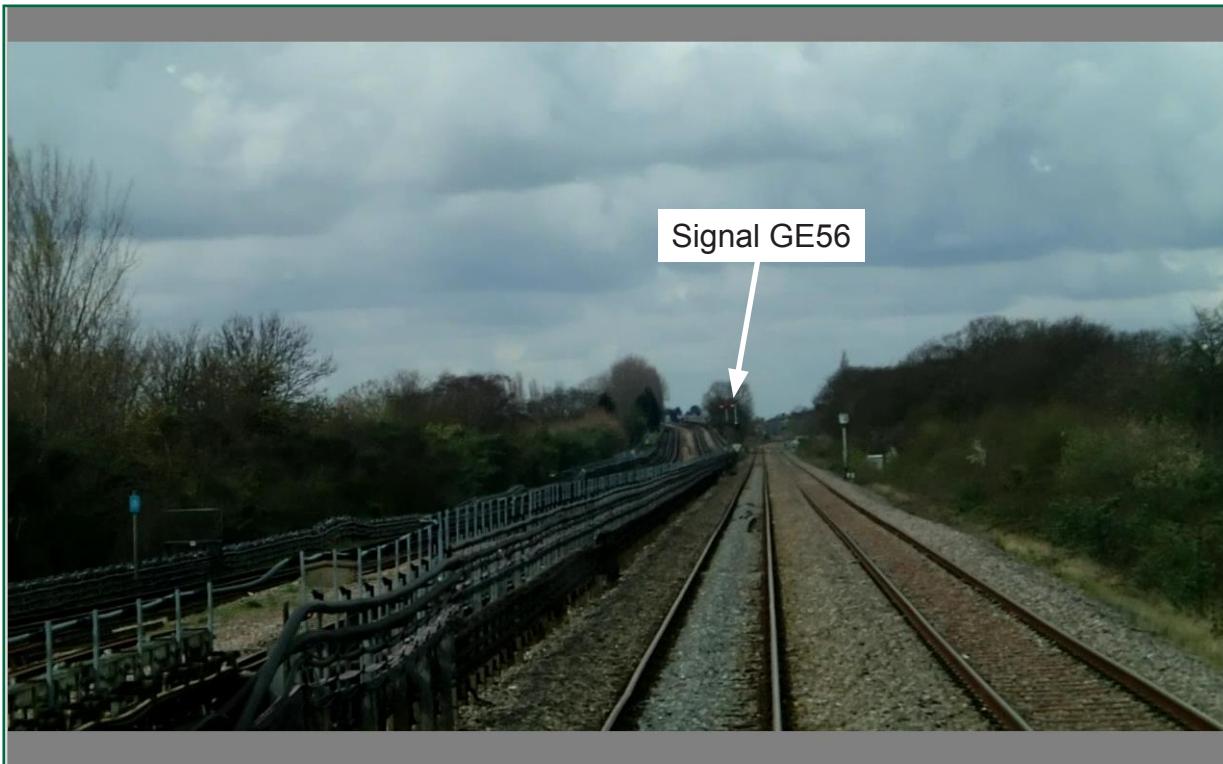
- 61 During the investigation, RAIB observed the running of train 2M30 when the same signaller was on duty in the signal box. He had been asked to signal the train in the same way as he did on 20 March. On the day of the test, the signaller cleared signal GE56 when the train was approximately 650 yards (594 metres) away from it (figure 10). The RAIB has calculated that this was approximately 30 seconds after the train moved off CD track circuit.

Figure 10: View of signal GE56 at clear, from 650 yards (594 metres) away

- 62 If the signaller had in fact operated the signals in the same way on 20 March, and only waited for 30 seconds before clearing signal GE56, the driver of 2M30 may not have realised that the clearance of signal GE56 had been delayed, if he had first noticed its position only after it was cleared, when the train was about 650 yards (594 metres) from it. This may have created the belief in his mind that the rest of the Greenford signals would also be clear for his train.

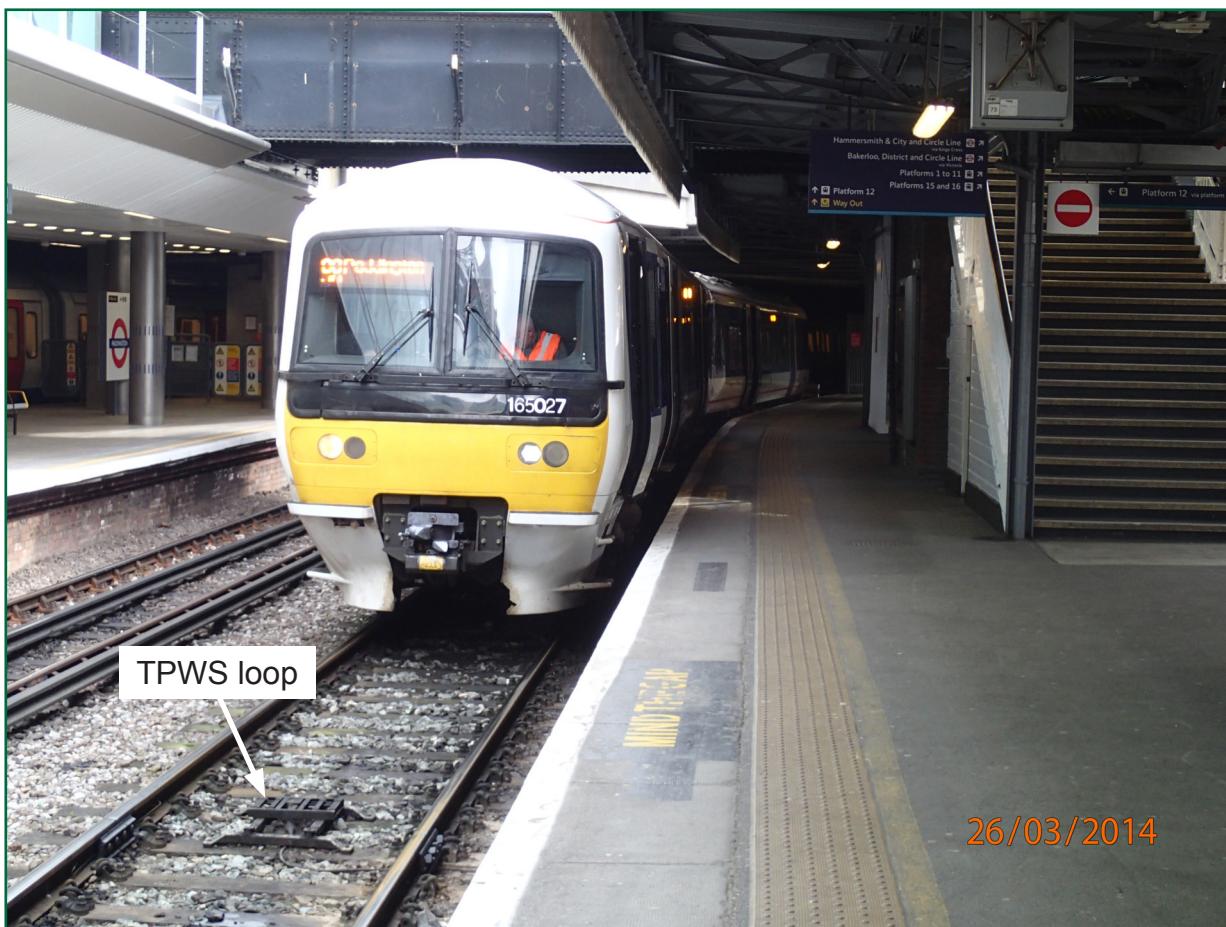
- 78 If a two-coach class 165 train (which is 46 metres long) is stopped two metres away from the stop block in platform 14 at Paddington, the rear of the train will be clear of the trigger loop for the TPWS associated with the stop block (figure 11).

Figure 11: Two-car class 165 drawn up the stop block in platform 14 at Paddington, showing TPWS trigger loop clear of west end cab

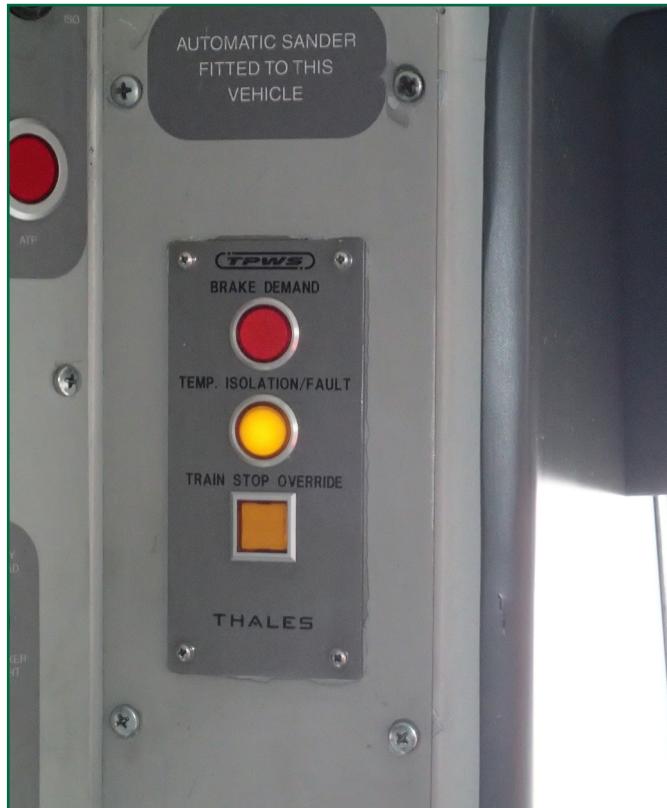
- Off               TPWS state is normal
- Flashing         A fault has been detected in the train TPWS equipment
- On (steady)      The train TPWS equipment has been temporarily isolated.

Figure 12: TPWS control panel in unit 165026

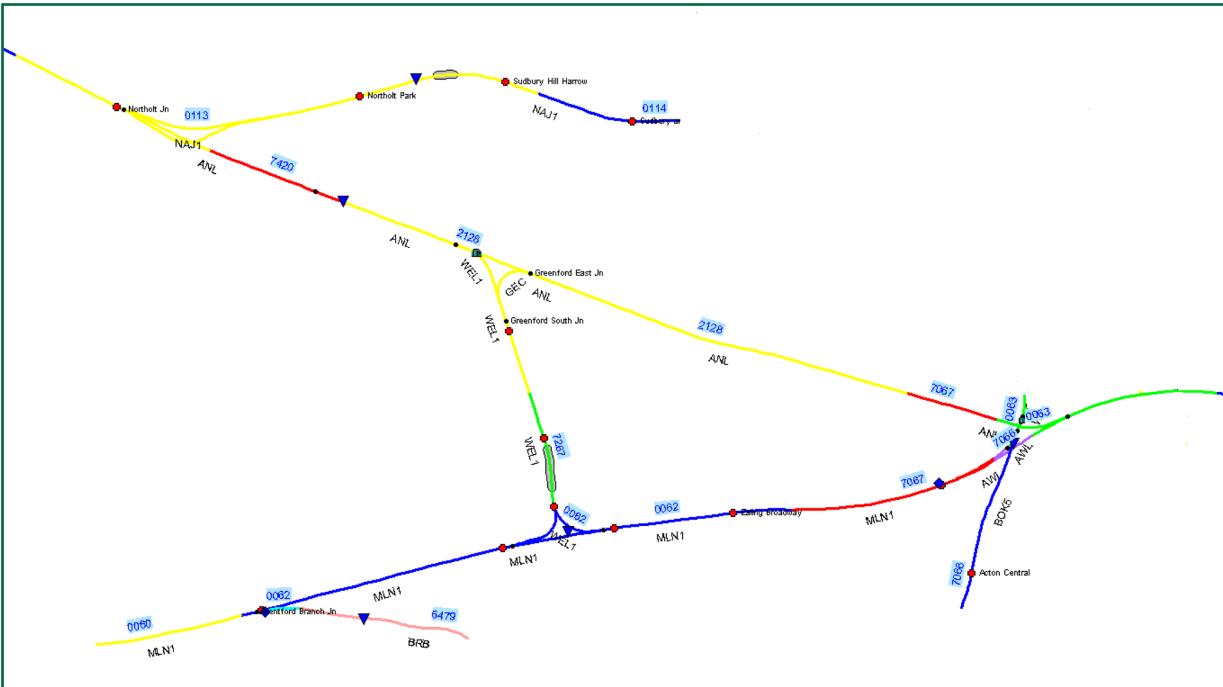
- 6 Greenford is the nominated signallers' terminal for cell 2128 only (figure 13). The coverage of cell 2128 corresponds closely to the control area of Greenford signal box: it extends approximately from North Acton to Northolt (mile post 4 to milepost 8¾) on the main line, and as far as Castle Bar Park (milepost 7½) on the Ealing branch.

**Figure 13: Greenford area, showing GSM-R cell coverage boundaries (courtesy of Network Rail)**

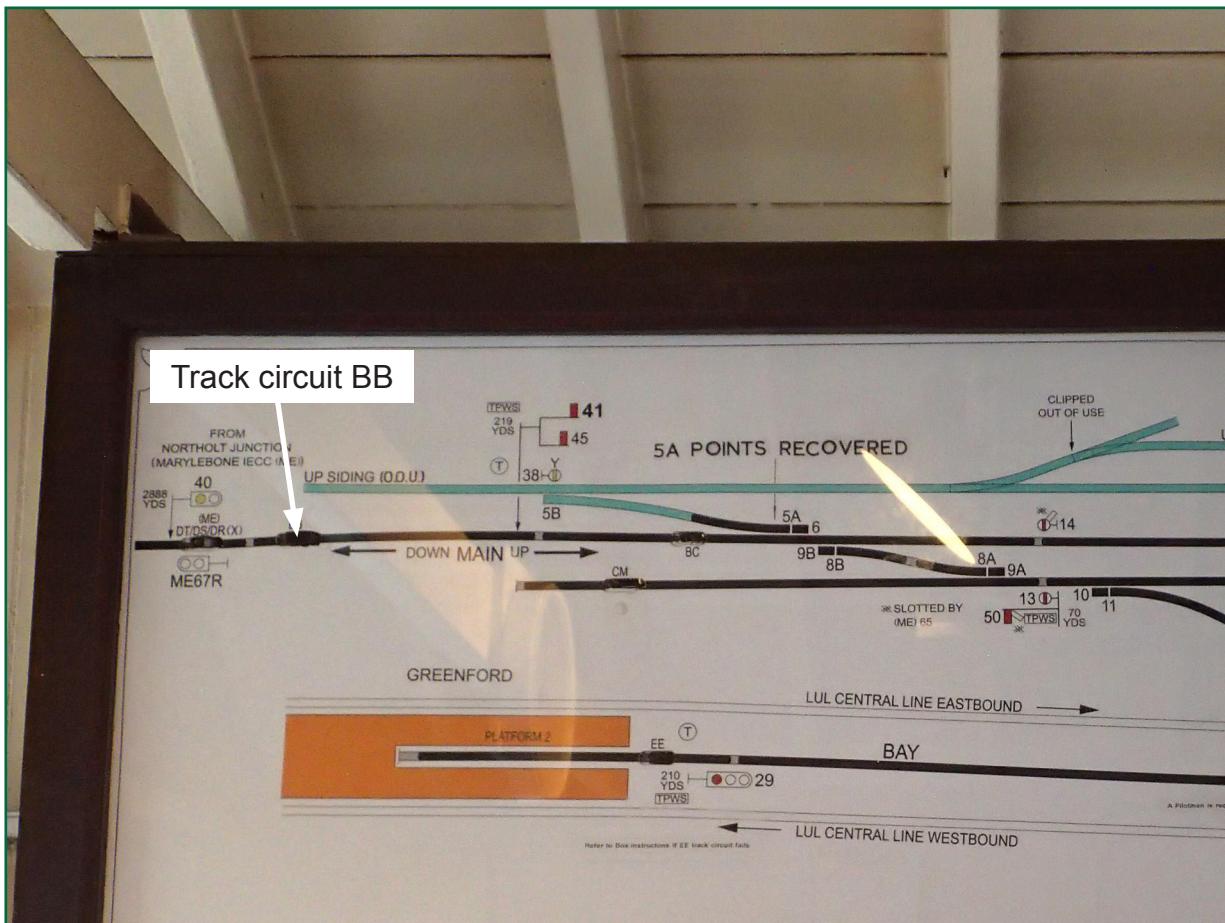
- 10 However, the first train describer berth in the GSM-R system associated with the Marylebone South control area was berth 0067. This train describer berth is linked to track circuits occupying nearly the entire length of the single line between Greenford and South Ruislip and begins adjacent to BB track circuit just to the west of signals GE41 and GE45 (figure 14).

Figure 14: Part of Greenford signal box diagram, showing the line to Northolt Junction

- 11 The effect of including berth 0067 in the ELDA configuration for Marylebone South was that as soon as the next three minute GSM-R poll occurred, the GSM-R system correlated the train radio to Marylebone South in ELDA mode and only displayed it on the Marylebone South signaller's terminal. Depending on exactly when the three minute poll of the train radio occurred, this would have made train 2M30 disappear from the Greenford GSM-R terminal when the train was a relatively short distance past the signal box on the single line.

- 3 *The intent of this recommendation is that Network Rail should improve the training given to signallers on the use of GSM-R, so that they are able to use it effectively in an emergency situation.*
