Rail Accident Report

Fatal accident involving a track worker at Saxilby
4 December 2012

Fatal accident involving a track worker at Saxilby, 4 December 2012

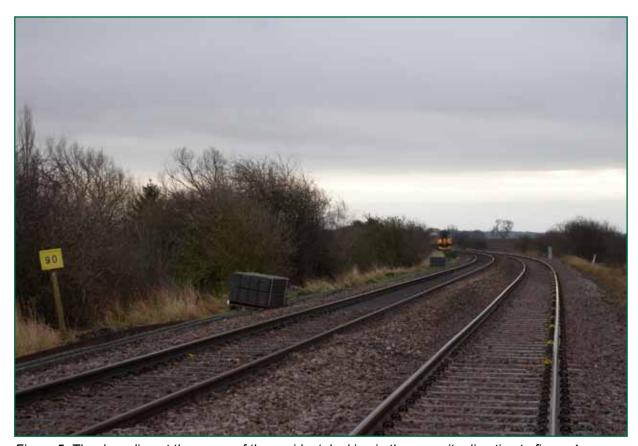
Figure 5: The down line at the scene of the accident, looking in the opposite direction to figure 4, showing the available view of down trains

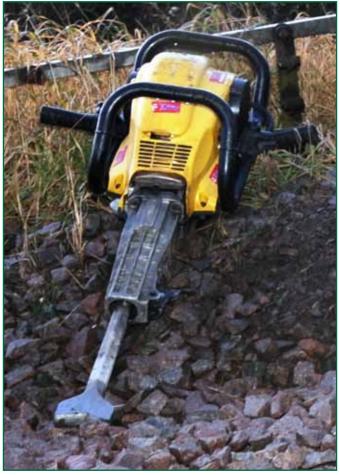
Figure 6: Hammer used at the time of the accident

16 Petrol driven *reciprocating hammers*² (referred to as hammers in the remainder of this report) were used by the track gang (figure 6) to move and compact the ballast under the track (figure 7) with the aim of rectifying various types of track fault (paragraphs 36 and 63).

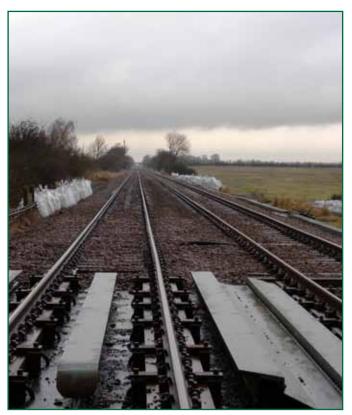
Figure 11: Image taken from the four-foot of the down line showing the extensive sighting distance of trains approaching on the up line

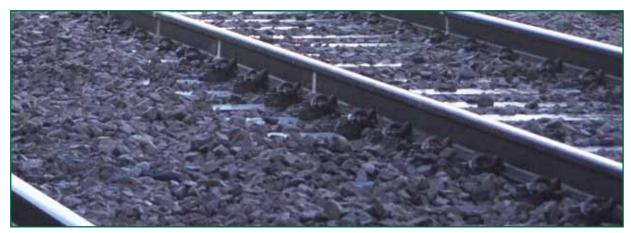
- 59 The COSS did not see or hear the approaching train. This was a causal factor.
- As indicated in paragraph 39, it is not clear what system of work the COSS thought he had implemented. If he was acting as site warden, there was no requirement for him to be present in the six-foot. If he was acting as lookout, he should have been looking towards approaching up trains; this task could also have been undertaken from the four-foot of the blocked down line. However, at some stage after the second line blockage was taken, the COSS took up a position within the six-foot. He then became distracted and may have participated in the work (figure 12). He was not looking towards the train and did not see it approaching.

Figure 12: The scene of the accident looking at the area of work on the down line with ballast tidied around the sleeper ends within the six-foot

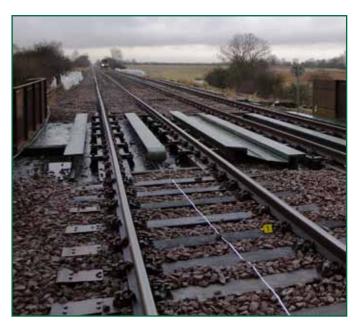
- A reconstruction undertaken by the RAIB showed that from a distance of 200 to 250 metres, a train driver would have had difficulty in distinguishing if a person was standing in an unsafe position if that person was located in the six-foot, but to the rear of people working in close proximity to each other (figures 13 and 14).

Figure 13: Image taken from the four-foot of the down line showing an up line train approaching underbridge 68 (approx. 200 to 250 metre distance from the location of the accident)

Figure 14: Reconstruction image showing the view from a cab of train travelling on the up Gainsborough line approaching Sykes Lane (approx 250 metre distance)

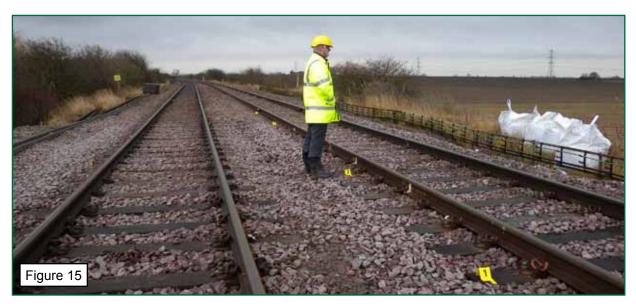
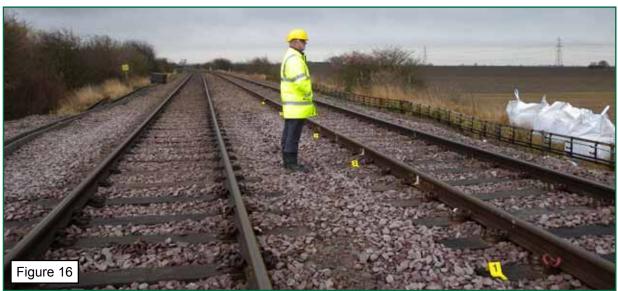
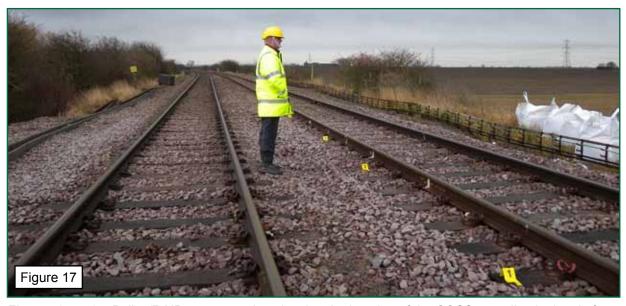
- 63 Members of the track gang stated that they did not hear the train's horn being sounded and were therefore unaware of its approach. Although the COSS and other track workers operating the hammers were not wearing ear defenders (which might have masked the sound of the train horn being sounded), the noise created by the machinery¹³ may have prevented them from hearing the approaching train¹⁴ (figures 15 to 17).

¹³ Technical data for the Atlas Copco 'Cobra' hammers approved by Network Rail show the noise generated by the machine to be 109 dB(A). This does not include the noise created or diminished by the material being worked on or the number of machines operated in one operation.

¹⁴ Railway Group Standard GM/RT 2482 'Audibility Requirement for Trains' mandates the minimum and maximum sound pressure levels for train horns to be 101 to 106 dB(A). Post-incident testing showed that on the unit involved, the low and high tones produced sound levels ranging from 108 to 110 dB(A) which were higher than the current standard (but appropriate for when the unit was designed). The audibility of the horn at the time of the accident would have been affected by the noise from the equipment, environment (weather/wind) and how far the train was from the worksite when the horn was sounded.

Figures 15 to 17: Police/RAIB reconstruction showing the location of the COSS: standing in the six-foot next to the six-foot rail of the down line (top); within the six-foot (middle); and next to the six-foot rail of the up line (bottom) at the time of the accident.
