Rail Accident Investigation Branch

# Rail Accident Report

**Train struck and damaged by equipment cabinet  
door in Watford Tunnel  
26 October 2014**

Report 12/2015  
August 2015

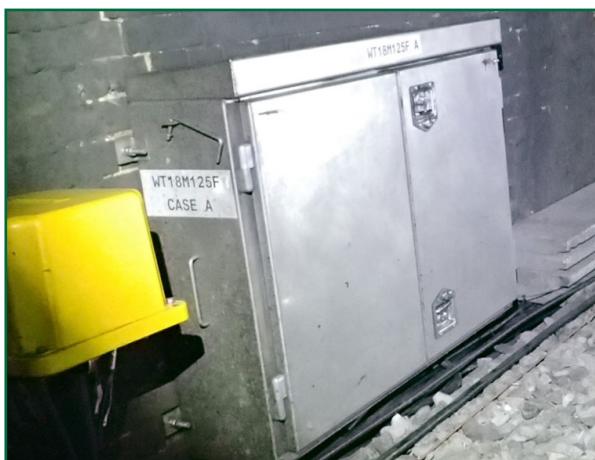
- 13 The cabinet involved in the accident was one of a number of such cabinets installed in Watford Tunnel on 4 October 2014 (figures 3 and 4). It contained equipment associated with the operation of signalling equipment in the tunnel. The installation of the cabinets was part of a project that started in 2009 to update the existing signals and associated equipment in the Watford area and to transfer control of the signalling equipment from Watford Power Signal Box to Wembley Main Line Signalling Control Centre.

Figure 3: The cabinet in its original condition in Watford Tunnel

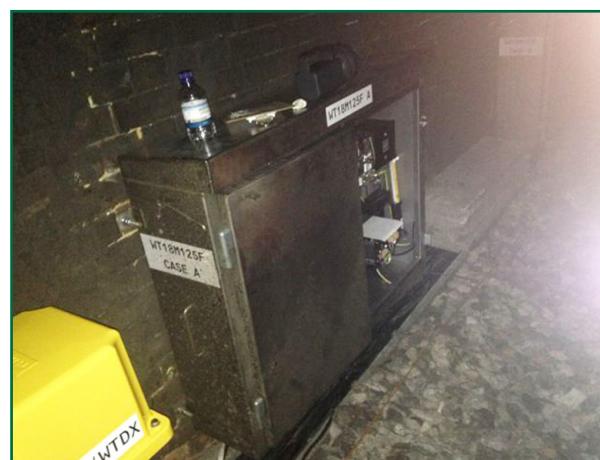
Figure 4: The cabinet as found after the accident with the right door missing

- 29 A mobile operations manager attended and examined the fast lines in Watford Tunnel. He discovered that one of the cabinets (Cabinet A) on the tunnel wall adjacent to the up fast line was damaged, and there was a damaged cabinet door in the cess next to the down fast line.

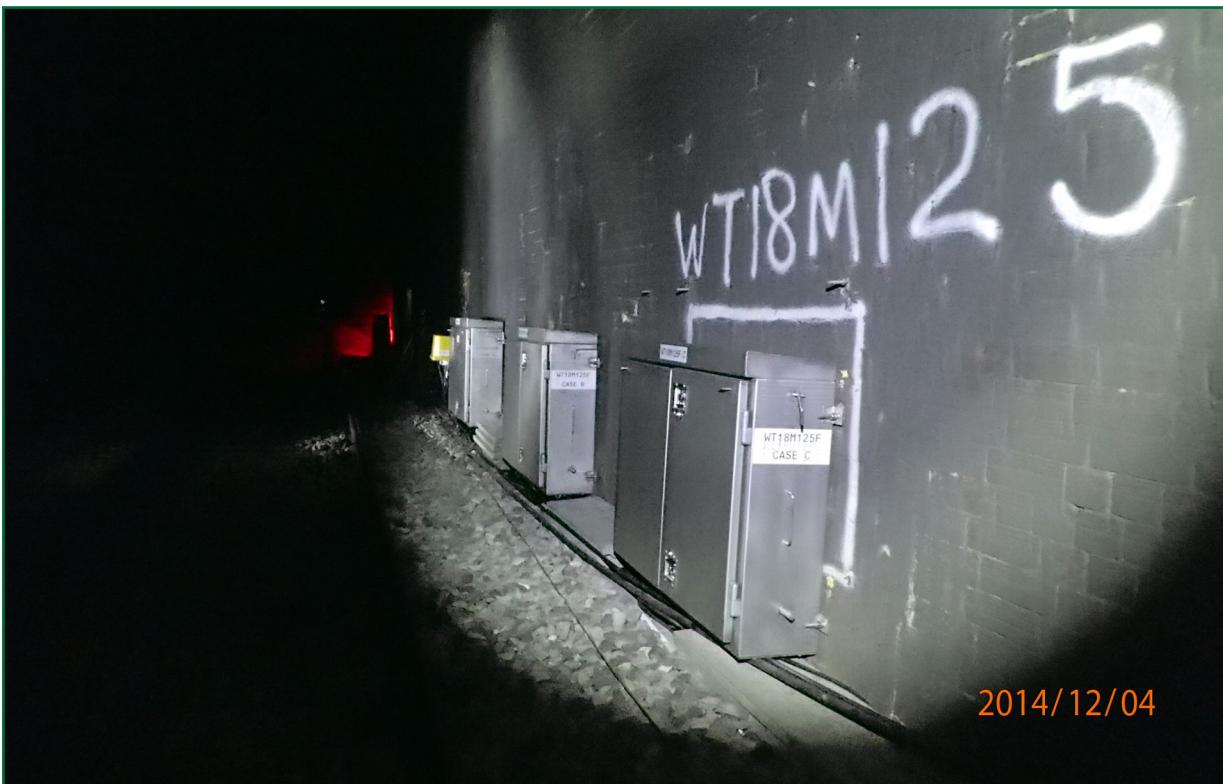
- 24 Cabinets WT18M125F 'A', 'B' and 'C' (referred to as cabinets A, B and C in the remainder of this report) were the three cabinets located on the tunnel wall adjacent to the up fast line. They housed the last items of equipment that were functionally tested before both groups of testers left the tunnel having completed their work. Cabinet A, the door of which was later struck by the train, was the most northerly of the three cabinets in the group (figure 5).

Figure 5: Cabinets A, B and C on the cess side of the up fast line

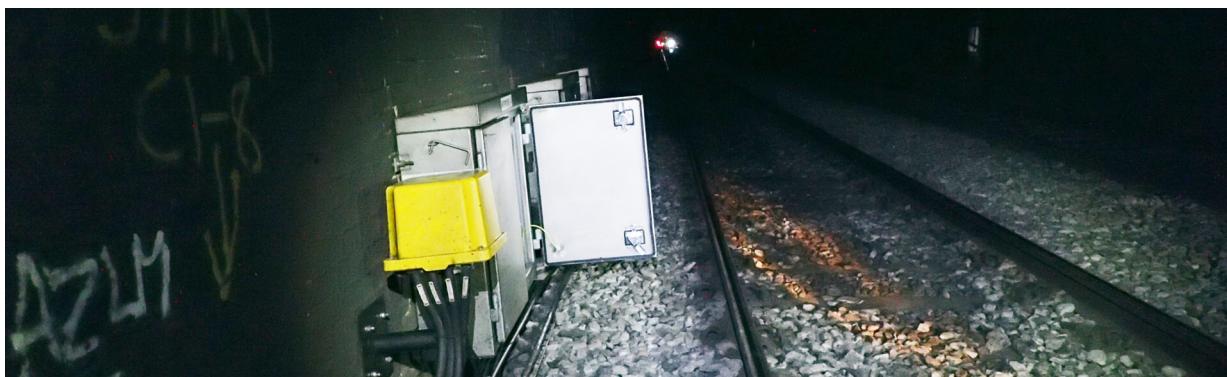
- 26 Shortly before 07:19 hrs, train 2K00 entered the north end of Watford Tunnel travelling towards London Euston on the up fast line at 88 mph (141 km/h). Carriages 1 and 2 of the train passed Cabinet A without incident. However, as carriage 3 passed Cabinet A, the right-hand door of the cabinet was struck by the train, having opened to become foul of the line (figure 6).

Figure 6: View from the cess adjacent to the up fast line looking towards London showing a reconstruction of the appearance of the door of Cabinet A fully open

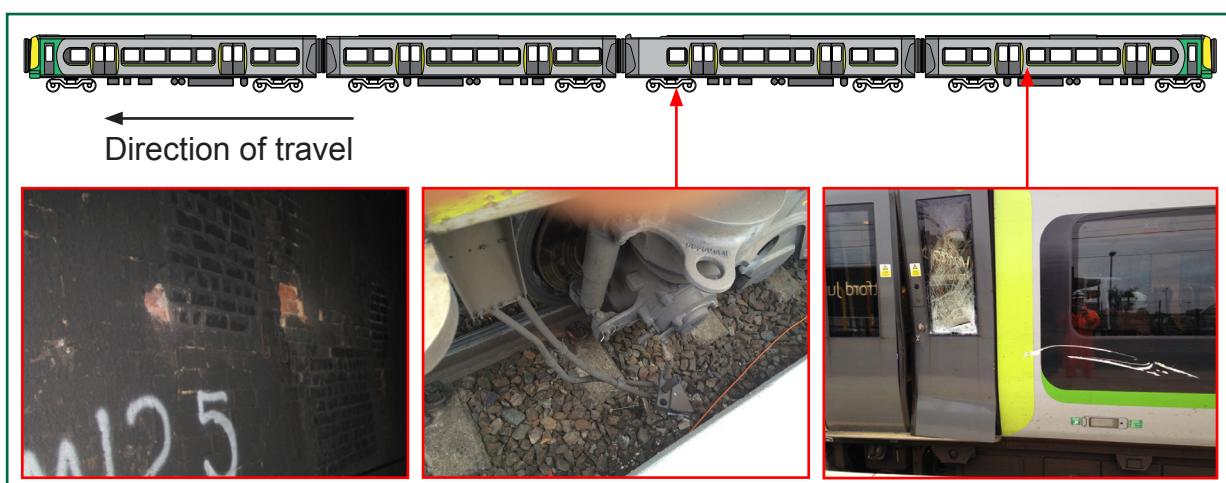
- 27 The leading bogie of the third carriage struck the cabinet door, which detached from its hinges and became airborne. The door struck the tunnel wall (figures 7 to 9), and then bounced between the tunnel wall and the train. It hit the leading set of passenger doors on the fourth carriage of the train, penetrating the door window and causing a shower of glass debris to enter the passenger compartment (figures 10 and 11). The safety circuits on the train detected that the door was no longer properly closed and automatically applied the train's brakes. At the same time, the driver observed a 'door open' indication in his cab.

Figures 7 to 9: (left to right) The initial impact damage on the tunnel wall, the equipment on the leading bogie of carriage 3 and damage to the door and body side of carriage 4

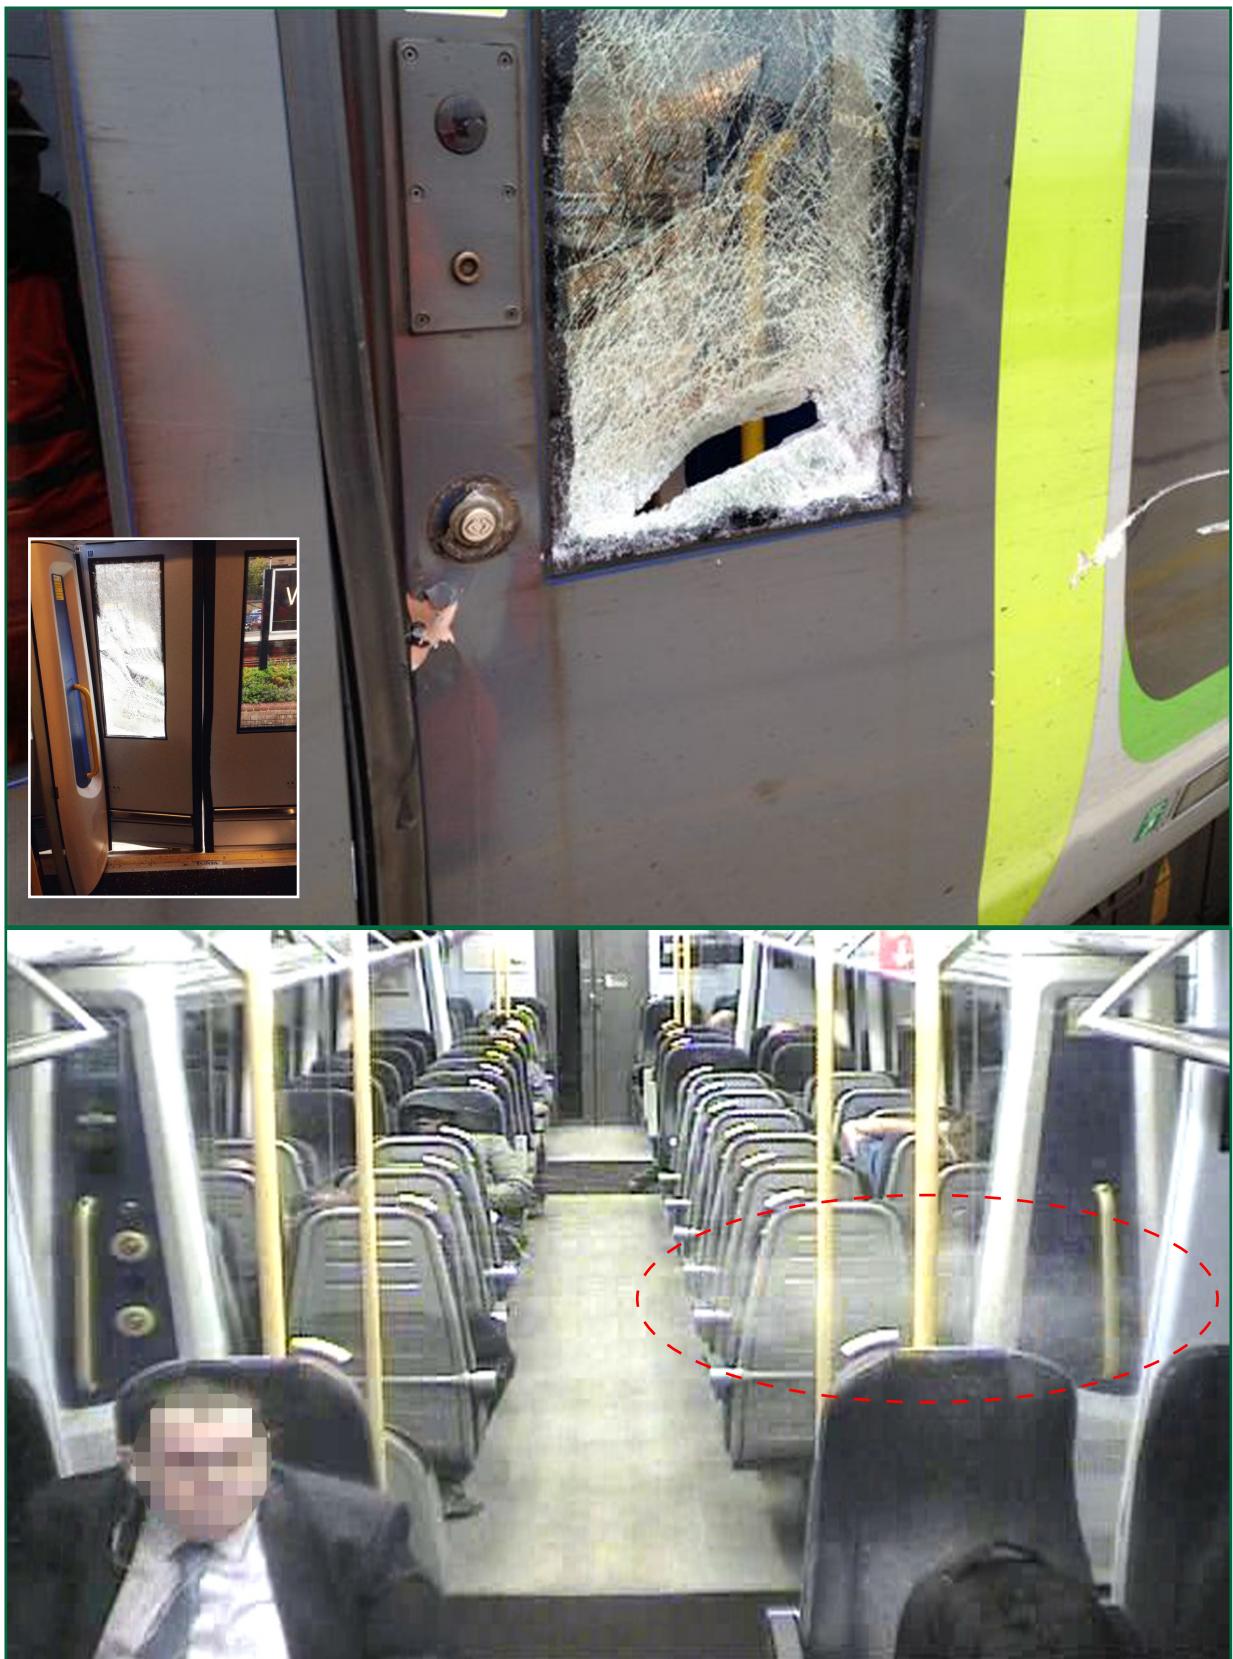
Figures 10 and 11: The damage to the door of carriage 4 and internal CCTV images of the glass entering the passenger compartment

- 28 The train stopped beyond the south end of Watford Tunnel and the train driver made an emergency call to the signaller requesting that both lines be blocked. The train driver and conductor examined the train and found the severely damaged doors on the last carriage, which were potentially out of gauge. The driver reported this to the signaller.

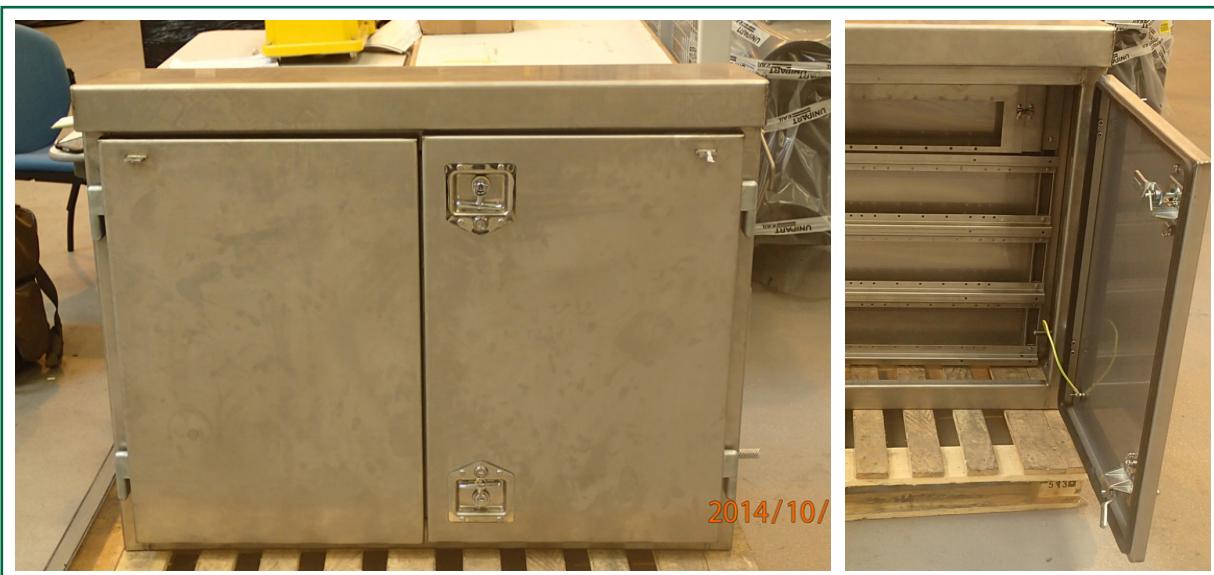
- 31 One of the doors of Cabinet A opened to become foul of the up fast line, most likely as a result of aerodynamic forces, as train 2K00 passed through the tunnel.
- 32 Figures 12 and 13 show a cabinet of the same type as Cabinet A and the arrangements for securing the door on Cabinet A in the closed position. The securing mechanism consists of a pair of levers which rotate to engage with the cabinet frame when the handle (figure 13) is turned, thus securing the door closed. It is then possible to lock the cabinet with a key.

Figures 12 and 13: (left) A cabinet of the same type as Cabinet A and (right) the right-hand cabinet door open, showing the securing mechanism

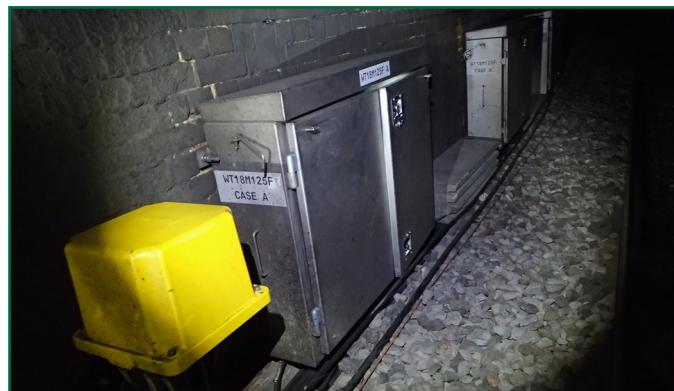
- *The door was closed, but left unsecured (ie the handle had not been turned).* There are two possibilities: the right-hand door was fully closed, but the handle was not turned or the right-hand door was closed as far as was possible, but still slightly proud of the left-hand door<sup>3</sup>, as shown in figure 14. The air flow associated with the movement of train 2K00 through the tunnel would have created a pressure differential at the doors of Cabinet A, which could cause an unsecured door to open after the front of the train had passed. The RAIB considers this to be the most likely scenario. When Network Rail staff examined the cabinet after the accident (paragraph 30), the left-hand door was found to be closed but not secured.

*Figure 14: View from the cess adjacent to the up fast line looking towards London showing a reconstruction of the appearance of the right-hand door of Cabinet 'A' slightly proud of the left-hand door*

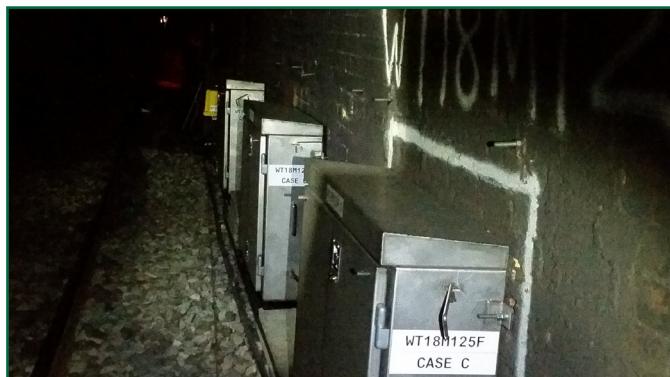
- 39 A reconstruction undertaken by the RAIB in Watford Tunnel showed that it is probable that, as the two groups of testers walked south (towards Watford) from the site of work, their head torches and handheld lamps did not illuminate the area sufficiently for them to see that the door of Cabinet 'A' was not secured (this would have been indicated by the position of the door handle). It would have been equally difficult to see if the door had not been completely closed (figure 15).

Figure 15: View from the cess adjacent to the up fast line looking north. Note that a door of Cabinet A (further from the camera) is in the same position as that shown in figure 14 and doors on Cabinet B (closer to the camera) are closed.

- the task lighting may have been inadequate, making it difficult for the testers to see that the door had been left unsecured (paragraphs 37 to 39, **Learning point 1, Recommendation 1**);

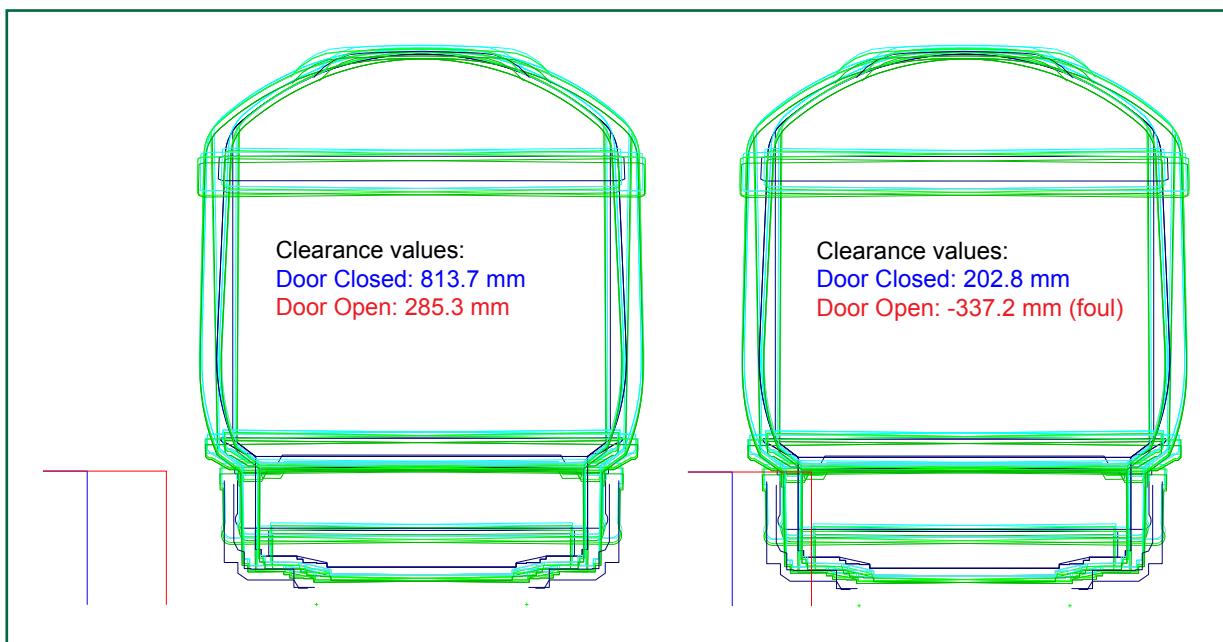
- 65 Siemens' proposal to use the refuges for housing the cabinets was not based on a recognised need to mitigate any risk associated with gauge clearance, but rather that it would be tidier to have the cabinets tucked away in refuges instead of on the tunnel wall. However, an open door on a cabinet positioned in a tunnel refuge would have been clear of a passing train (figure 16). Siemens did not confirm during the IDC>IDR meeting on 1 July 2013 whether using the refuges was acceptable. The Network Rail DPE did not notice the proposal to site the cabinets in the refuge contained in the notes at the end of the plan. The LAP schematic drawing does not show the exact positioning of cabinets nor the position of tunnel refuges, although Siemens stated that its designers had identified which cabinets were to be positioned in the refuges with a specific 'hash' mark and the note referred to in paragraph 64.

Figure 16 (left) typical clearance values of a slimline cabinet if it had been installed in the refuge (door open) and (right) typical clearance values with the cabinet attached to the tunnel wall with the doors open (diagrams provided courtesy of Network Rail). Note that the open door of a standard cabinet located in the refuge would not have infringed the gauge. The figure shows a number of different rolling stock profiles, but although the values may change from the typical values given, the effect of positioning the cabinet in the refuges and on the tunnel wall does not.

- 4 *The intent of this recommendation is for Network Rail to reduce the risk arising from equipment that has the potential to foul the gauge.*  
Network Rail should establish a policy and guidance on managing the risk from lineside equipment that can foul the gauge, with specific consideration of the siting of equipment in areas of limited clearance and, for example, the use of refuges in tunnels for that purpose (paragraph 95b).

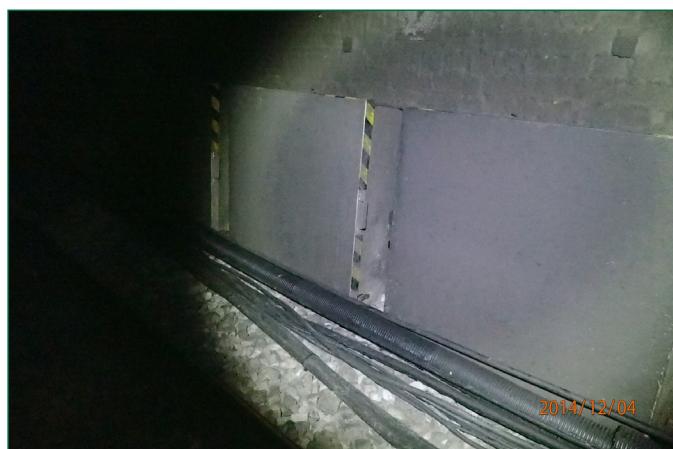
- 73 After Network Rail instructed Siemens in November 2013 not to use the tunnel refuges for siting the cabinets Siemens set about procuring a suitable product and looked at several design options (figure 17) for ‘off the shelf’ products that already had *product acceptance* for use on Network Rail’s infrastructure.

Figure 17: The standard cabinet design with lift-off panel

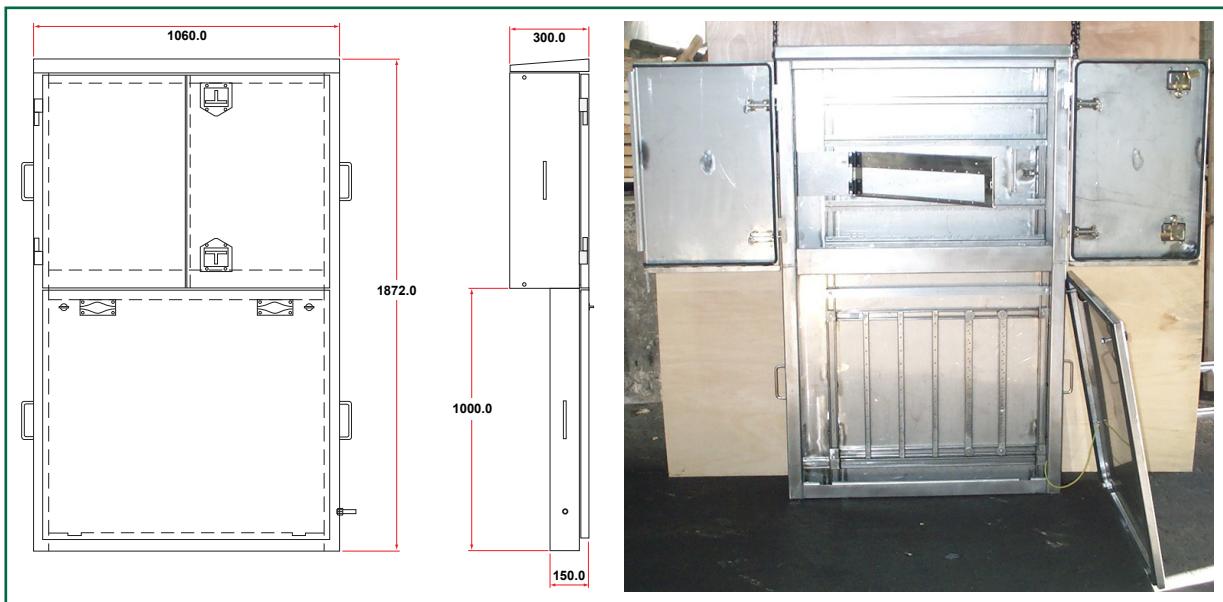
- 74 The RAIB understands that some of Siemens’ signalling technicians who had previously worked on the Thameslink project identified an alternative design that they had used in Belsize Tunnel which therefore had product acceptance (figure 18). In December 2013, Siemens’ design risk log showed that the CEM had recorded that an assessment of the solution for providing tunnel cabinets should be completed, as Siemens intended to use the same cabinets as those used on the Thameslink project, but use of the cabinet would be dependent on a site analysis and an additional IDC. The CEM closed this entry on 21 February 2014 showing that the cabinets would now be mounted on the tunnel wall. The additional IDC did not take place.

*Figure 18: The slimline double chamber cabinet with lift-off panel (bottom) and double doors (top) specifically designed for the Thameslink project (Belsize Tunnel) in 2004 (image supplied courtesy of MGB Engineering, Plymouth)*

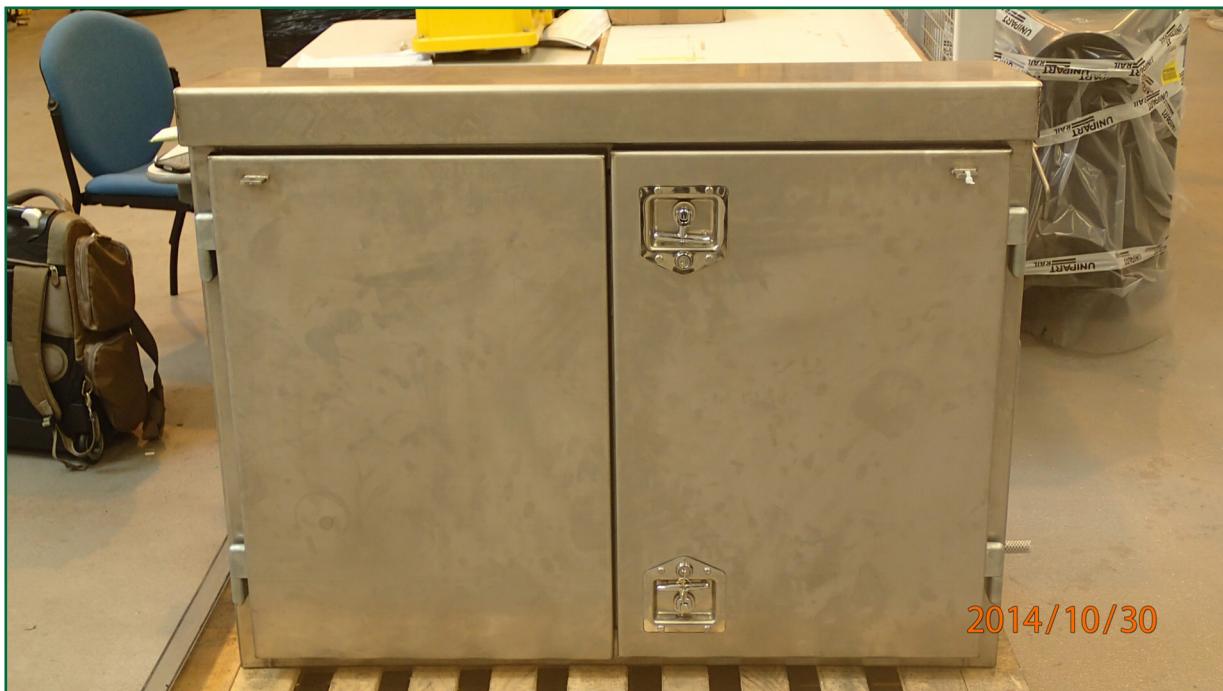
- 76 The design risk log shows that in April 2014 Network Rail requested Siemens to raise an additional Technical Query to risk assess the mounting specification for the new cabinets. Contractors acting on behalf of Siemens undertook a site visit to inspect how the new cabinets would be sited and mounted on the wall. The additional risk assessment for the mounting was completed in July 2014 and the response to the Technical Query (including a cabinet specification) was submitted on 14 July 2014 and authorised by the DPE on 31 July 2014. Witness and documentary evidence show that although the risk from aerodynamic forces was considered, it was confined to consideration of the cabinet in normal condition (ie with doors closed and secured).

Figure 19: The modified slimline cabinet

- 1 *The intent of this recommendation is for Network Rail to eliminate by design, or mitigate, the risk from lineside cabinets fouling the gauge.*  
Network Rail should mandate a requirement in its company standards for a design of cabinet that removes by design the risk of an open door infringing the gauge where the cabinet needs to be located in an area of limited clearance. Where this is not practicable, the design of cabinet should alert staff to an unsecured door (paragraph 95a(i)).

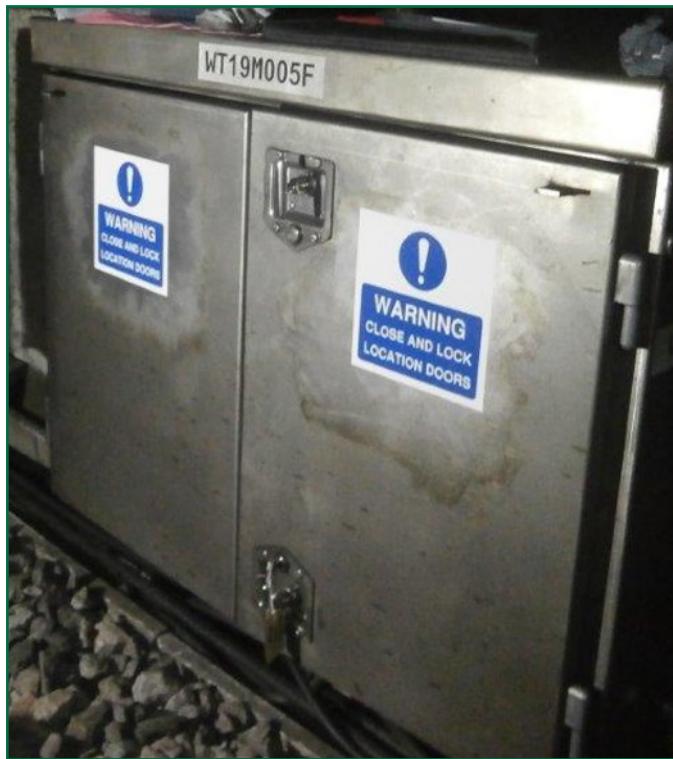
*Figure 20: The cabinets within Watford Tunnel with safety notices placed on the doors*

- ii. issued a safety alert to brief staff and contractors on the immediate cause of the accident and to remind them to make sure they close and lock lineside equipment on completion of work (paragraph 94a(ii)); and
