Rail Accident Investigation Branch

Rail Accident Report

Freight train derailment at Heworth, Tyne and Wear
23 October 2014

Report 16/2015
September 2015

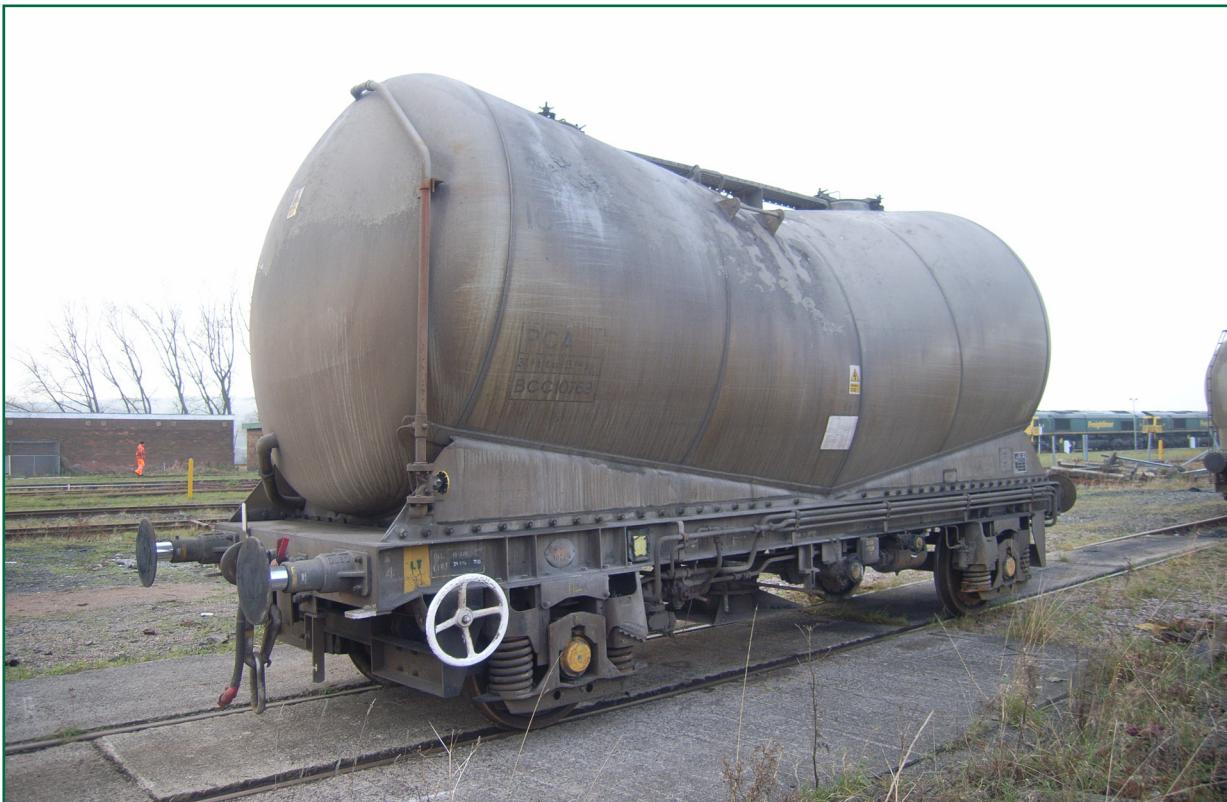
Figure 4: PCA wagon 10769 that derailed at Heworth

- 11 The freight train that derailed, reporting number 6S26, was the 14:47 hrs service from Seaham Harbour, near Sunderland, to Dunbar cement works at Oxwellmains. It consisted of a class 66 diesel-electric locomotive, 66 616, hauling 25, two-axle, PCA cement tank wagons (the PCA wagon type is described in more detail in paragraphs 24 and 25). All of the wagons were empty. The wagon that derailed was number 10769 (figure 4).

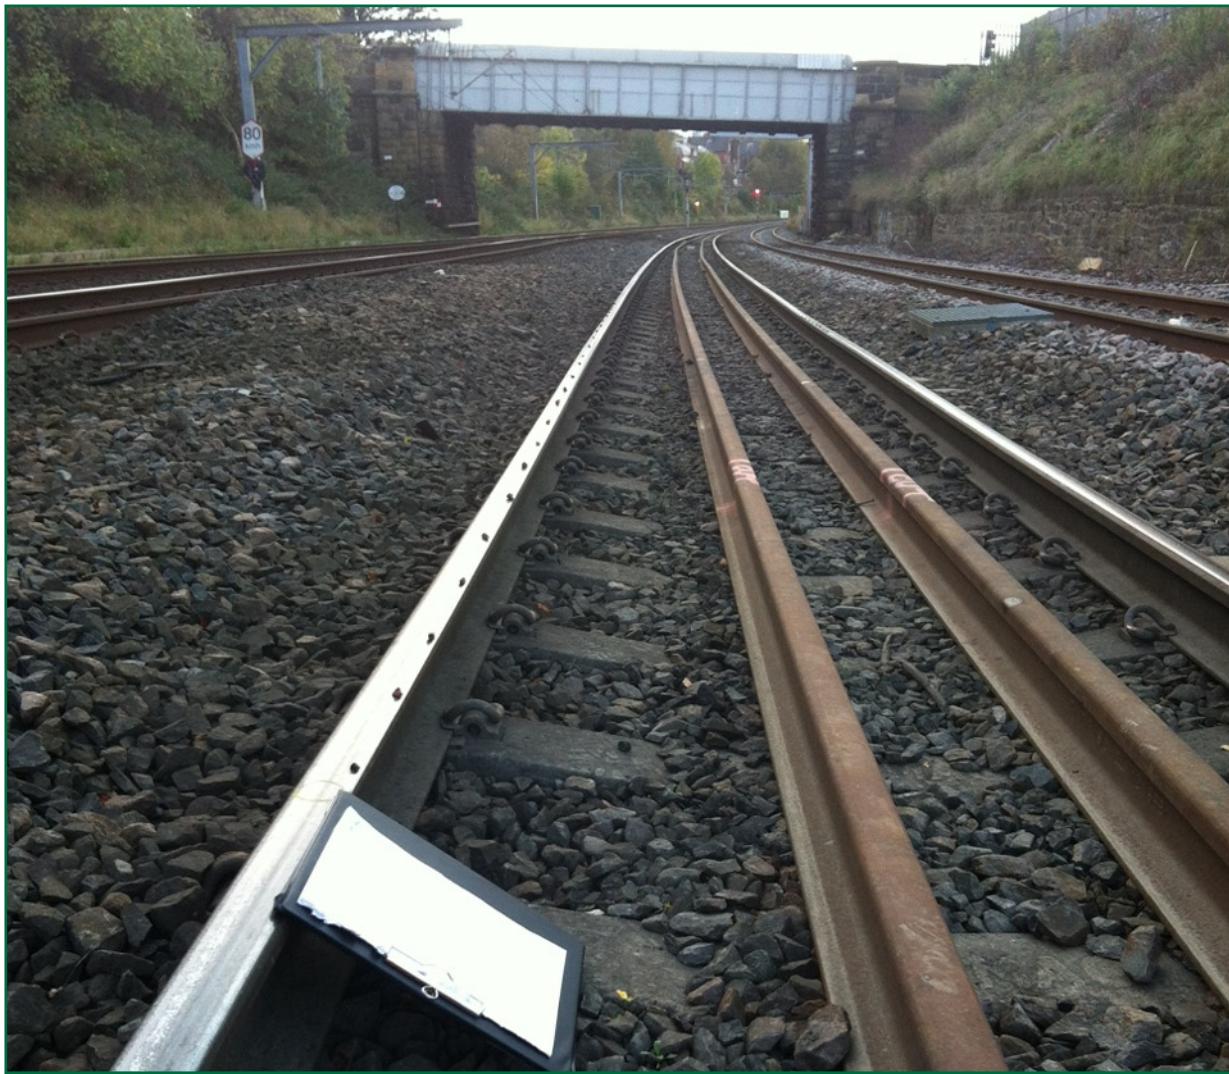
- 18 Marks found on the head of the left-hand rail show that the flange of a wheel had climbed onto the top of this rail at 99 miles 253 yards (figure 5). The flange ran along the head of the rail for 10.3 metres before the wheelset derailed to the left. At this point the right-hand wheel derailed into the *four foot*.

Figure 5: The path of the flange marked out on the head of the left-hand rail (image courtesy of Network Rail)

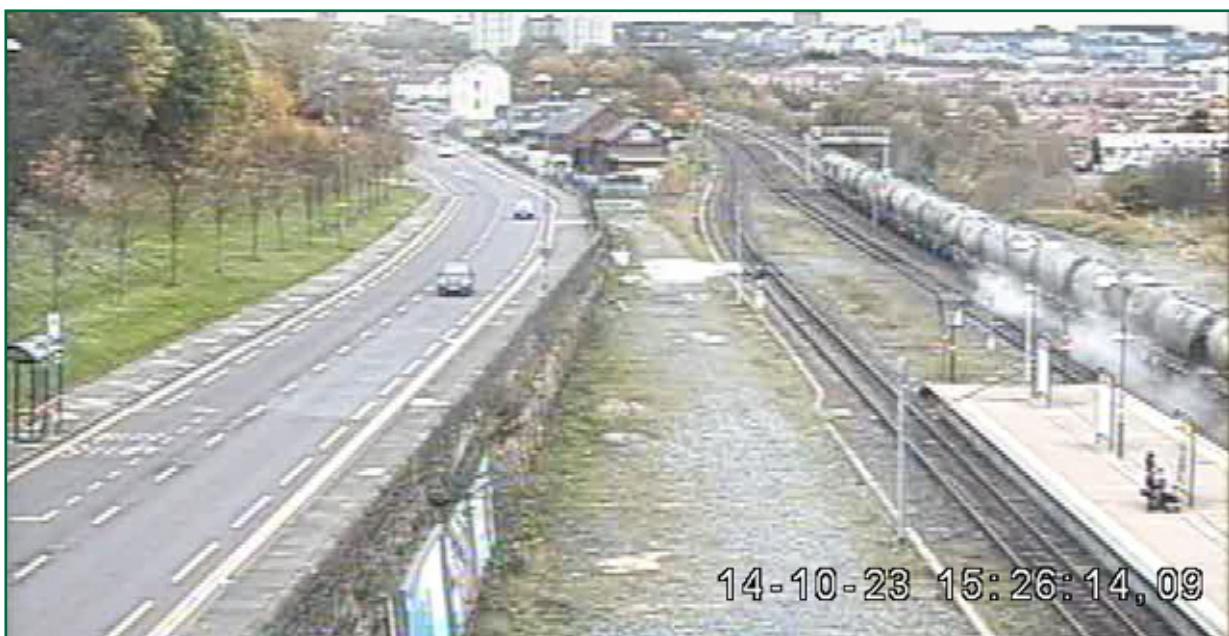
- 20 The derailed wagon was kept generally in line by the couplings of the adjacent wagons. The wheels were running on top of the concrete sleepers (evidenced by the closed circuit television (CCTV) footage of the train passing through Felling – see figure 6). The derailed wheels struck a set of *points* at St James Bridge junction at 100 miles 506 yards while travelling at about 13 mph (21 km/h), causing damage to the points and also to the wagon's suspension.

Figure 6: CCTV image of the derailed wagon passing Felling Metro station (image courtesy of DB Regio Tyne and Wear Metro)

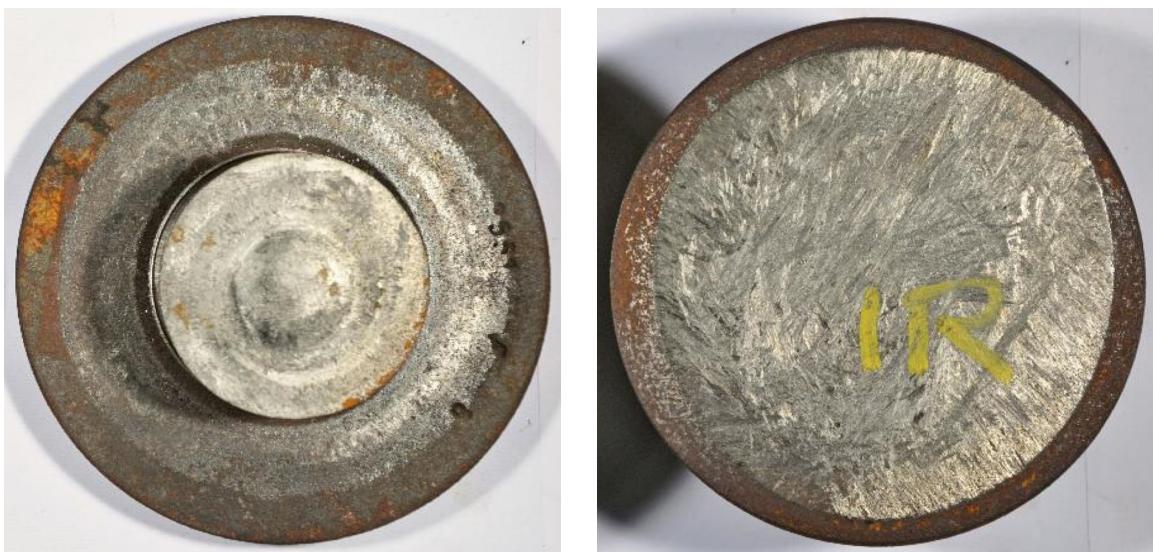
Figure 13: The wear faces on the damper pad from the leading right-hand corner

- 61 The scuff marks on the larger diameter end of the damper pad are shown in figure 13. These marks are aligned in different directions and indicate that the damper pad had been rotating while in service. Evidence of rotation could also be seen on the spigot end of the damper pad and on the damper pot it wore against. This rotating movement would have worn away the material at the spigot end of the damper pad.

- 62 While the possibility that the damper pad was defective cannot be discounted, the available evidence indicates that this was unlikely. Instead, it is likely that all of the hardened material at the damper pad's spigot end had worn away due to it rotating in service. Once the hardened material was worn away, the rate of wear significantly increased, resulting in 12 mm of wear in a 9 month period. This occurred because:

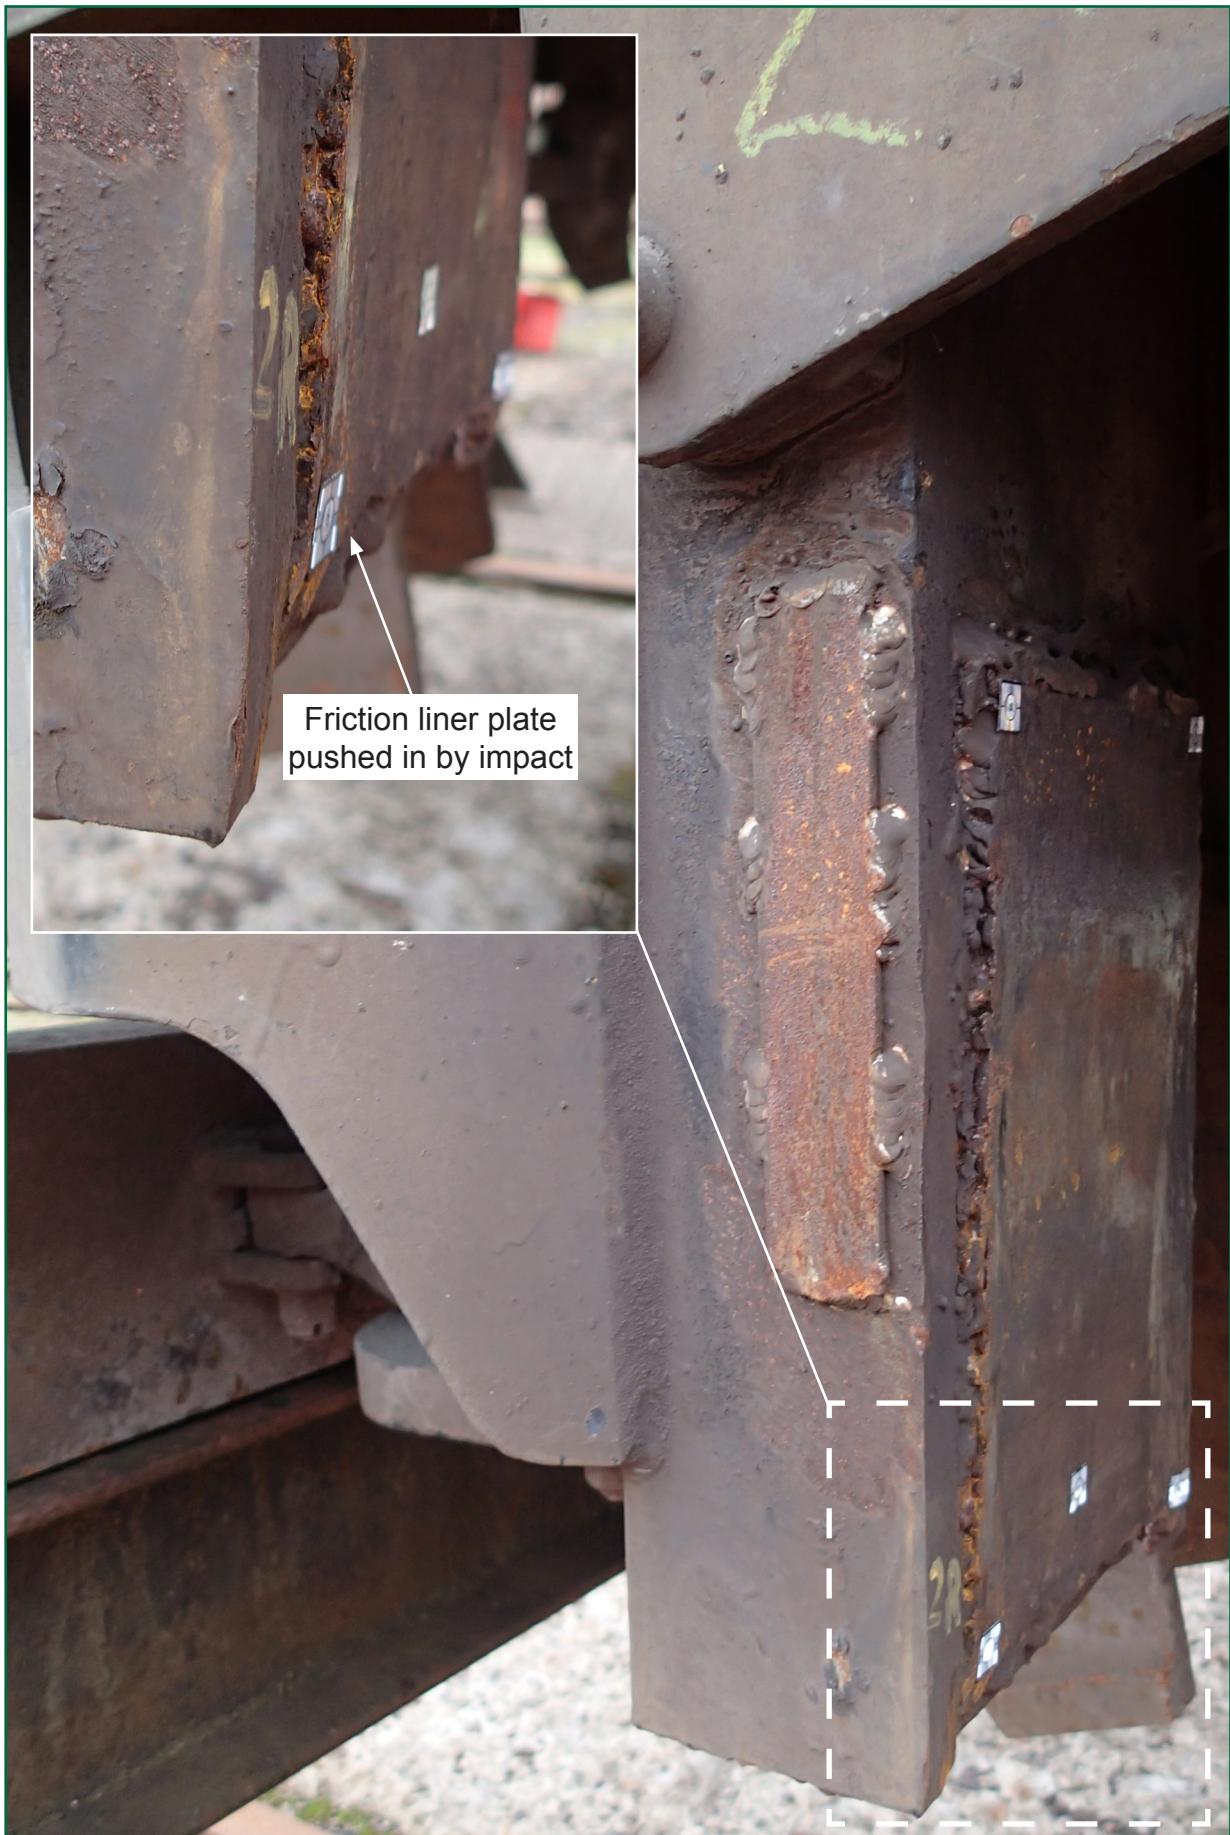
- 70 The RAIB surveyed wagon 10769 after the accident to measure these dimensions and found the results did not fall within the defined tolerances². This was probably due to the amount of damage that the pedestals had sustained while the wagon ran derailed. The trailing right-hand pedestal was the most damaged (figure 16). Further measurements taken at the top of the pedestal friction liner plates, where there was less damage to the pedestals, showed dimensions A and B and dimensions C and D (figure 15) were within about 1 mm of each other, which is within the specified tolerance. The measurement for dimension E (leading end) was in tolerance at 1.9 mm but dimension F (trailing end) was outside the tolerance at 3.8 mm.

Figure 16: The damage to the trailing right-hand pedestal

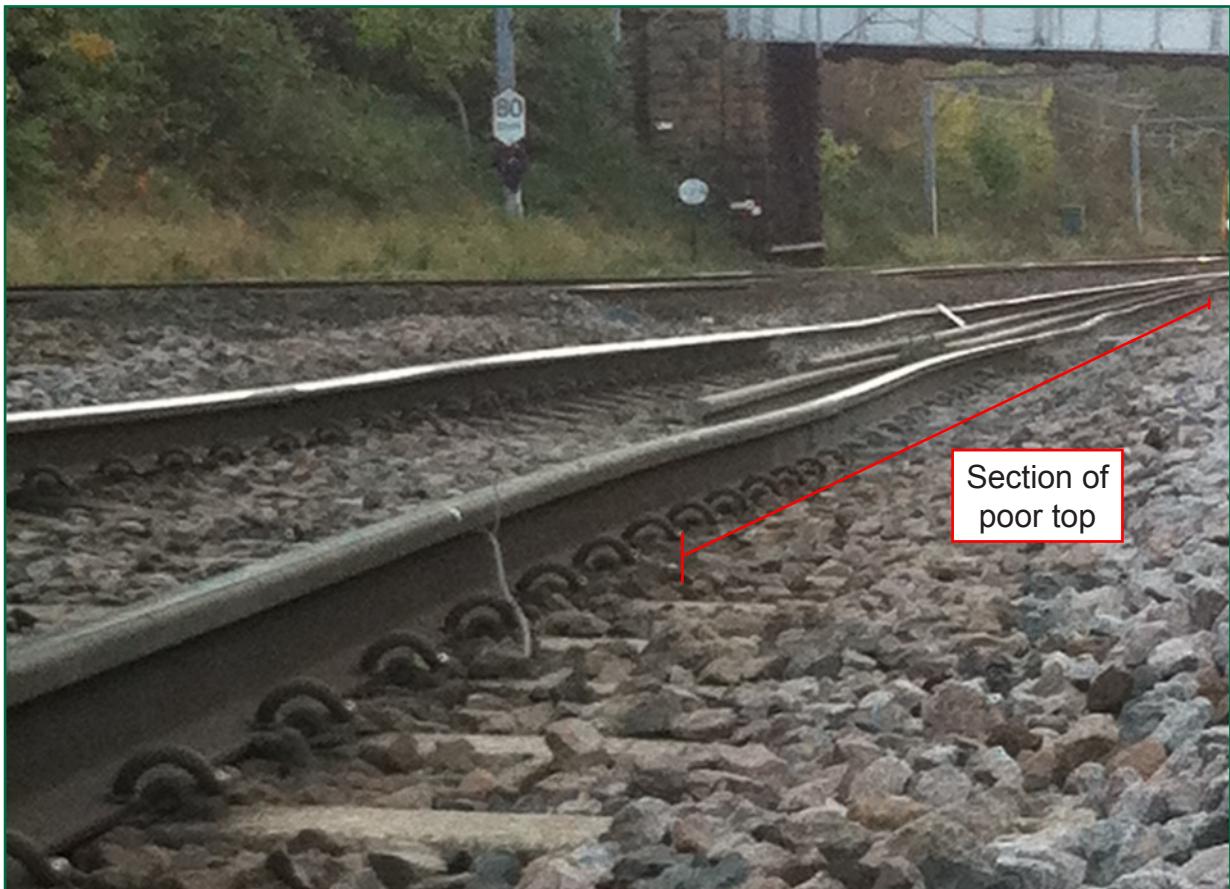
Figure 20: The variation in the height of the rails on the approach to the point of derailment (image courtesy of Network Rail)

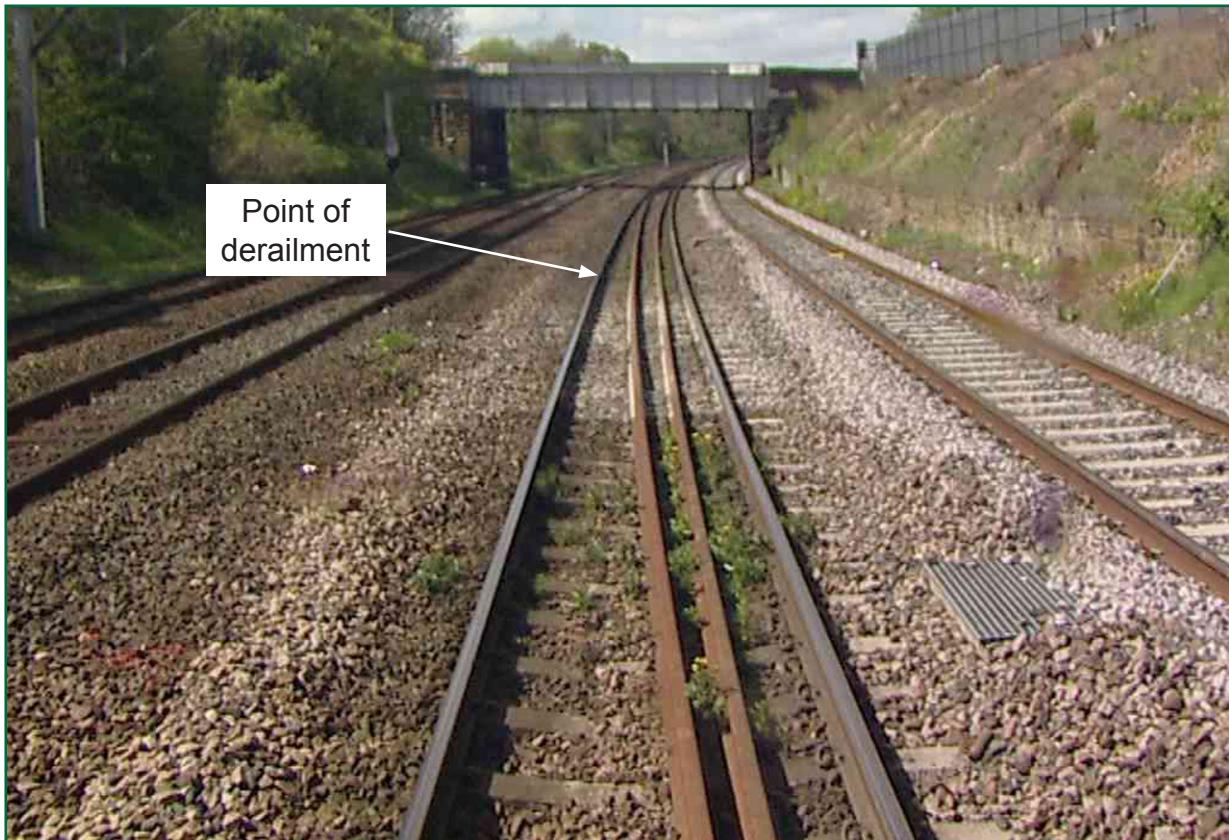
- 94 In 2006, the then Track Maintenance Engineer proposed that the track in the Pelaw to Heworth area should be renewed, citing ballast contamination as the key reason. Documentation for the proposed renewal noted that the installed ballast dated back to 1972 and over many years the ballast on the Down Sunderland had become contaminated by coal dust. In 2011 when this renewal work was scoped, it included Network Rail digging trial pits at various locations along the Down Sunderland line. A trial pit was dug at 99 miles 220 yards, which is close to the point of derailment, and found that from the surface of the ballast to a depth of 400 mm, the ballast was heavily contaminated with coal dust and silt. From 400 mm to 650 mm down, the ballast was noted as heavily contaminated with clay and silt. Standing water was found at 650 mm below the surface. Track renewals subsequently took place in the Pelaw to Heworth area in 2012 and 2013 but this work did not include the point of derailment (see paragraphs 120 to 125).

Figure 23: Footage recorded in May 2014 showing vegetation growing in the four foot of the Down Sunderland line (image courtesy of Network Rail)

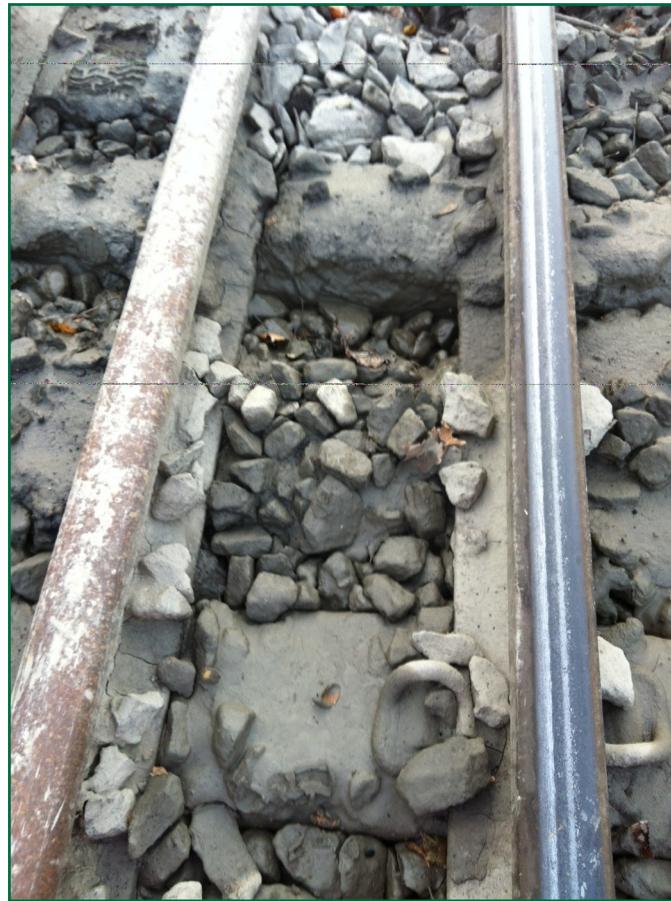
- 97 The wet beds and resulting vertical track geometry faults at Heworth were repeatedly found by the track inspection regime, but other than mandated reactive repairs in response to faults reports from track geometry recording trains, no repairs were planned or took place.
- 98 Wet beds often coincide with dips in the rails due to voiding under the sleepers. Individual dips result in discrete top defects. As trains continue to run over the wet beds and their number increases, the number of dips will also increase resulting in cyclic top defects.

Figure 24: Close up view of a wet bed at the point of derailment on the Down Sunderland line (image courtesy of Network Rail)

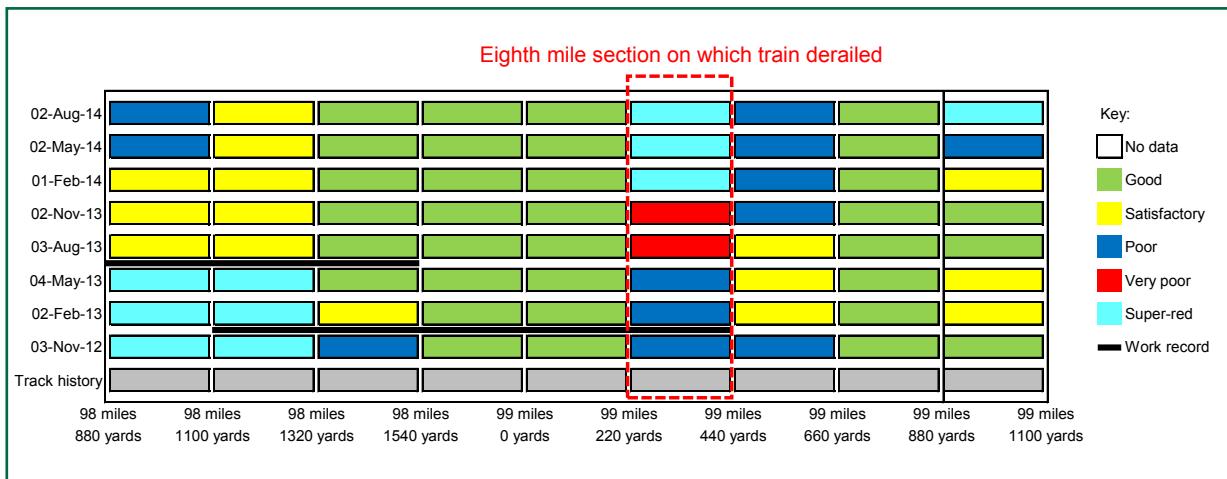
Figure 26: Chart showing the SD values recorded on the Down Sunderland line

101 The track geometry recording trains that ran over the Down Sunderland line also recorded a *standard deviation* (SD) value for the overall quality of the vertical track geometry for each eighth of a mile section (appendix E, paragraphs E3 to E4). A chart showing how the SD values for the eighth of a mile section in which the train derailed have changed over the previous 10 recordings is shown in figure 26. It shows that the SD value for the portion of track from 99 miles 220 yards to 99 miles 440 yards had worsened over that time, falling into the very poor band in August 2013. In 2014, each run recorded a SD value which fell in the *super-red* band (appendix E, paragraph E4).

102 When the SD value fell into the very poor band, NR/L2/TRK/001/mod11 required TSM2 to inspect this track by no later than the next supervisor inspection. The aim of this inspection is to identify the actions needed to address the underlying causes of the very poor track geometry, improve the condition of the track components and rectify track geometry defects. However, there is no evidence that this inspection took place.
