*Century Builders*

DOC-CB/EHS/LW-01

**LINE WALK**  
**SINTER PLANT(RMBB#1)**  
**Date: 05-02-2026**

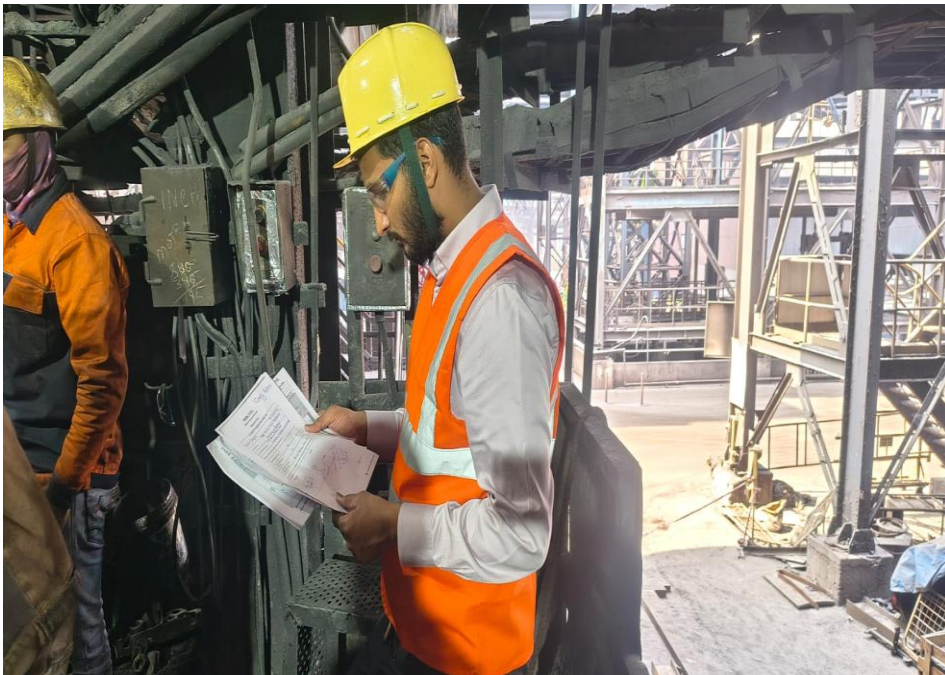
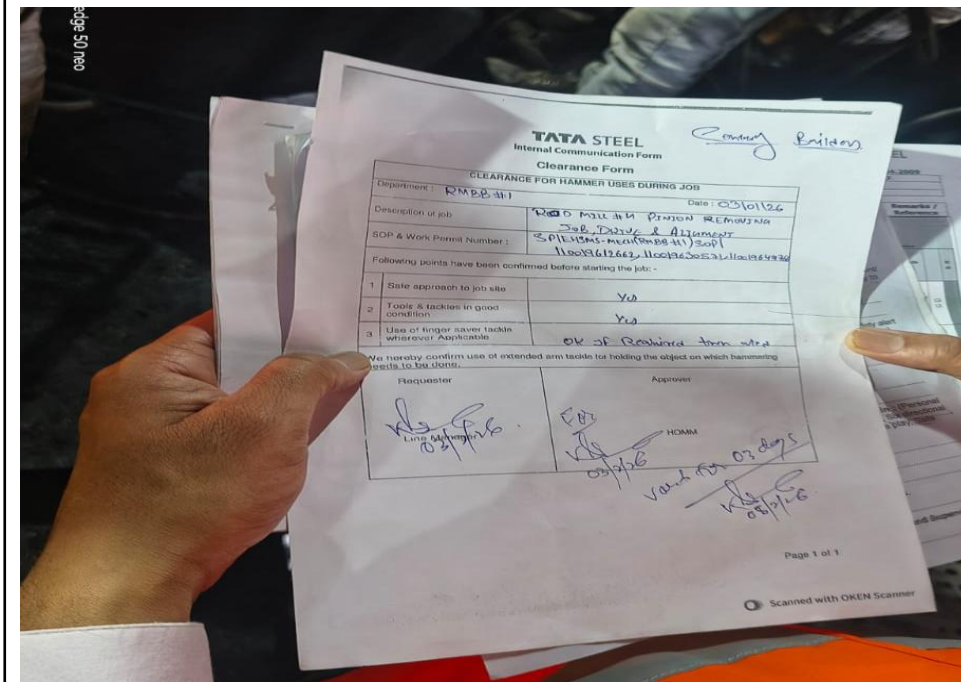
| Department | Description of Condition | Root cause | Correction & Immediate Action Taken | Observed on | Severity | Responsible | Target Date | Status |
|---|---|---|---|---|---|---|---|---|
| RMBB/Sinter Plant | Verified all documents such as valid SOP, daily TBM, hot permit and hammer clearance , calibration certificate etc .found valid and correct | Not required | N/A | 05-02-2026 | N/A | Supervisor | N/A | N/A |

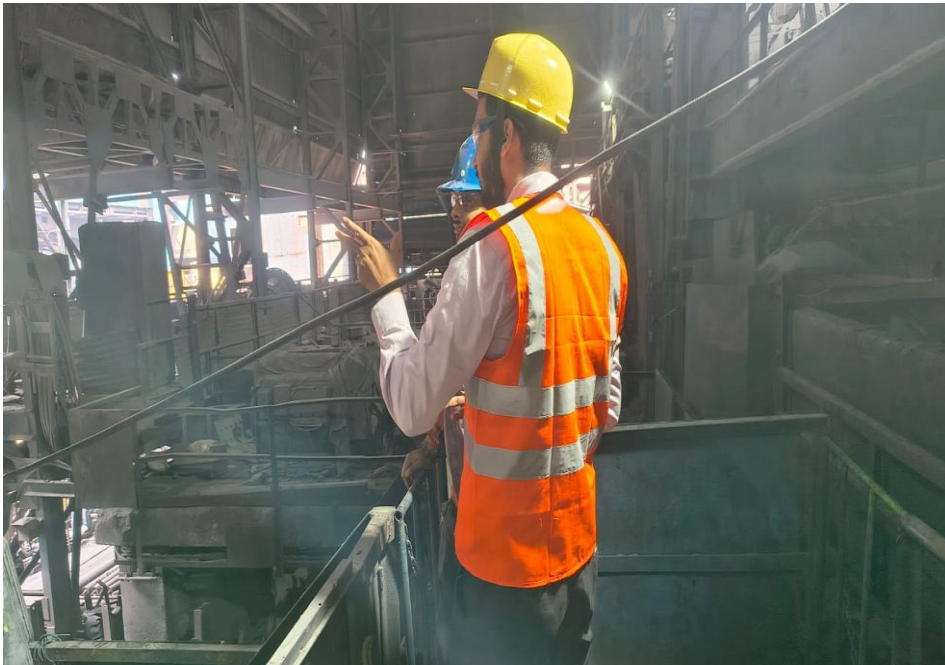
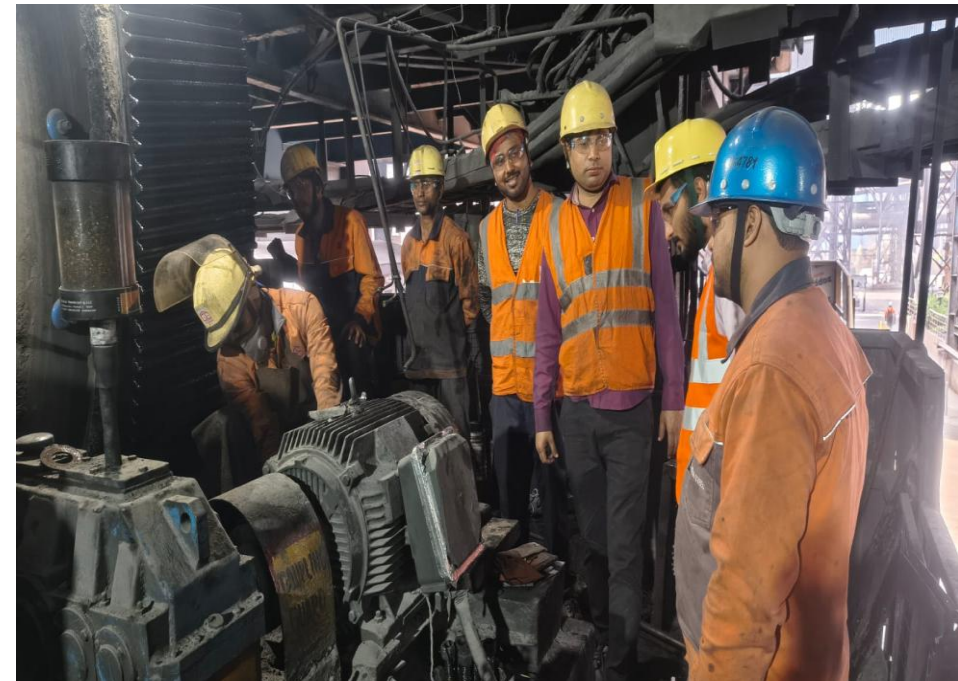
| Department | Description of Condition | Root cause | Correction & Immediate Action Taken | Observed on | Severity | Responsible | Target Date | Status |
|---|---|---|---|---|---|---|---|---|
| RMBB/Sinter Plant | <b>Two way communication:</b><br>Discuss with working crew ,TSL officer and supervisor regarding their feedback, grievances and suggestion. Checked their knowledge of SOP and safety requirement at site and past incidents. | Not required | N/A | 05-02-2026 | N/A | Site Supervisor | N/A | N/A |

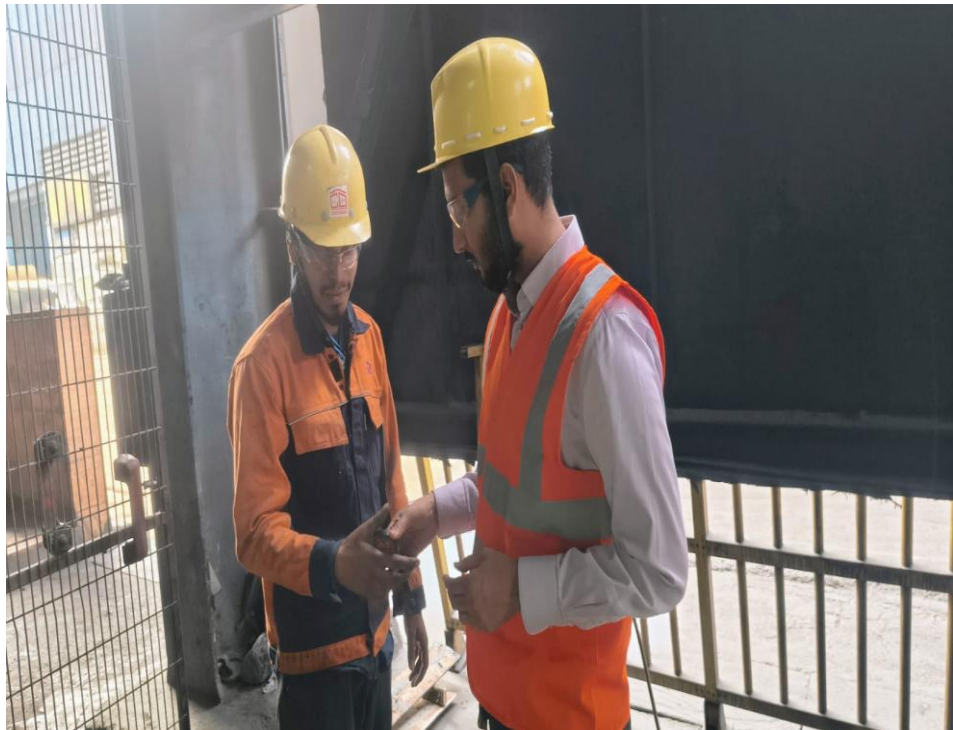
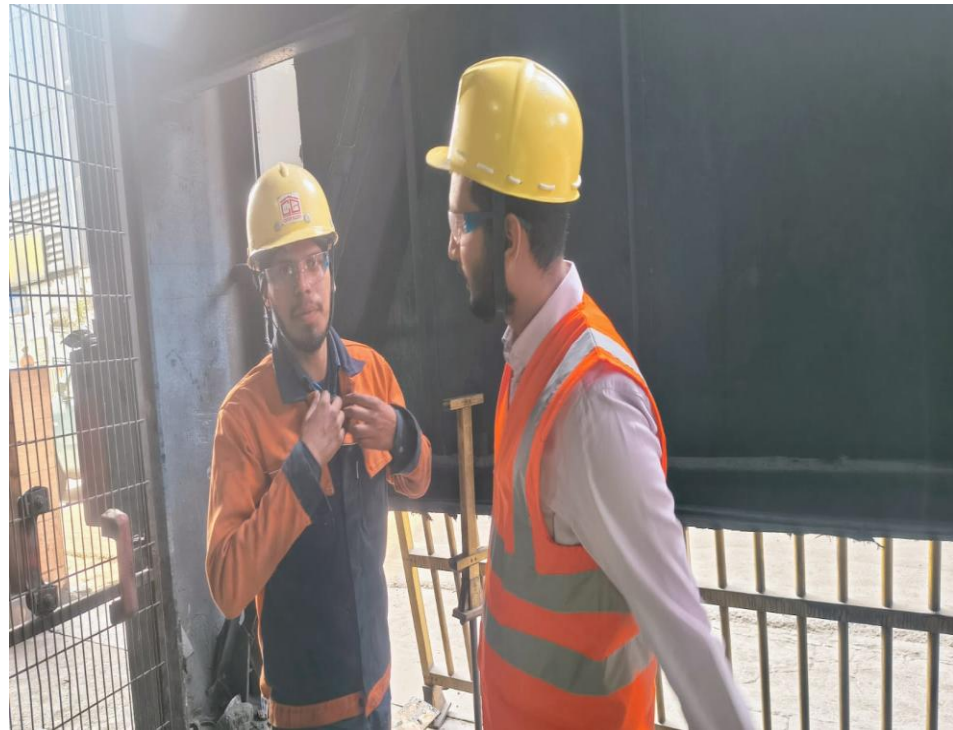
| Department | Description of Condition | Root cause | Correction & Immediate Action Taken | Observed on | Severity | Responsible | Target Date | Status |
|---|---|---|---|---|---|---|---|---|
| RMBB/Sinter Plant | Physically inspection of PPE has been done on site found in good condition | Not required | Not required | 05-02-2026 | N/A | Site Supervisor | N/A | N/A |

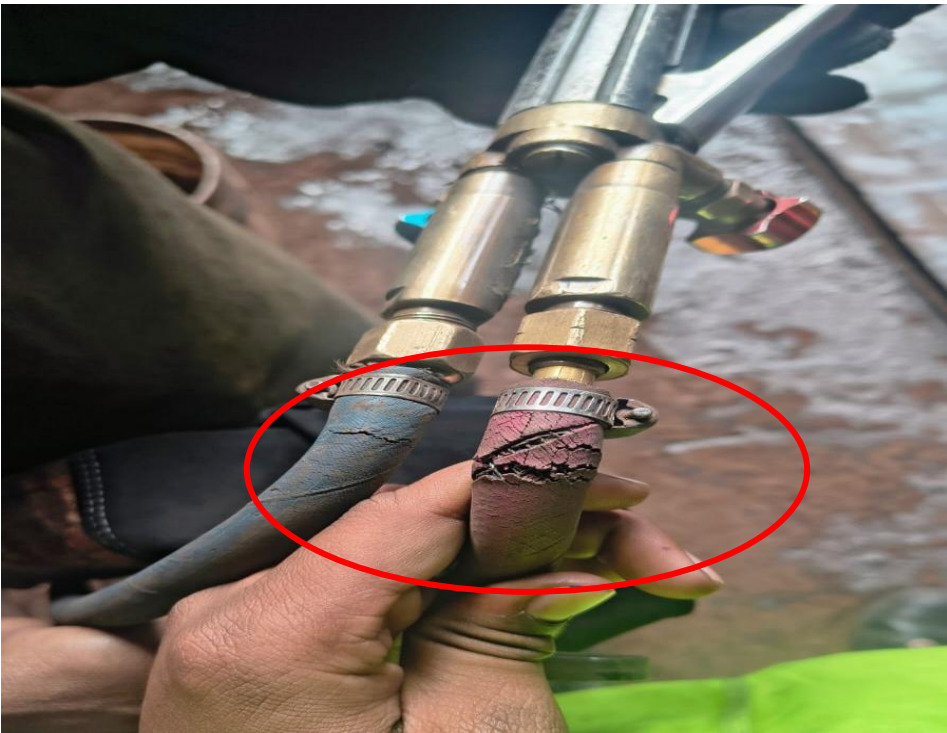
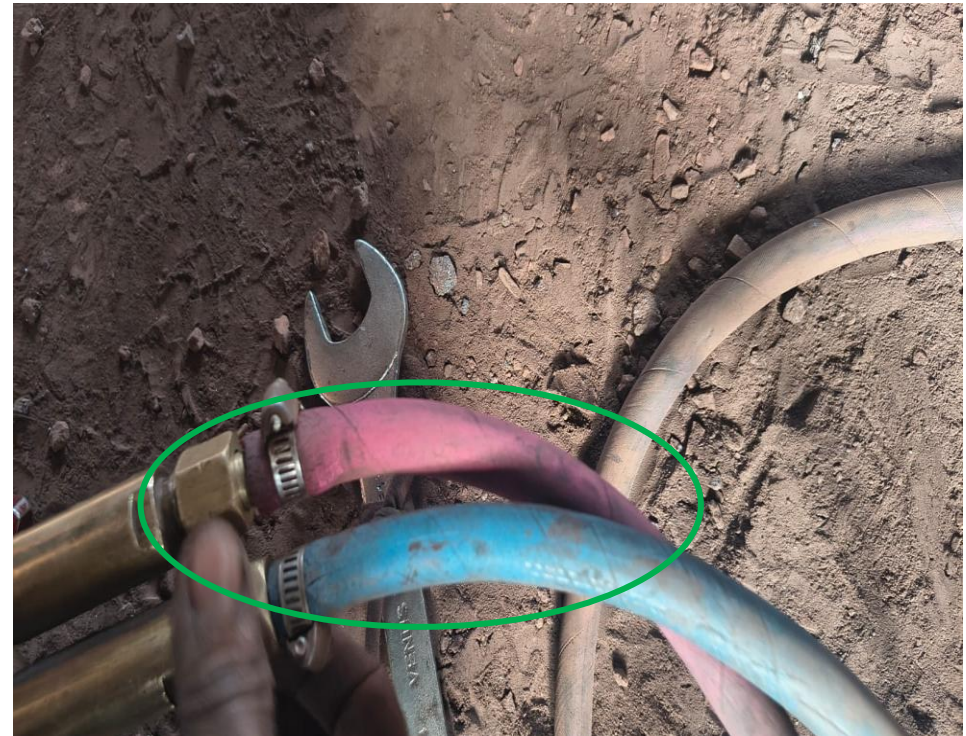
| Department | Description of Condition | Root cause | Correction & Immediate Action Taken | Observed on | Severity | Responsible | Target Date | Status |
|---|---|---|---|---|---|---|---|---|
| RMBB/Sinter Plant | During inspection of tools and tackles hoses found in damage condition | Tools and tackles inspection not done before starting the job | Immediate stop the activity and damaged parts were rectified and securely reinstalled | 05-02-2026 | 3 | Site Supervisor | 05-02-2026 | Closed |

| SL NO. | Finding | Severity | Recommendations | Responsibility | Target date | status |
|---|---|---|---|---|---|---|
| 1 | During inspection of tools and tackles hoses found in damage condition | 3 | Instructed to the supervisor to ensure conduct regular inspection to prevent recurrence of such conditions | Site supervisor | 05-02-2026 | closed |

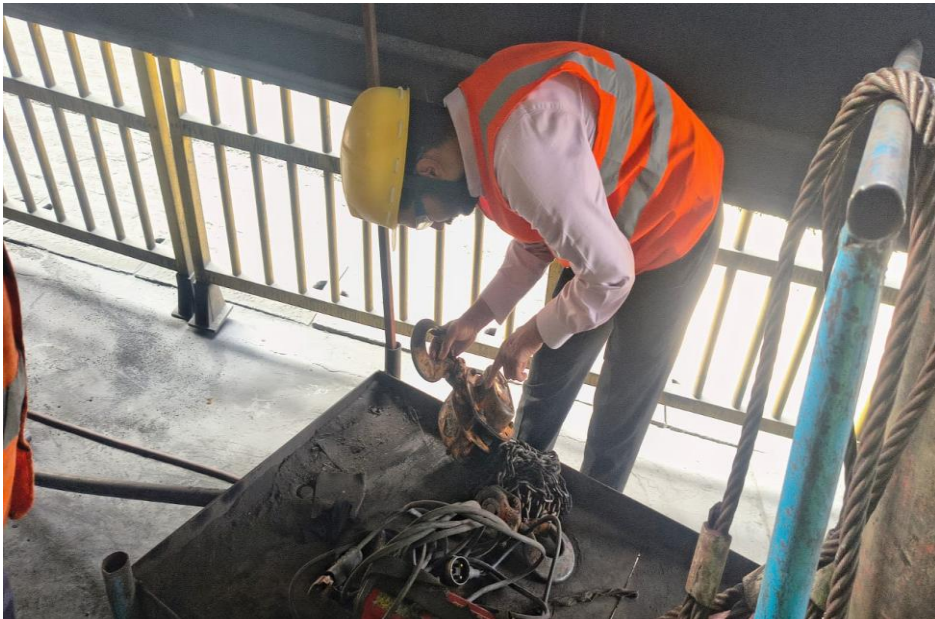
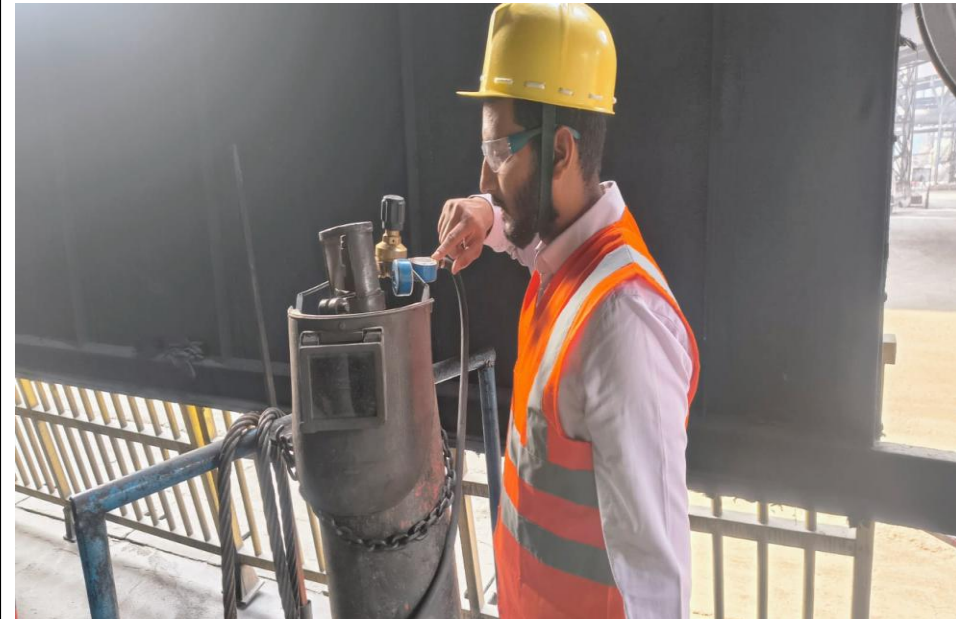
| Department | Description of Condition | Root cause | Correction & Immediate Action Taken | Observed on | Severity | Responsible | Target Date | Status |
|---|---|---|---|---|---|---|---|---|
| RMBB/Sinter Plant | A physical inspection was conducted, and all inspected equipment, including the chain block and LPG and oxygen cylinder pressure gauges, were found to be in safe and operational condition | Not required | Not required | 05-02-2026 | N/A | Site Supervisor | N/A | N/A |

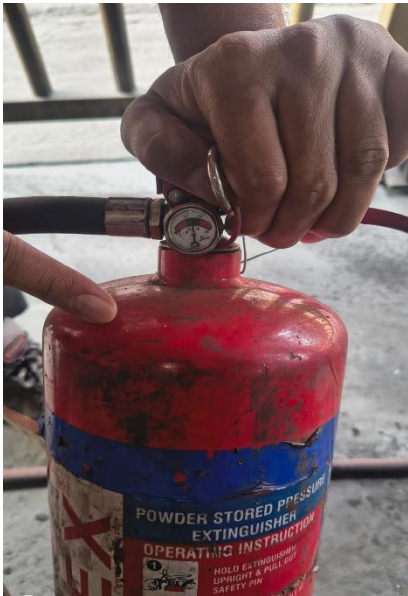
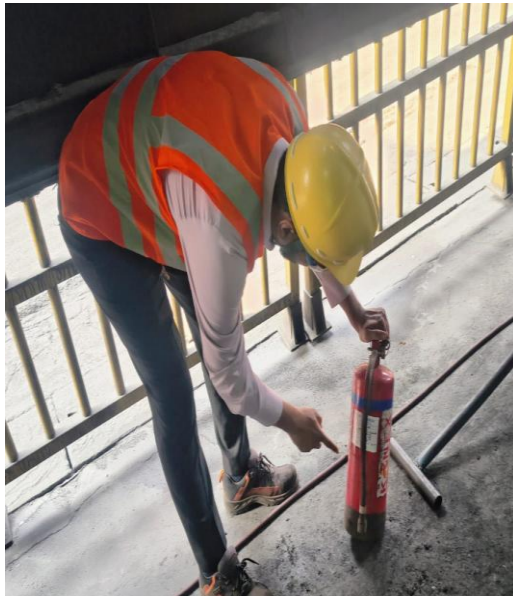
| Department | Description of Condition | Root cause | Correction & Immediate Action Taken | Observed on | Severity | Responsible | Target Date | Status |
|---|---|---|---|---|---|---|---|---|
| RMBB/Sinter Plant | Calibrated fire extinguisher found good and working condition | Not required | Not required | 05-02-2026 | N/A | Site supervisor | N/A | N/A |

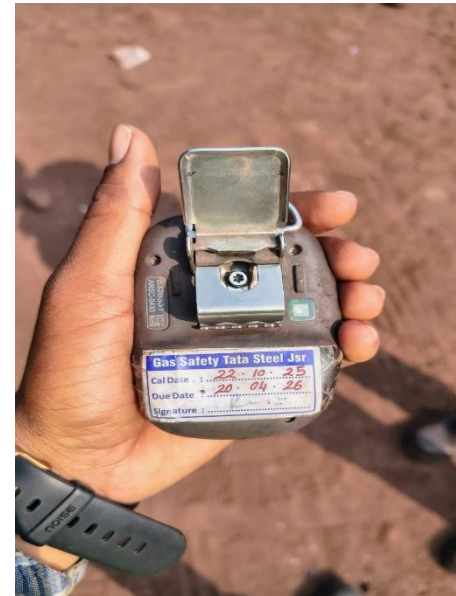
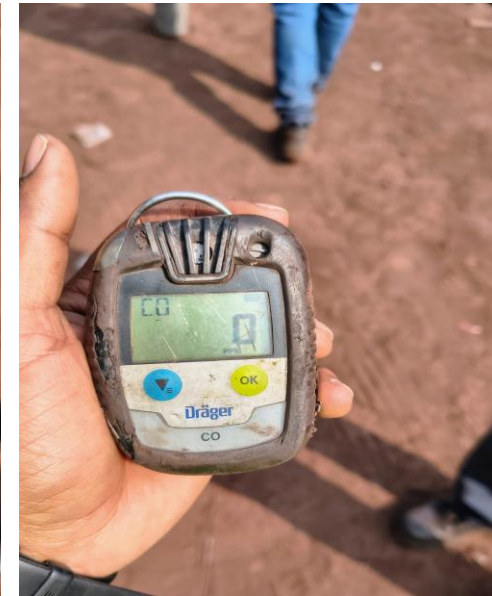
| Department | Description of Condition | Root cause | Correction & Immediate Action Taken | Observed on | Severity | Responsible | Target Date | Status |
|---|---|---|---|---|---|---|---|---|
| RMBB/Sinter Plant | Gas detector found good and working condition with calibrated | Not required | Not required | 05-02-2026 | N/A | Site supervisor | N/A | N/A |
