# SAN TAN PROPERTY INSPECTIONS

Sample Property

Home Inspection Report · Tuesday, April 28, 2026

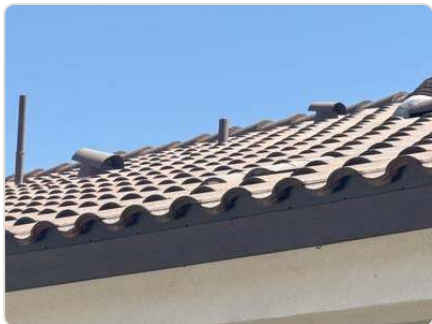
Roof west side

A roof penetration cover or boot is missing or improperly installed. An open or improperly sealed penetration allows water to enter the roof assembly directly. Repair by a licensed roofing contractor is recommended.

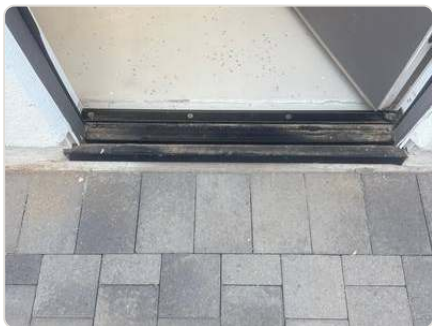
Garage side entry door

The threshold at the door between the garage and the interior is loose. Recommend tightening by a qualified person.

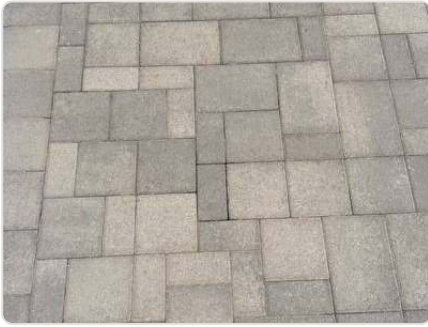
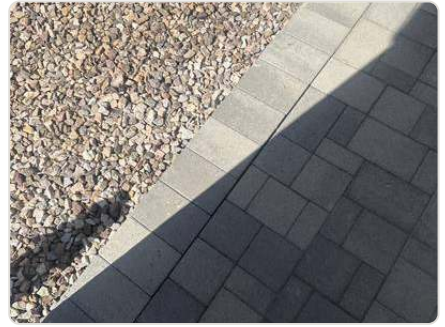
Front patio

The sand between the pavers is low/missing. This can start to make the pavers come loose. Recommend repair by a qualified contractor.

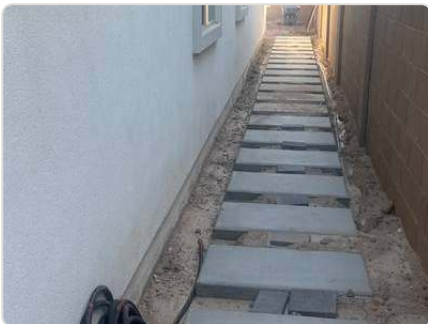
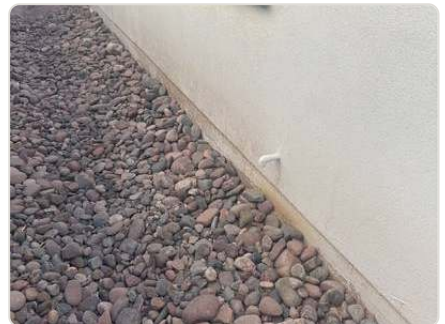
East side

The ground does not slope away from the foundation at the indicated location, directing surface water toward the structure. Negative grading is a leading cause of foundation moisture problems. Regrading away from the structure by a licensed contractor is recommended.

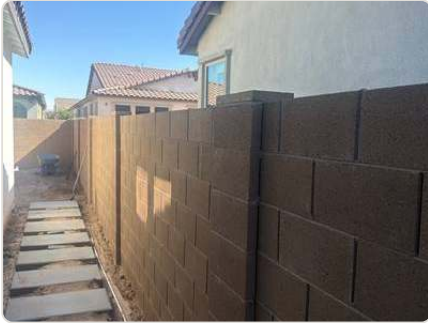
East side

Fence caps loose around perimeter. Recommend repair by a qualified contractor.

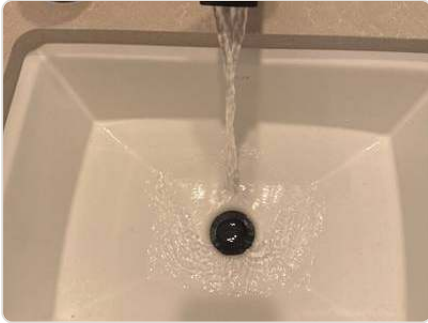
Hallway half bathroom

Drain stop loose at the indicated area. Recommend repair by a qualified contractor.

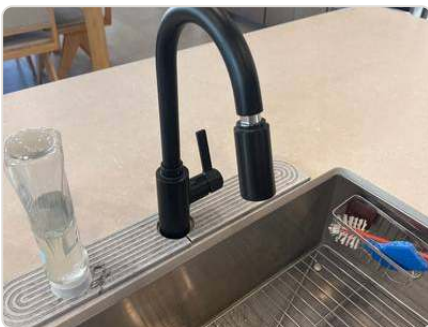
Kitchen faucet

A faucet is loose or not properly secured at the fixture and won't retract properly. Repair by a qualified contractor is recommended.

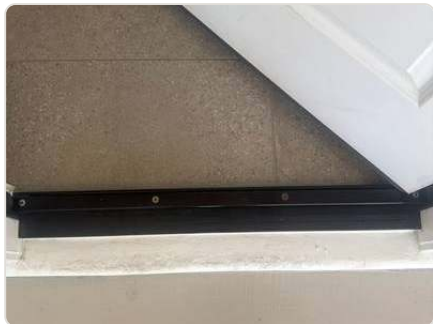
Garage door threshold

The threshold at the door between the garage and the interior is loose. Recommend tightening by a qualified person.

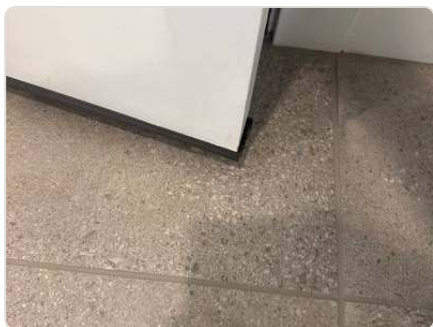
Garage occupant door

The weatherstripping at the occupant door to the garage from the interior of the home is loose and should be repaired. Recommend repair by a qualified contractor.

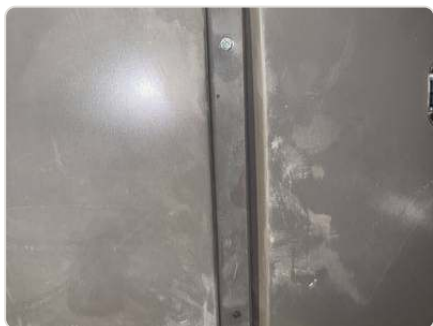
Furnace door is missing a screw to hold down the door. Recommend repair by a qualified contractor.

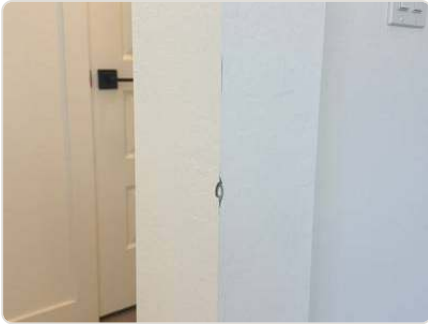
Front entry

Drywall damaged at indicated area. Recommend repair by qualified contractor.

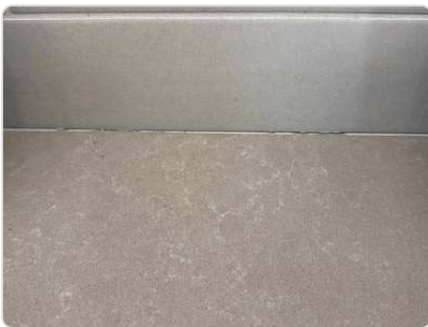
Kitchen

Grout is damaged at the indicated area. Recommend repair by a qualified contractor.

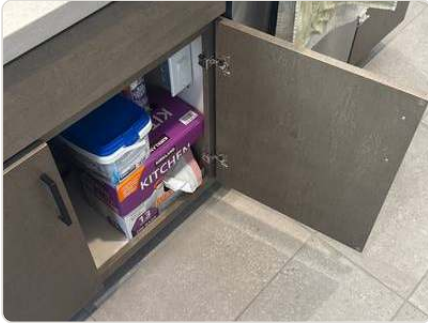
Kitchen

Cabinet door is loose at the hinges. Recommend repair by a qualified contractor.

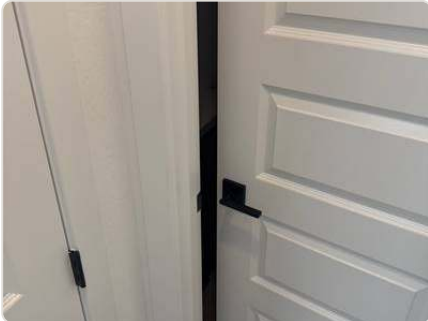
Hallway half bathroom

Interior door does not properly latch and sticks. Repair by a qualified contractor is recommended.

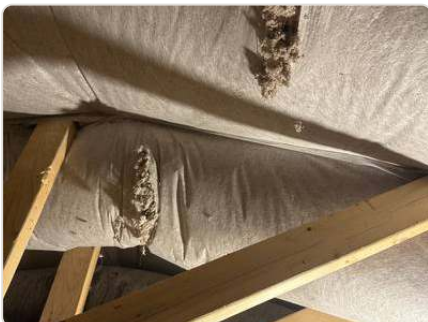
Attic

The netting holding up the insulation is ripped or torn in areas around the attic. This can lead to the insulation falling over time. Recommend repair by a qualified contractor.

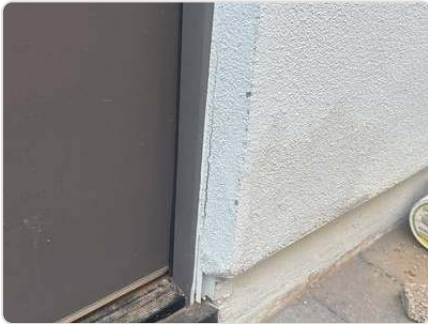
Garage side entry door

Cracks are observed in the stucco exterior. Open cracks allow moisture infiltration behind the stucco, potentially causing rot of the wall sheathing and framing behind. Sealing and monitoring by a qualified contractor is recommended.

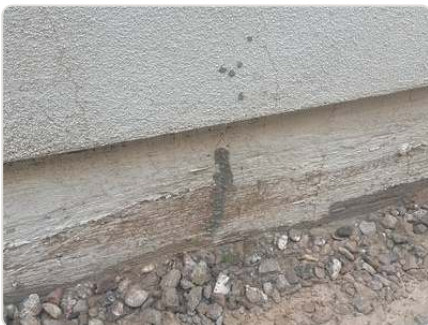
East side

Extra stucco present on siding. Recommend removal and repair by a qualified contractor.

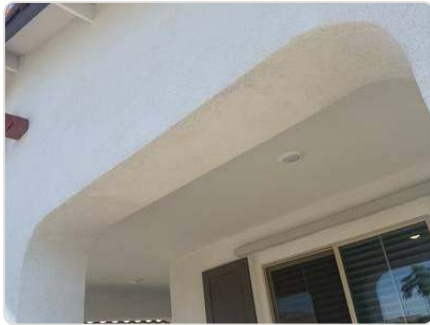
Front patio

Paint on stucco is incomplete and does not completely cover the stucco. Recommend repair by a qualified contractor.

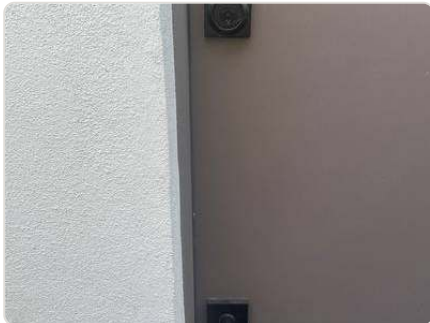
Garage side entry door

Exterior door handle/lock not installed straight or is loose. Recommend repair by a qualified contractor.

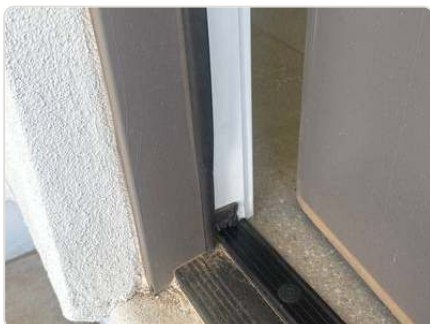
Backyard door

A gap is present at the exterior door frame allowing air, water, and pest infiltration. Repair or weatherstripping replacement by a qualified contractor is recommended.

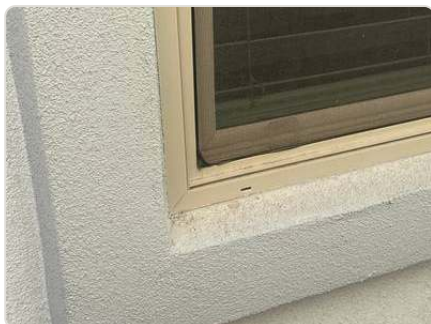
West side

Window screen damaged at indicated area. Recommend repair by a qualified contractor.

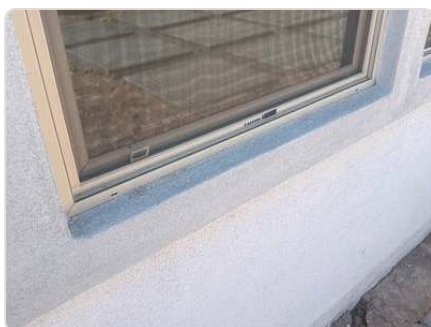
North side

Window screen installed backwards. Pull tabs should be facing the inside. The pull tab is also damaged. Recommend repair by a qualified contractor.

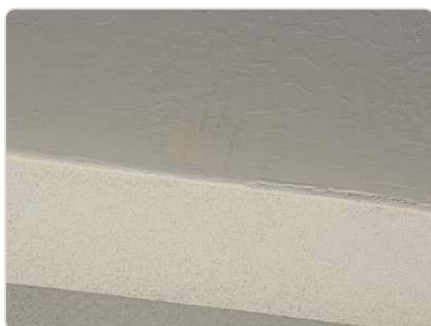
Back porch

Paint unfinished at the indicated area. Correction is needed by a qualified contractor.

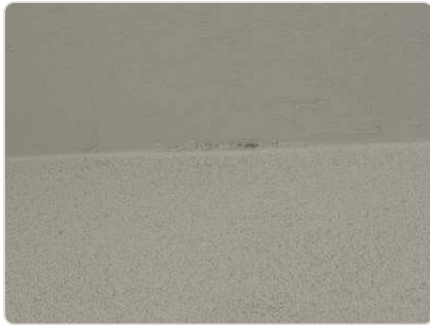
Front patio

Caulking damaged at the indicated area. Recommend repair by a qualified contractor.

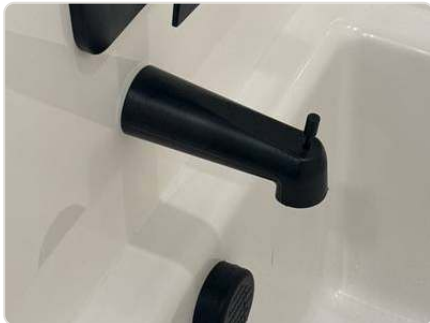
Hallway bathroom

Shower faucet is loose or not properly secured at the fixture. Repair by a licensed plumber is recommended.

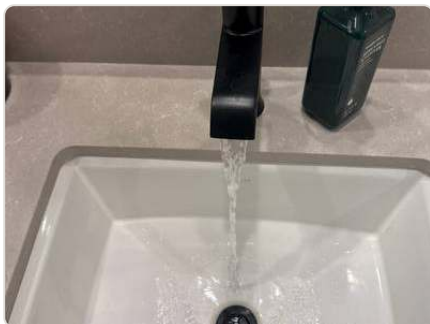
Middle full bathroom

Water pressure is low at sink compared to other sinks in house. Evaluation by a qualified contractor is recommended.

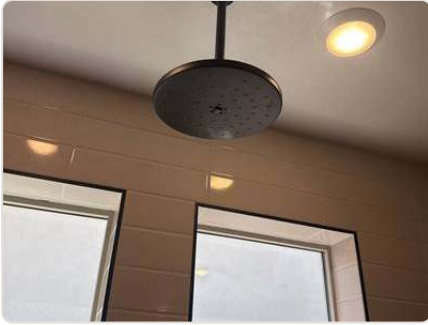
Master shower head

Shower head continues to drip after use. Verify if this is normal for specific shower head or repair and replace as needed.

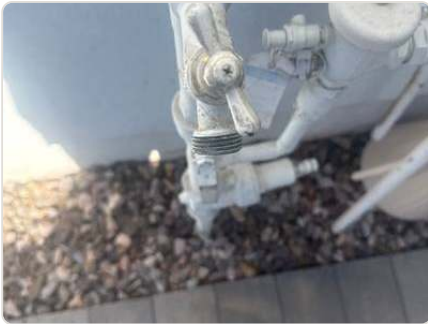
All exterior hose bibs

All hose bib lack a vacuum breaker. Without backflow protection, a submerged hose can back-siphon contaminants from the ground into the potable water supply. Installation of vacuum breakers is recommended.

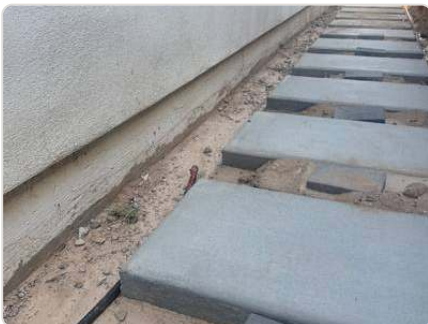
East side

Paint missing at stem wall around home. Paint protects the foundation from water. Recommend repair by a qualified contractor.

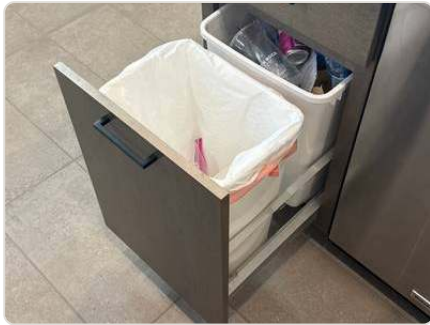
Kitchen

A cabinet door or drawer is loose or not operating properly. Repair or replacement by a qualified contractor is recommended.

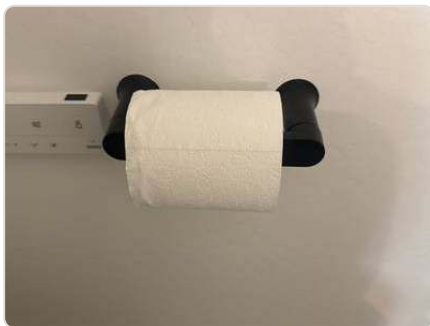
Master bathroom

A toilet paper holder is loose at the wall. Re-securing with appropriate anchors by a qualified person is recommended.

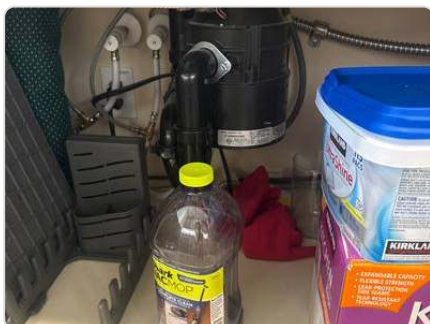
Disposal

The garbage disposal produces excessive noise or vibration during operation. Evaluation and repair or replacement by a qualified technician is recommended.

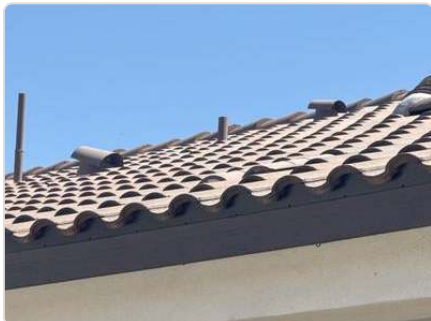
Roof west side

A roof penetration cover or boot is missing or improperly installed. An open or improperly sealed penetration allows water to enter the roof assembly directly. Repair by a licensed roofing contractor is recommended.

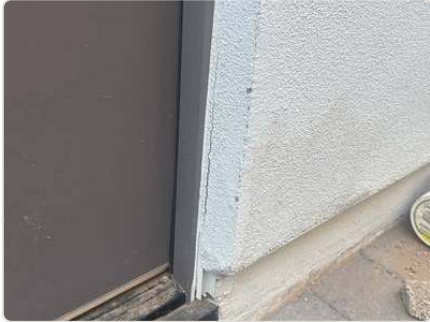
Garage side entry door

Cracks are observed in the stucco exterior. Open cracks allow moisture infiltration behind the stucco, potentially causing rot of the wall sheathing and framing behind. Sealing and monitoring by a qualified contractor is recommended.

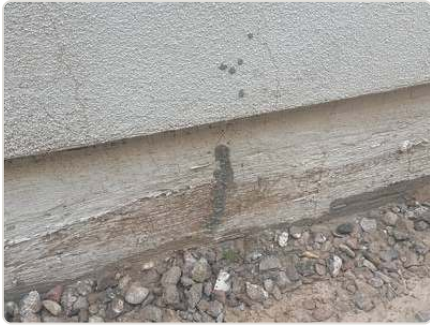
East side

Extra stucco present on siding. Recommend removal and repair by a qualified contractor.

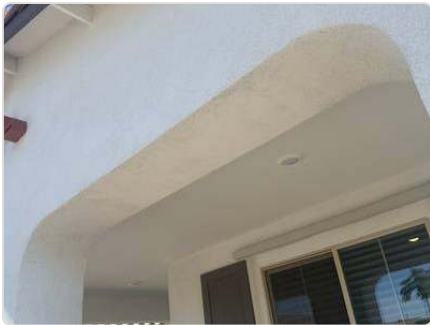
Front patio

Paint on stucco is incomplete and does not completely cover the stucco. Recommend repair by a qualified contractor.

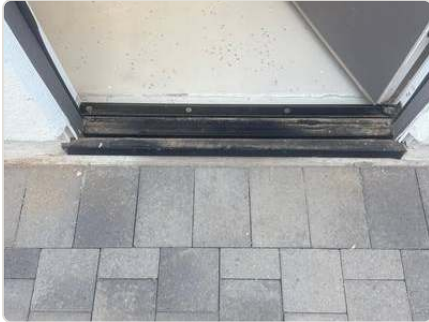
Garage side entry door

The threshold at the door between the garage and the interior is loose. Recommend tightening by a qualified person.

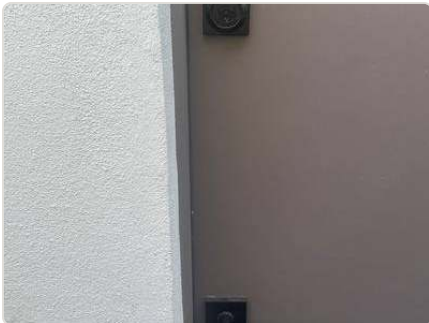
Garage side entry door

Exterior door handle/lock not installed straight or is loose. Recommend repair by a qualified contractor.

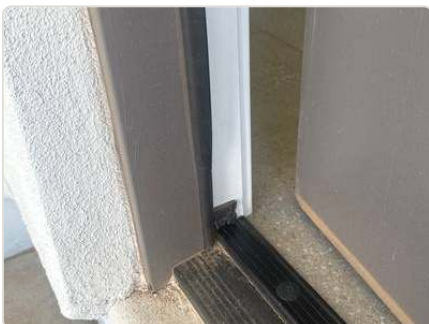
Backyard door

A gap is present at the exterior door frame allowing air, water, and pest infiltration. Repair or weatherstripping replacement by a qualified contractor is recommended.

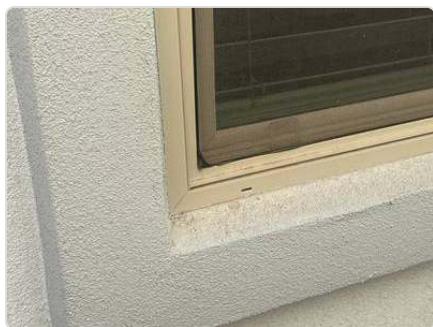
West side

Window screen damaged at indicated area. Recommend repair by a qualified contractor.

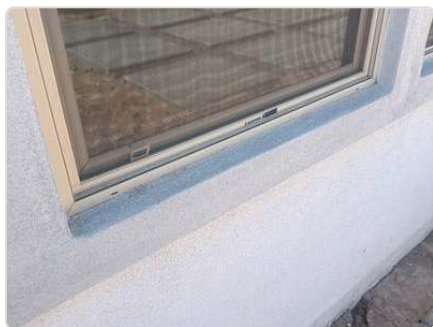
North side

Window screen installed backwards. Pull tabs should be facing the inside. The pull tab is also damaged. Recommend repair by a qualified contractor.

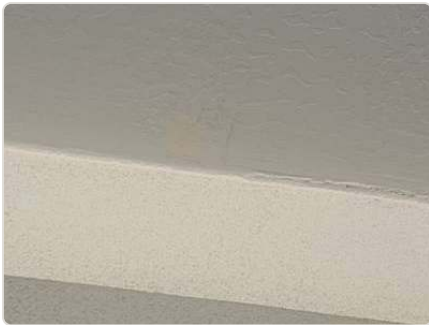
Back porch

Paint unfinished at the indicated area. Correction is needed by a qualified contractor.

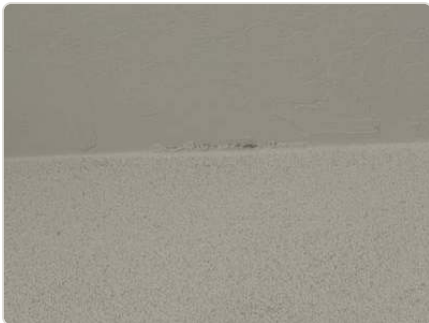
Front patio

Caulking damaged at the indicated area. Recommend repair by a qualified contractor.

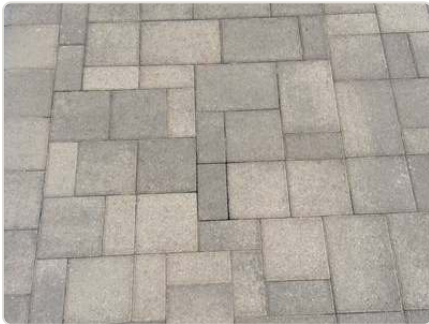
Front patio

The sand between the pavers is low/missing. This can start to make the pavers come loose. Recommend repair by a qualified contractor.

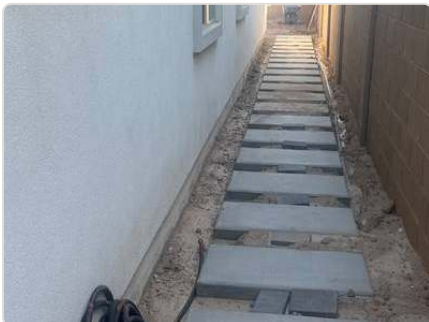
East side

The ground does not slope away from the foundation at the indicated location, directing surface water toward the structure. Negative grading is a leading cause of foundation moisture problems. Regrading away from the structure by a licensed contractor is recommended.

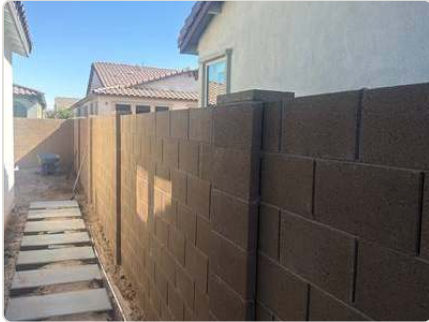
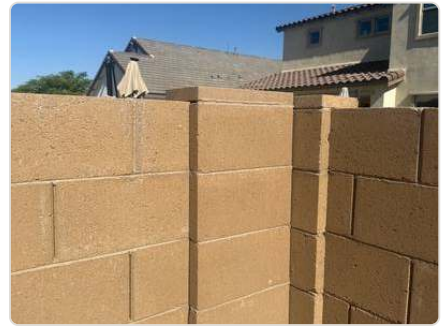
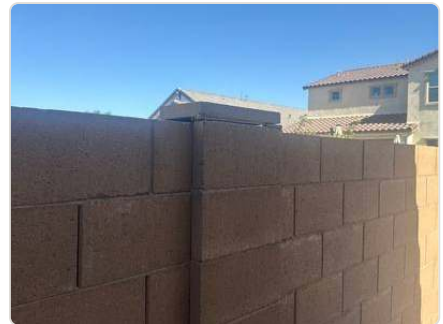
East side

Fence caps loose around perimeter. Recommend repair by a qualified contractor.

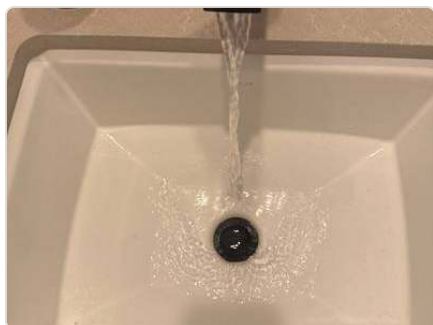
Hallway half bathroom

Drain stop loose at the indicated area. Recommend repair by a qualified contractor.

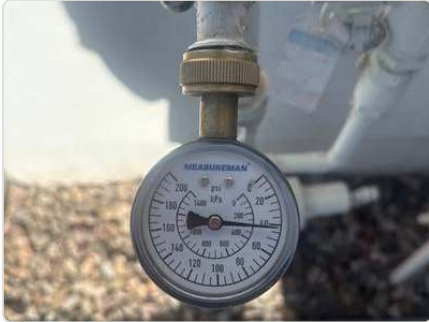
At main hose bib

Water pressure was tested and found within the acceptable range of 40-80 PSI at the time of inspection.

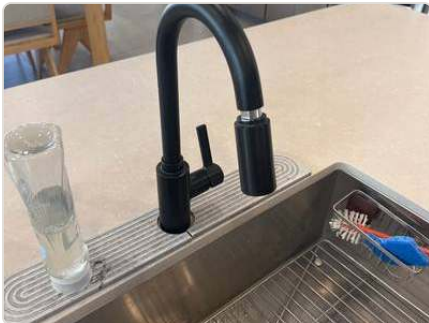
Kitchen faucet

A faucet is loose or not properly secured at the fixture and won't retract properly. Repair by a qualified contractor is recommended.

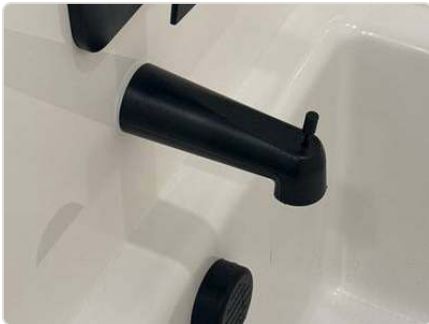
Hallway bathroom

Shower faucet is loose or not properly secured at the fixture. Repair by a licensed plumber is recommended.

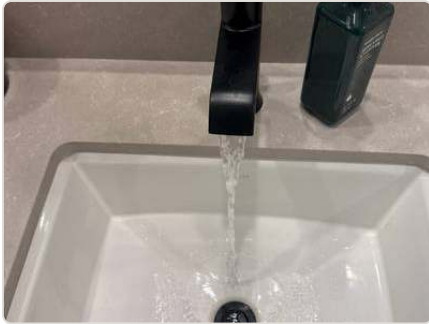
Middle full bathroom

Water pressure is low at sink compared to other sinks in house. Evaluation by a qualified contractor is recommended.

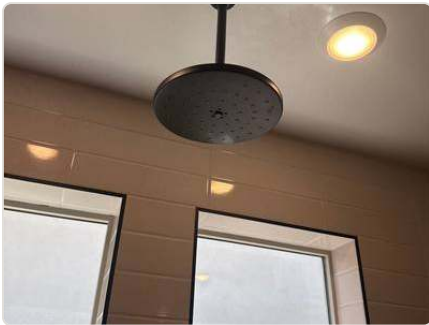
Master shower head

Shower head continues to drip after use. Verify if this is normal for specific shower head or repair and replace as needed.

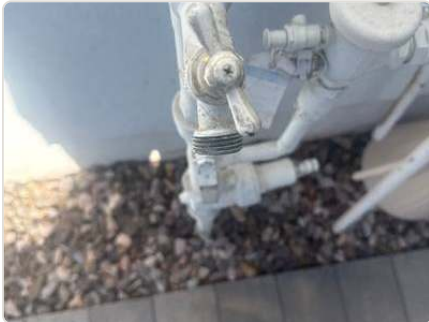
All exterior hose bibs

All hose bibs lack a vacuum breaker. Without backflow protection, a submerged hose can back-siphon contaminants from the ground into the potable water supply. Installation of vacuum breakers is recommended.

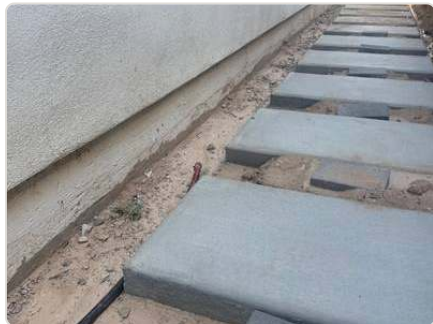
East side

Paint missing at stem wall around home. Paint protects the foundation from water. Recommend repair by a qualified contractor.

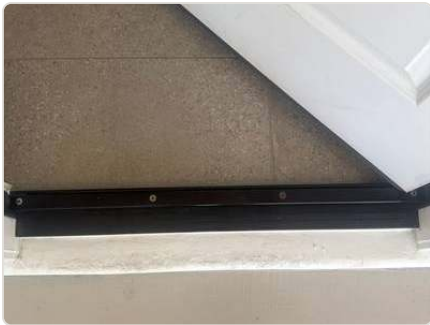
Garage door threshold

The threshold at the door between the garage and the interior is loose. Recommend tightening by a qualified person.

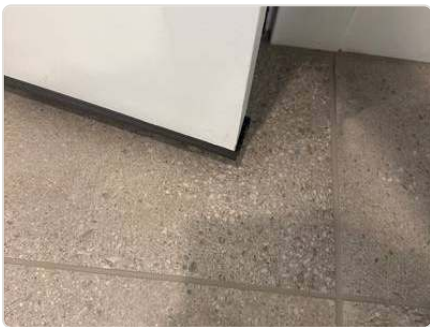
Garage occupant door

The weatherstripping at the occupant door to the garage from the interior of the home is loose and should be repaired. Recommend repair by a qualified contractor.

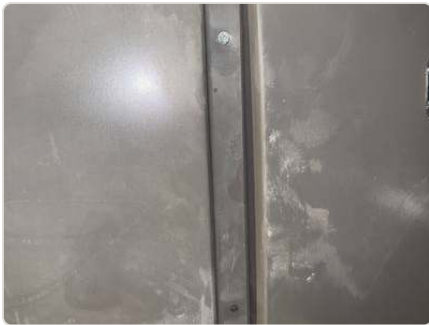
Furnace door is missing a screw to hold down the door. Recommend repair by a qualified contractor.

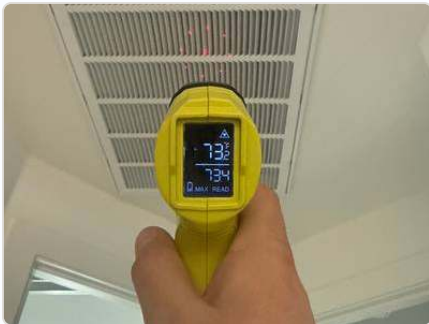
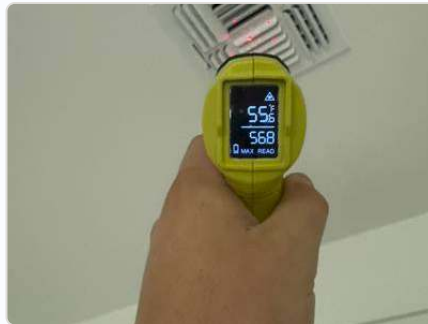
Temperature split was measured within the acceptable range of 14-22 degrees F at the time of inspection. The system is performing as intended.

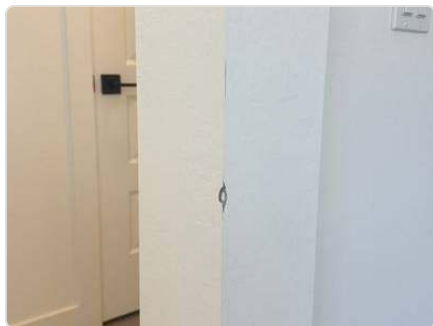
Front entry

Drywall damaged at indicated area. Recommend repair by qualified contractor.

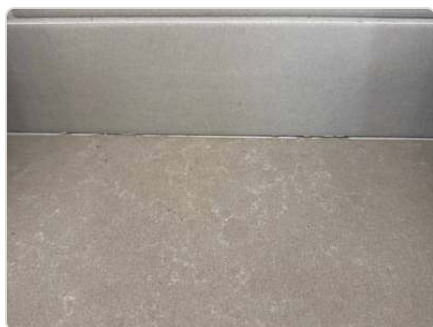
Kitchen

Grout is damaged at the indicated area. Recommend repair by a qualified contractor.

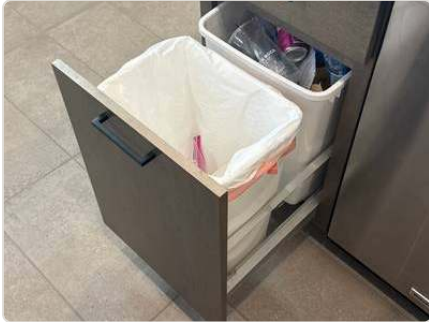
Kitchen

A cabinet door or drawer is loose or not operating properly. Repair or replacement by a qualified contractor is recommended.

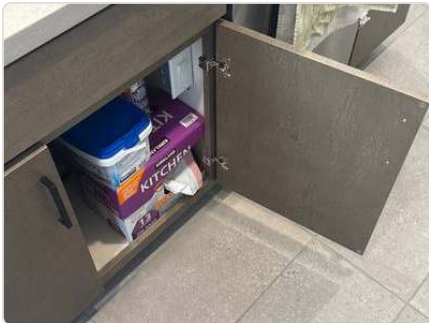
Kitchen

Cabinet door is loose at the hinges. Recommend repair by a qualified contractor.

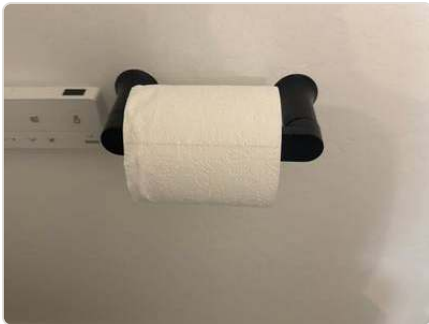
Master bathroom

A toilet paper holder is loose at the wall. Re-securing with appropriate anchors by a qualified person is recommended.

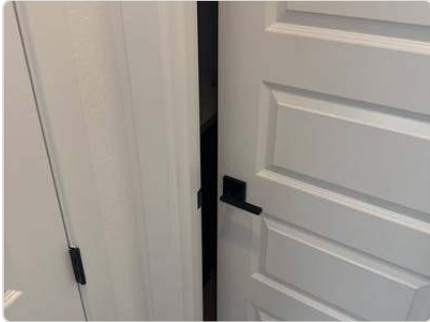
Hallway half bathroom

Interior door does not properly latch and sticks. Repair by a qualified contractor is recommended.

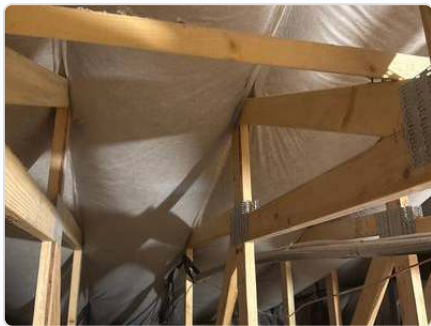
Attic insulation level was observed and appears to be at or near the recommended R-value for this area.

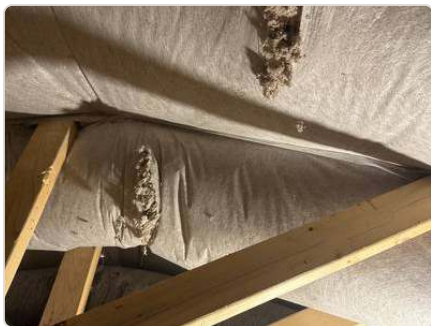
Attic

The netting holding up the insulation is ripped or torn in areas around the attic. This can lead to the insulation falling over time. Recommend repair by a qualified contractor.

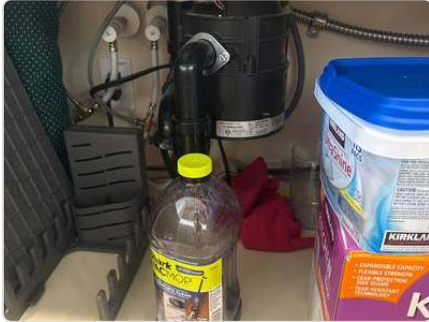
Disposal

The garbage disposal produces excessive noise or vibration during operation. Evaluation and repair or replacement by a qualified technician is recommended.
