# WOOD DESTROYING PESTS AND ORGANISMS INSPECTION REPORT

| Building No.<br>433 | Street<br>E. Highway 4 | City<br>Murphys | ZIP<br>95247 | Date of Inspection<br>01/28/2026 | Number of Pages<br>6 |
| <div style="display: inline-block; vertical-align: top; margin-left: 10px;"> <b>Lawson Home Services</b><br/> 11185 Racetrack Rd<br/> Sonora CA 95370<br/> (209) 770-5980<br/> Jlawson37@outlook.com </div> | | | | Report # : 12417<br>Registration # : PR8529<br>Escrow # :<br><input type="checkbox"/> CORRECTED REPORT | |

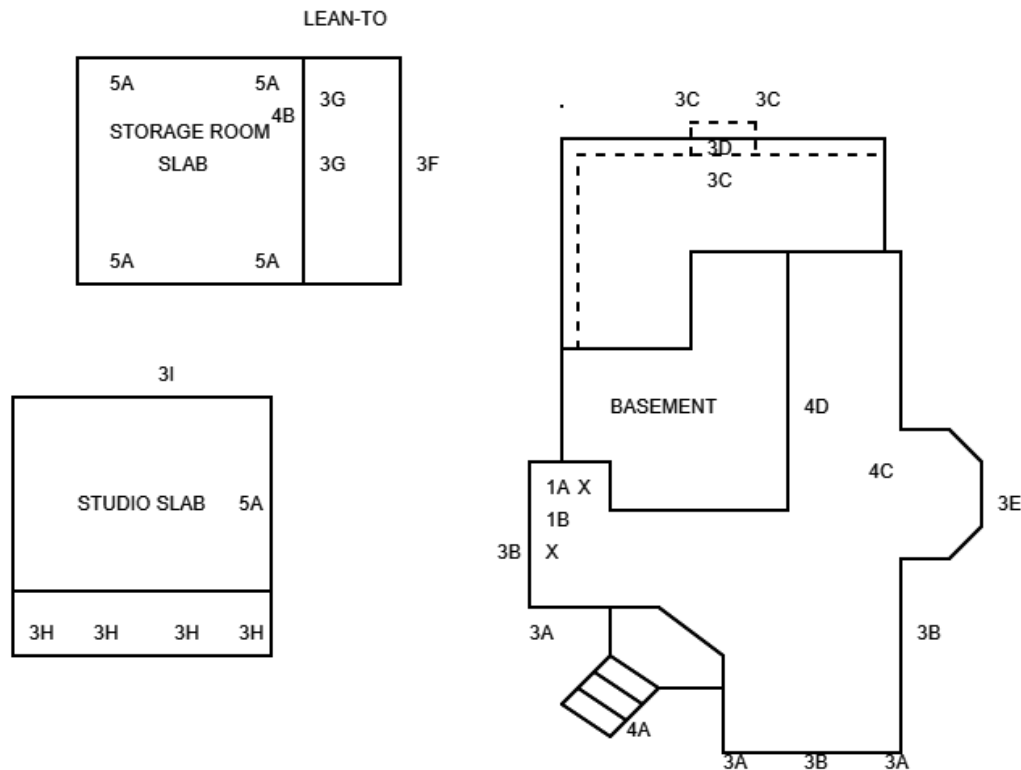
**Diagram Not To Scale**

FINDING: Subterranean Termite activity was noted at the foundations and forms.

RECOMMENDATION: To prevent subterranean termites from constructing mud tubes between the foundations and the wood members, apply Taurus to the soil in accordance with the label adjacent to the area of infestation (see X on diagram). Post a completion tag listing the materials used. Treatment to be applied by Lawson Home services licensed applicator per current label instructions. Local Treatment is not intended to be an entire structure treatment method. If infestations of wood-destroying pests extend or exist beyond the area(s) of local treatment, they may not be exterminated.
