SIBOOK REPAIR I.

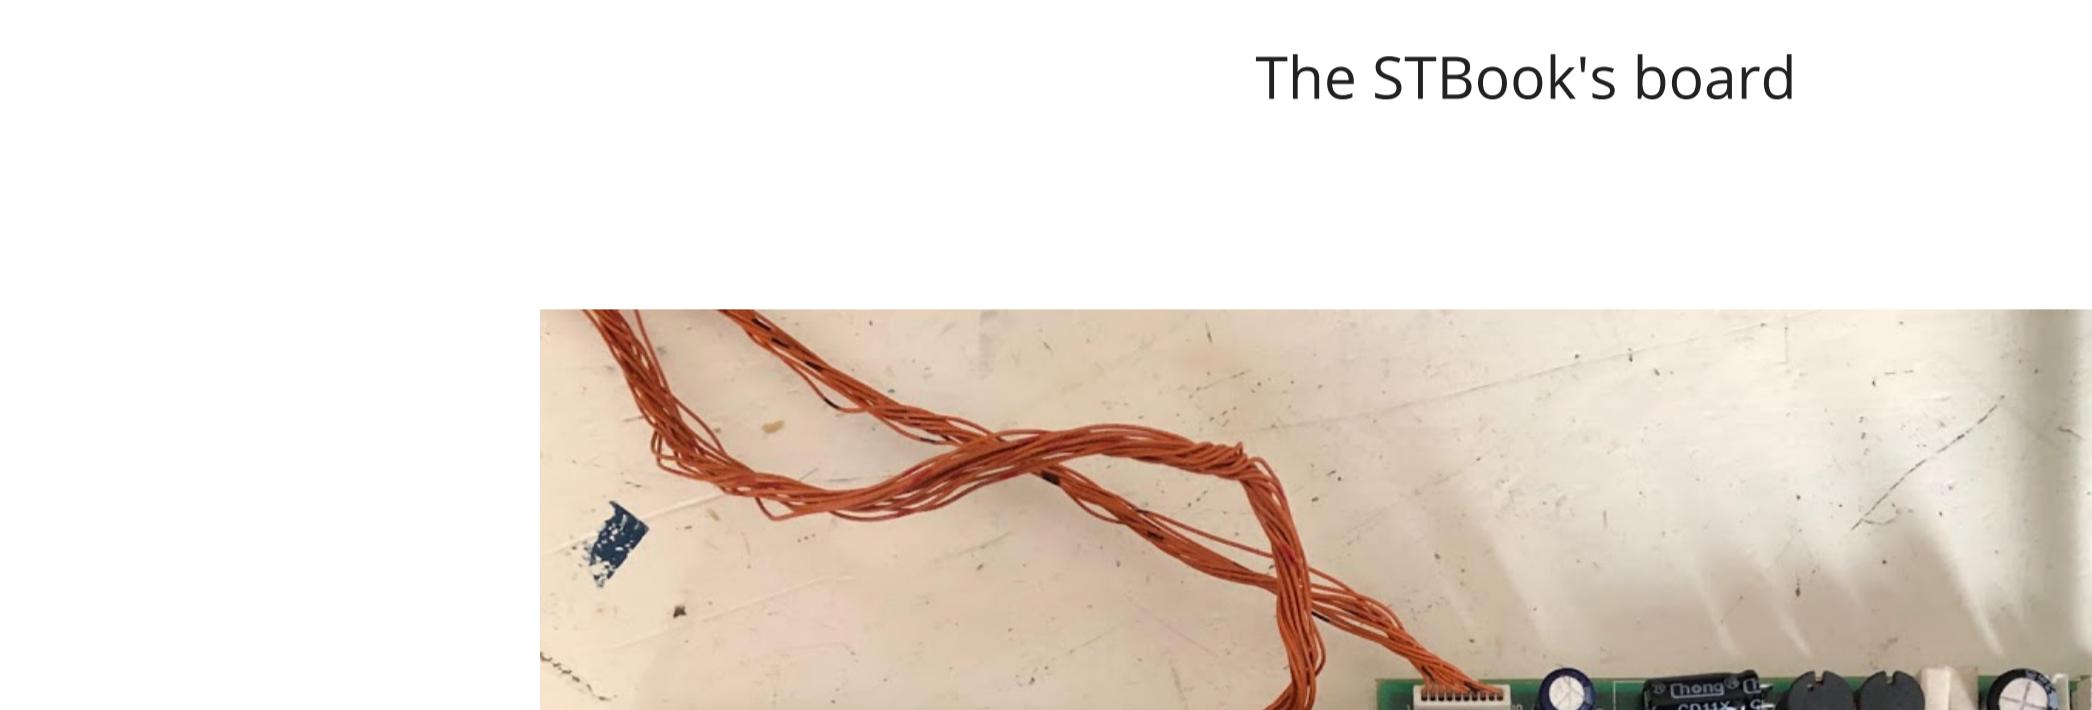
L1003 IN THE BIAS CIRCUIT

After replacing the inductor it came back to life but bombed out (4 bombs). This is due to a (certain version) TOS bug, that stops the STBook from booting when the HDD is not detected. So I removed the installed and failing ugly CF adapters and mods, replaced it with a fresh CF that I prepared in my Falcon.

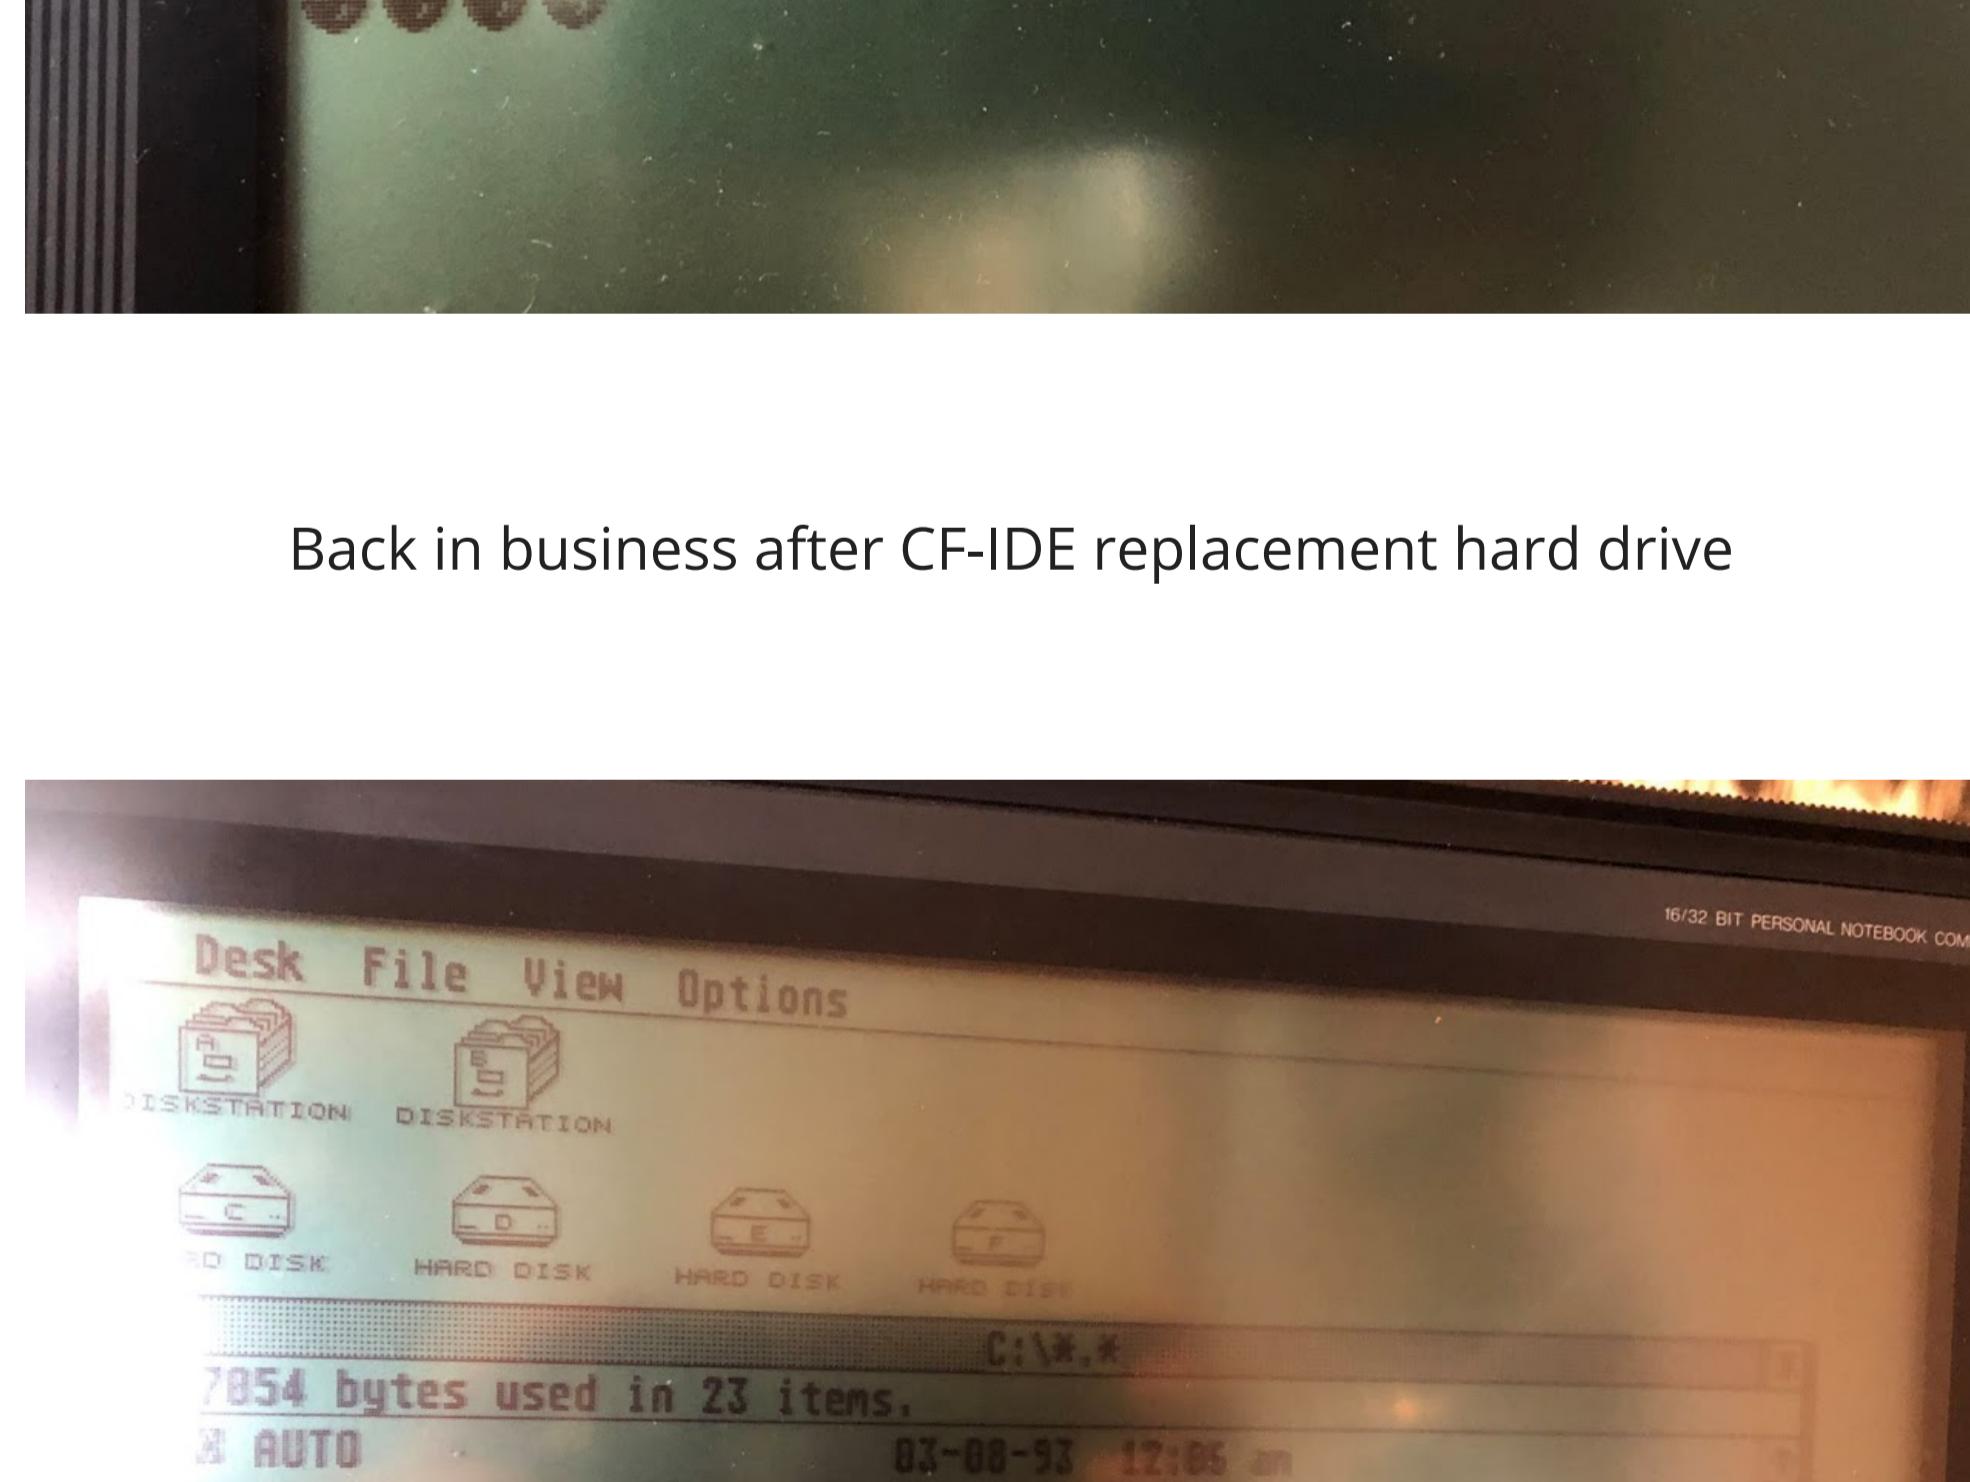
1024 KB
Complete.

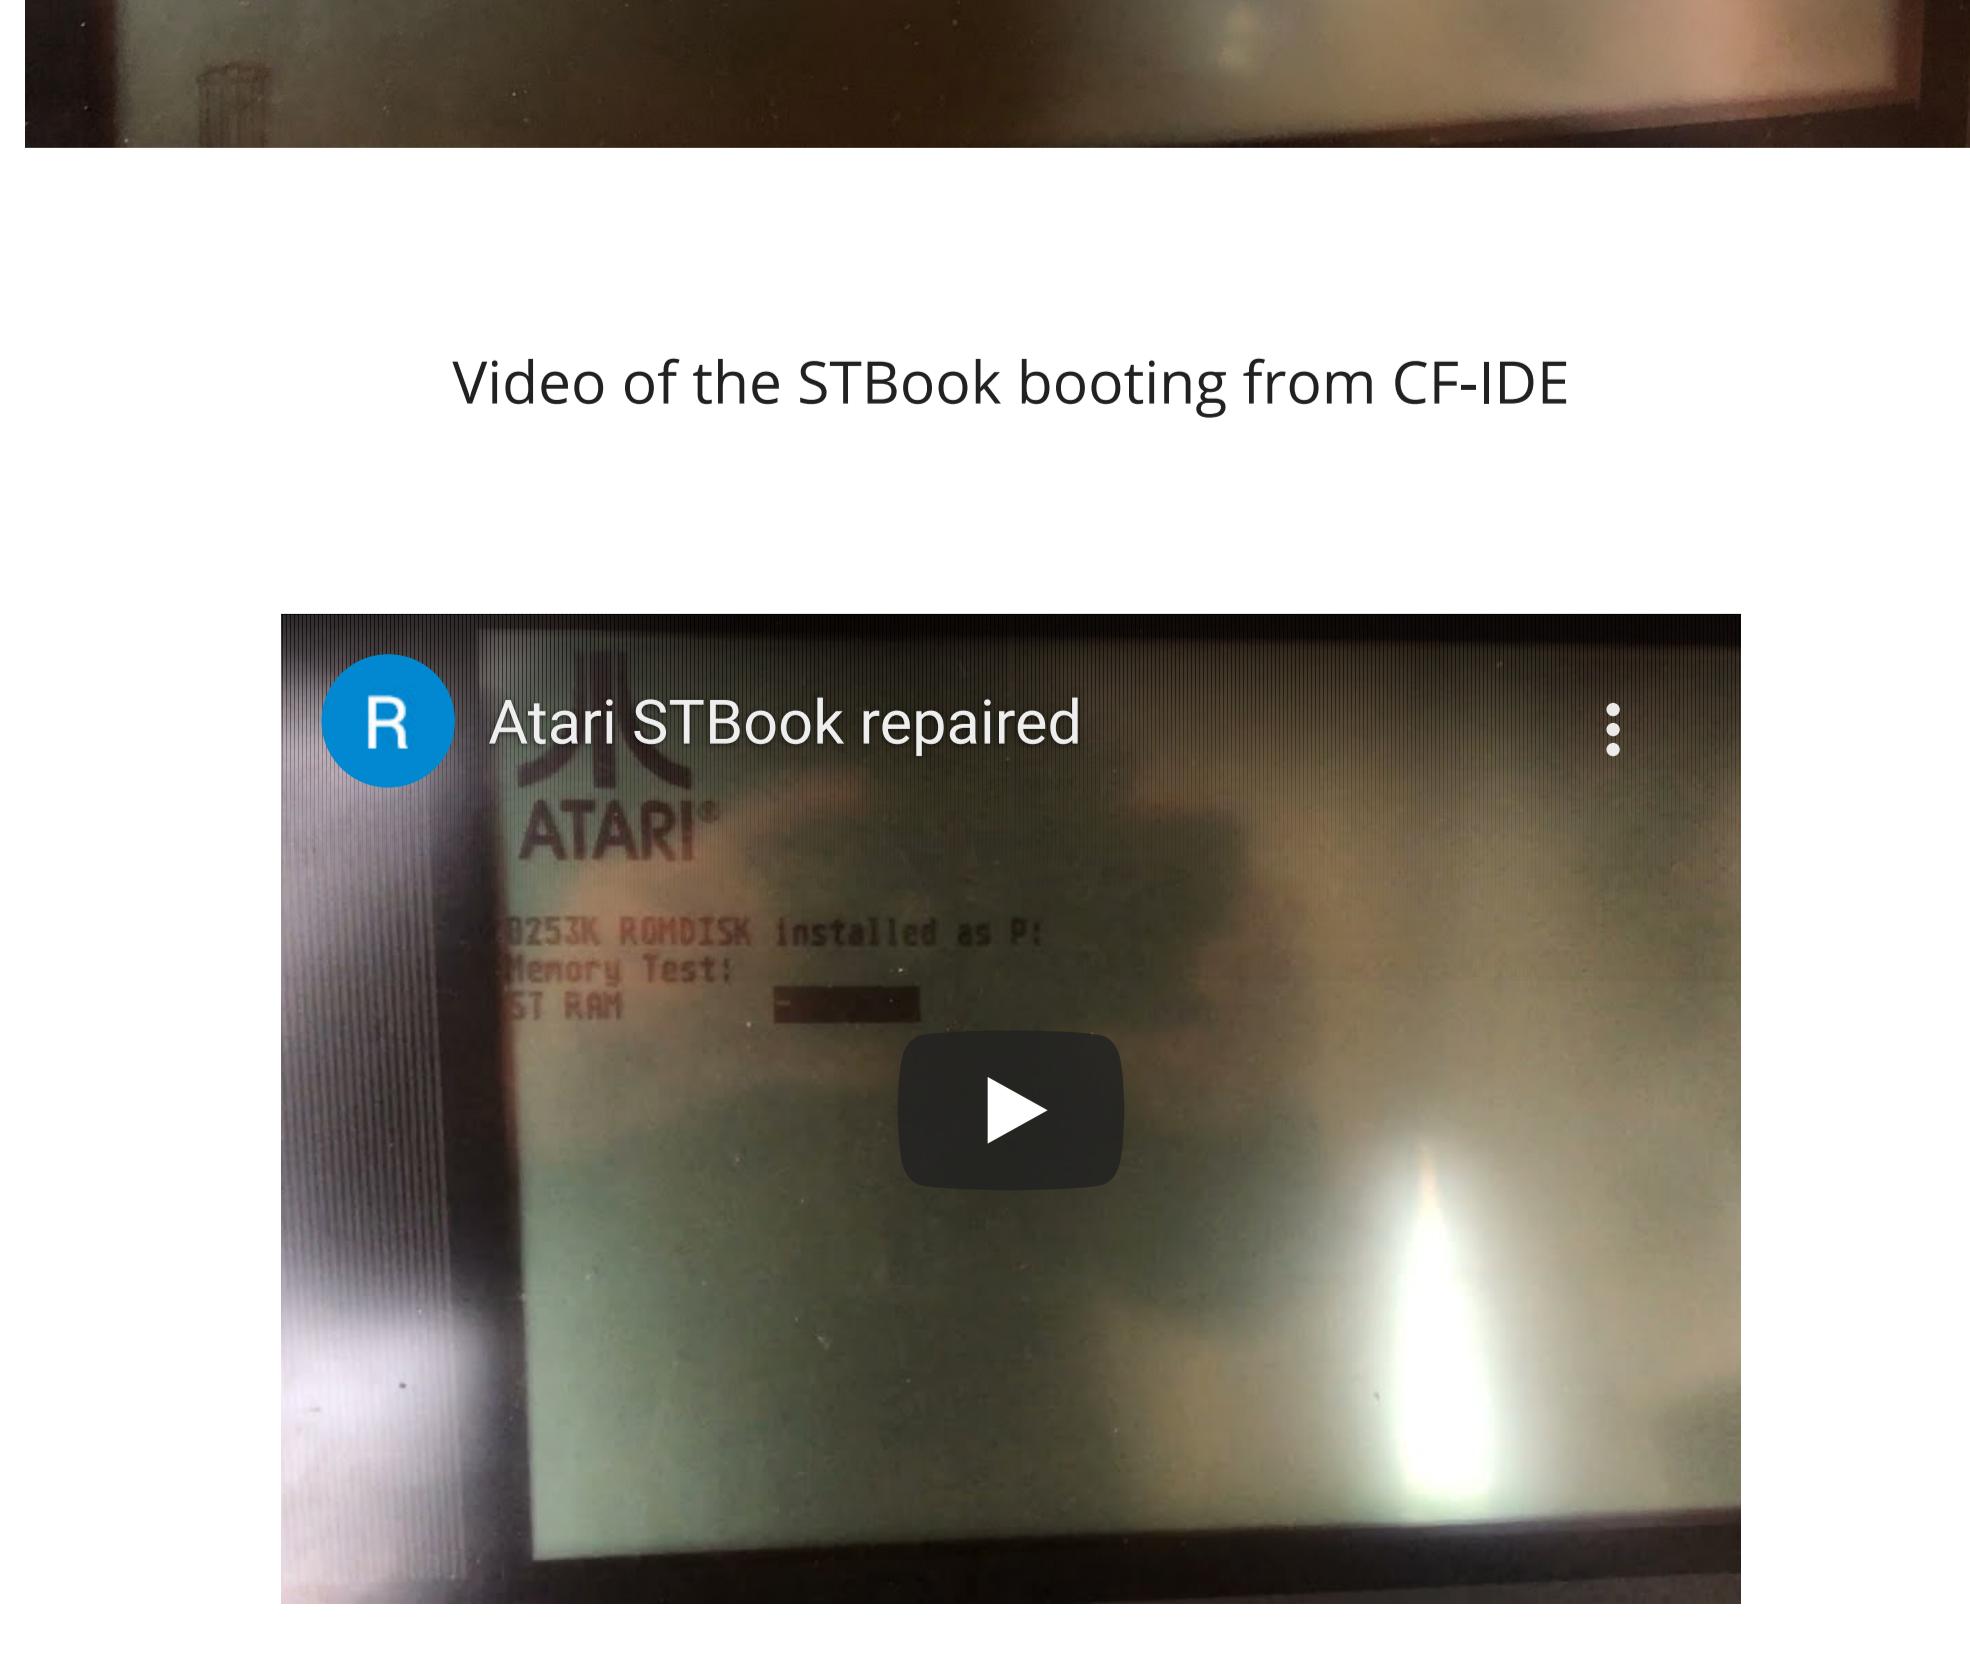
This STBook is now fully working again.
