## **REPORT ON MPPL ABU ROAD MP1 FUEL PUMP CAM EYE FAILURE**

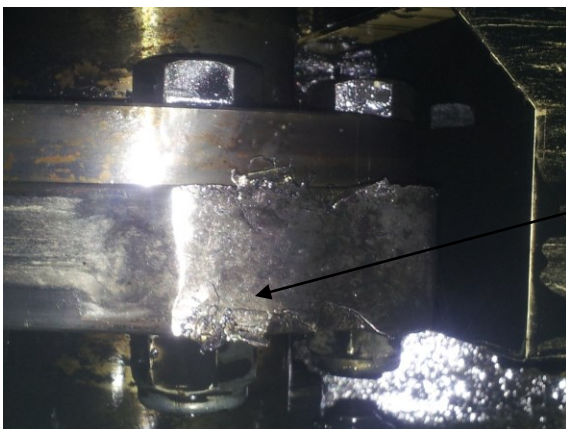
Damage in Fuel Pump  
cam

- Roller guide came out from its slotted position in the fuel pump bracket due to material failure of fuel pump bracket. During running of the engine roller guide got twisted from its actual position. This caused shear load on the fuel pump cam eye elongating the material along the edges.

Two pair of old fuel pump cam eye were brought from Sanganer to be replaced in cylinder number 7 and cylinder number 8 of MP-1, MPPL, Abu Road. New fuel pump bracket and roller guide taken from Abu Road stores were fitted in cylinder 7.

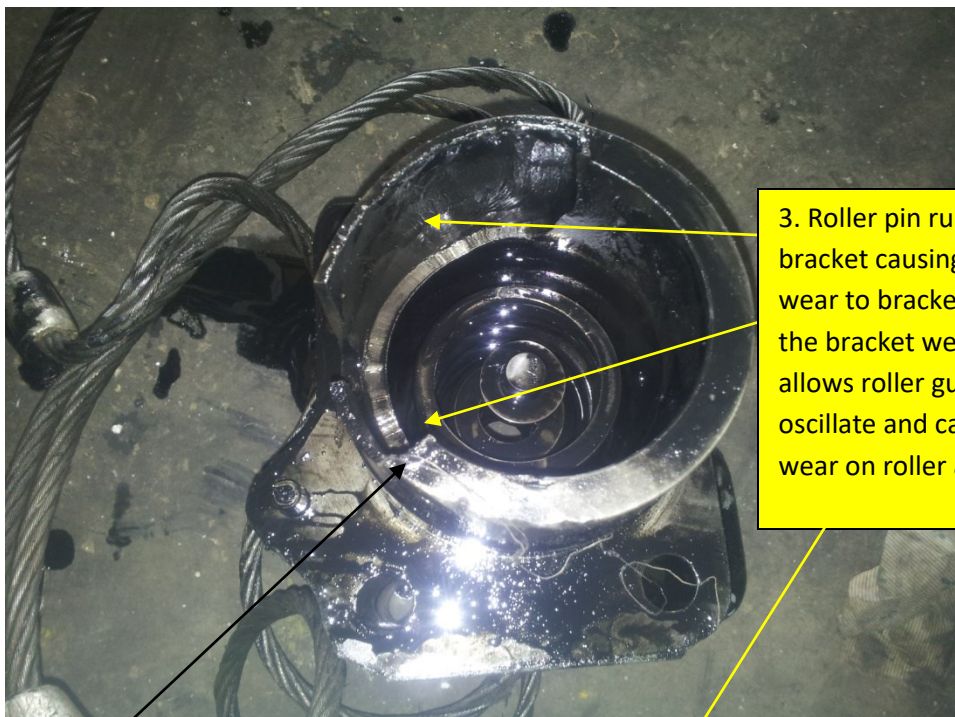
3. Roller pin rubs on guide bracket causing excessive wear to bracket. As slot in the bracket wears this allows roller guide to oscillate and causes uneven wear on roller and fuel cam

Material broke from fuel pump bracket

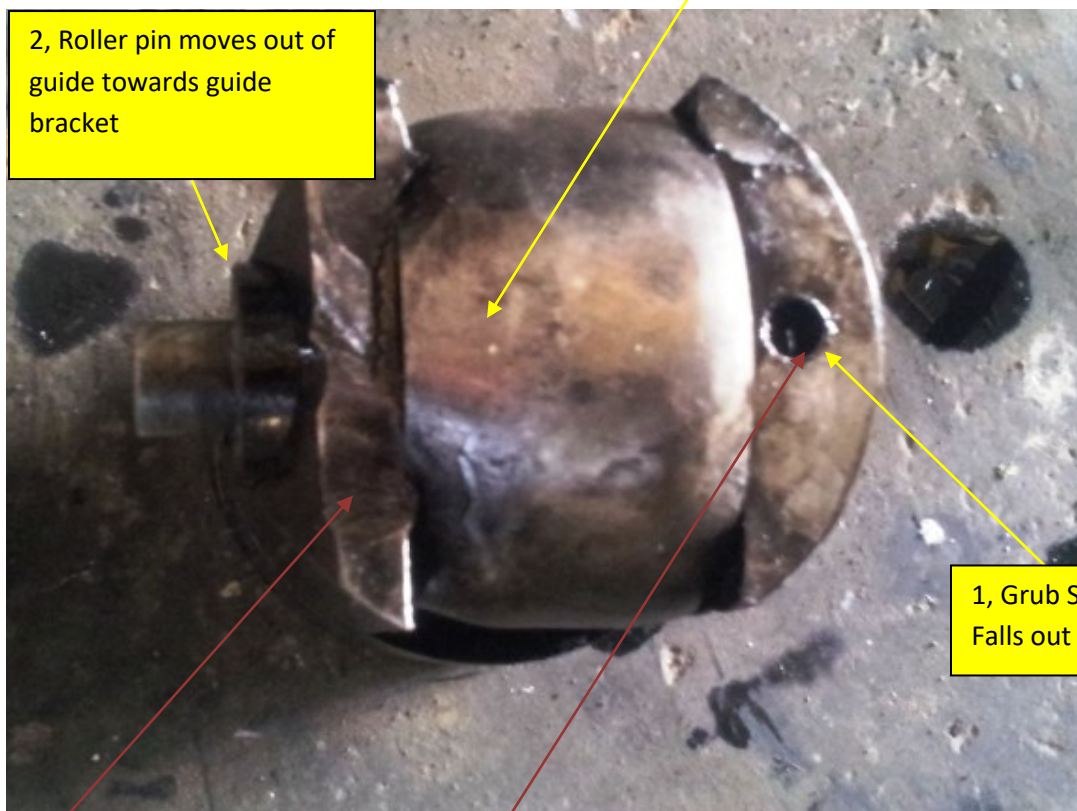
2, Roller pin moves out of guide towards guide bracket

1, Grub Screw Falls out

Damaged Roller guide

Pin not found here
