## **Analysis of leakage from threaded portion of seal cooling pipe of MP-08 NDE side at WRPL, Viramgam (Western Region Pipeline)**

**Document No: TR-24-089**

**Nov. 2024**

**Research and Development Centre  
Indian Oil Corporation Ltd.  
Sector-13, Faridabad, Haryana**

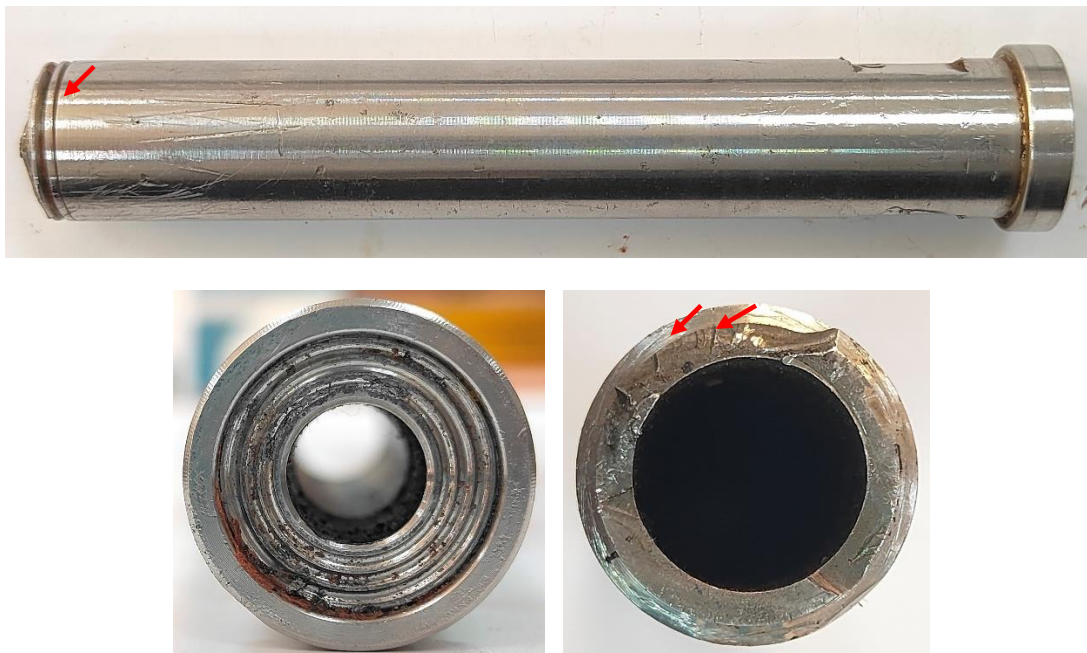
- No Significant corrosion was observed on the ID/OD surface of the sample.
- The failed surface of the sample revealed a fracture from near the thread end (Fig. 1).

- Beach marks on the failed fracture surface could be observed from naked eye (Fig. 3).
- Thickness data revealed thickness around 3.5 mm.

**Fig. 2-4: As received failed sample images showing failure from thread root and beach marks on the failed fracture surface**

- Visual examination revealed:
  - No Significant corrosion on the ID/OD surface of the sample.
  - Fracture from the thread root.
  - Beach marks on the failed fracture.

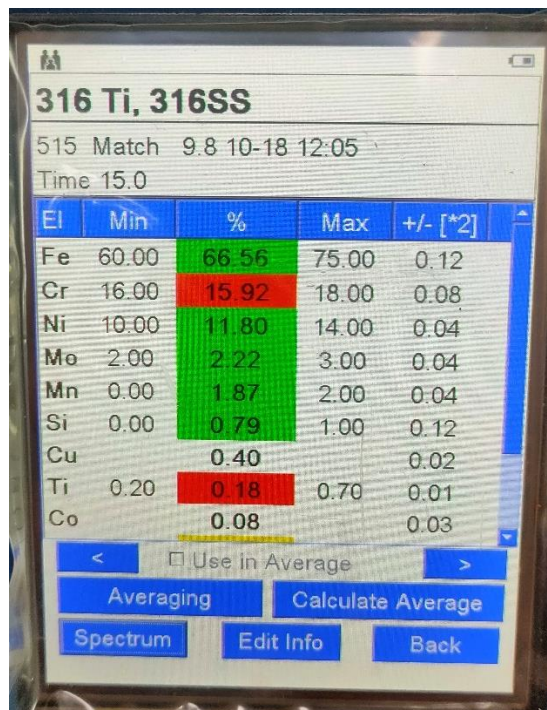
PMI of the samples were performed to identify the grade mismatch if any. PMI data revealed the material to be of SS 316 grades (Fig. 12).

**Fig. 12: PMI results showing material to be of SS 316 grades**
