**INDIAN OIL CORPORATION LIMITED**  
(Pipelines Division, NOIDA)

**Sub: Investigation report on Breakdown of 500 KVA DG Set at SMPL Rewari**

## **INCIDENT INVESTIGATION REPORT ON FAILURE OF THE 500 KVA DG SET AT SMPL, REWARI**

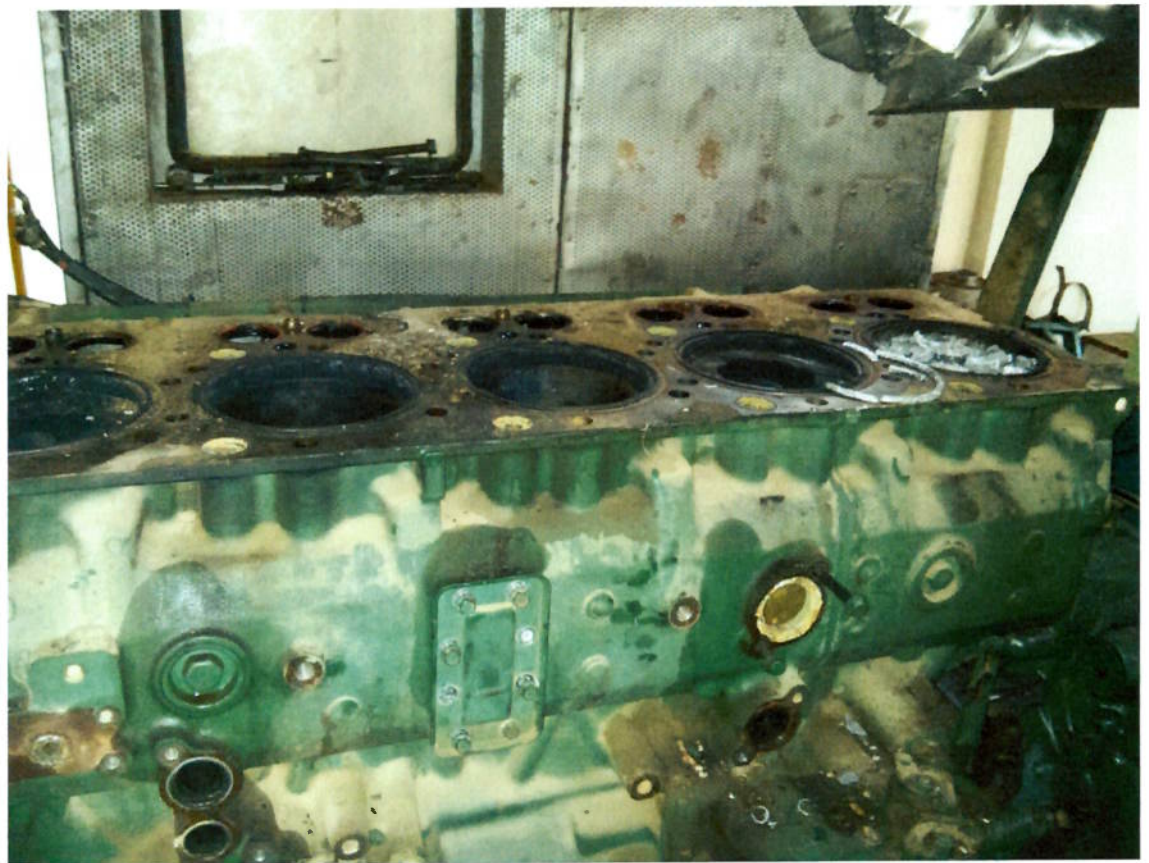
**Engine Block after Removal of Cylinder Heads**

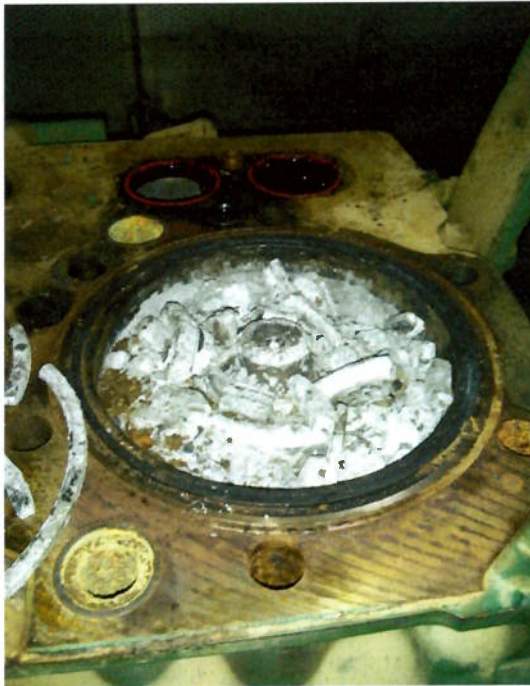
**Pieces of Top Portion of Piston No. 6**

The major damage has occurred to the Piston and the Liner No. 6. The Piston is made up of Aluminum having a melting temperature of 660 degree C. In this case, the top portion of Piston has melted and the molten material was found stuck up over the Exhaust Valves and also on the broken pieces of Piston Ring.

From the nature of damage caused to the top portion of Piston No. 6, it appears that it may be due to excessive heat generation.

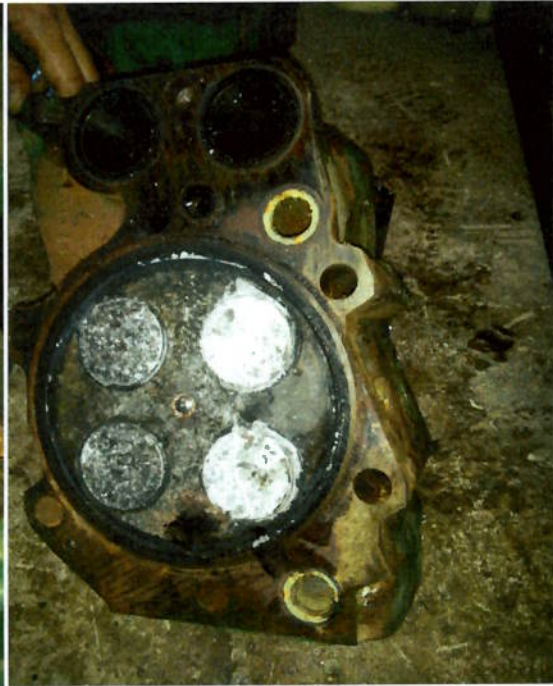
- Part of the Piston material was found stuck up on the bottom portion of Cylinder Head and Exhaust Valves.
- The top portion of Liner of Cylinder No. 6 was also found damaged. Pieces of Piston Ring were found with coating of white material of Piston.
- One Push Rod of Cylinder No. 6 found bent.
- Vertical scratch marks observed on the liners.
- Lube oil was found mixed with jacket water inside the sump. Lube oil is black in colour and with high viscosity even after running for only 174 hrs after last change.
- Lube oil starvation observed particularly on Liner No. 6 and 1.

**Cylinder Head No. 6 with Valves**

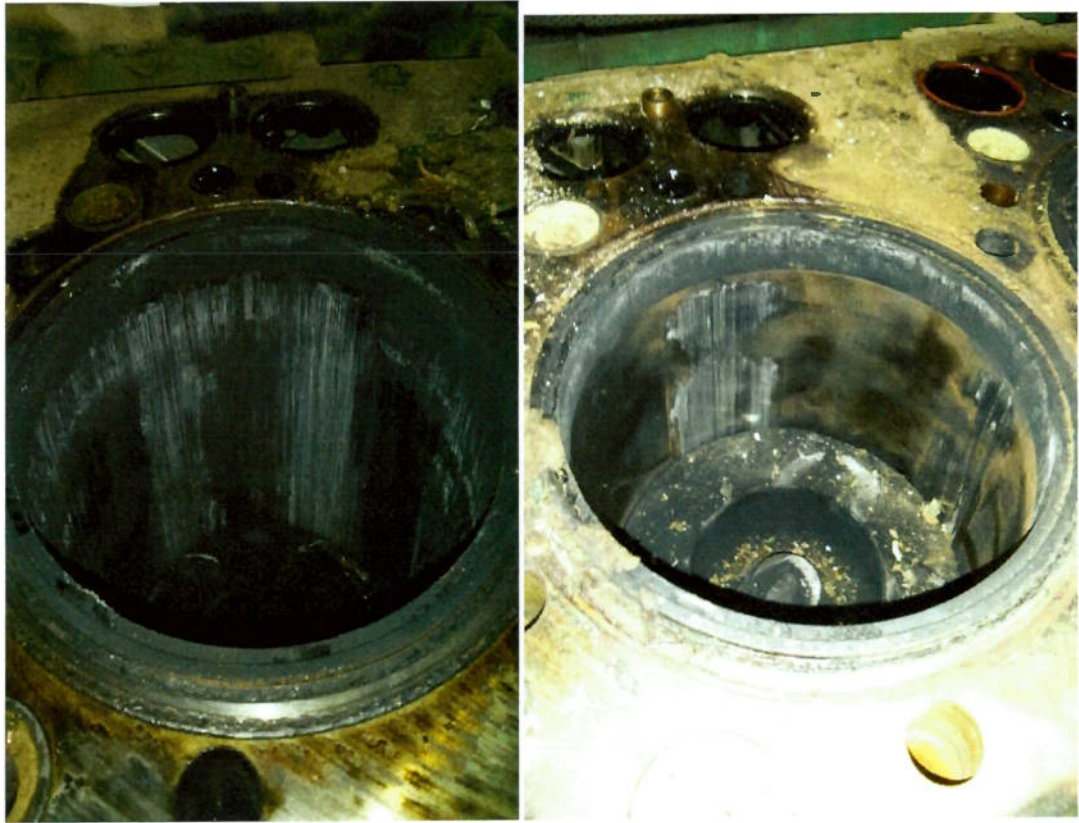
**Vertical Scratch Marks Observed on Liners.**

The several loose pieces of the Pistons & engine block casting got contaminated in the Engine lube oil system & produce scratch marks in the cylinder liner's wall of the other cylinders . Also some particle of the damage piston of cylinder head no 6 may have entered in the turbo charges through the exhaust system due to which turbo chargers rotation is not free , hence the turbo charger also needs to be replaced with new one .

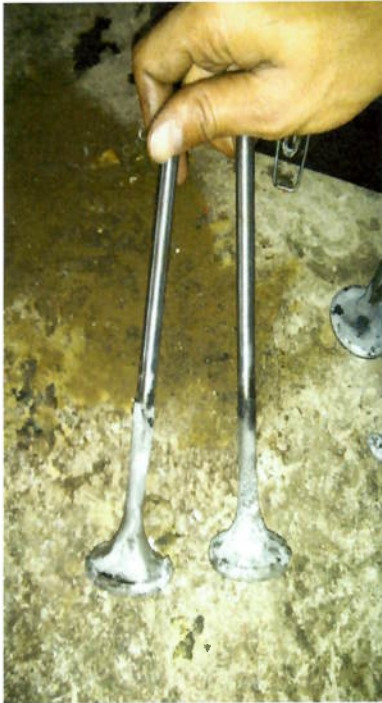
**Exhaust Valves of Cylinder No. 6**
