## **ROOT CAUSE ANALYSIS**

ANSALDO make, 1230 KW, 6.6 KV, 2984 RPM, sr. no. 10208534, Frame size- ETV 630, induction motor

## JOINT-INSPECTION

CUSTOMER NAME: I.O.C.L. PRRPL, JATNI, ODISHA

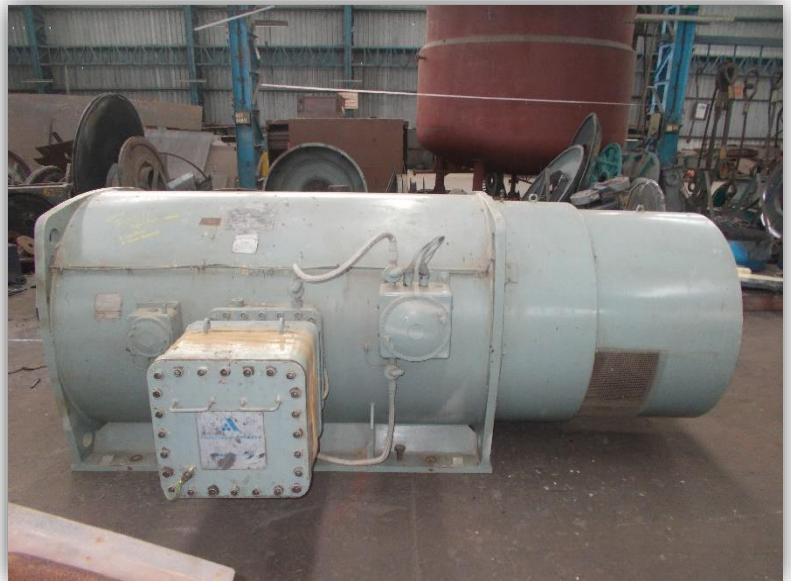
- Inner bearing cover found damage and rubbing observed on rotor shaft.

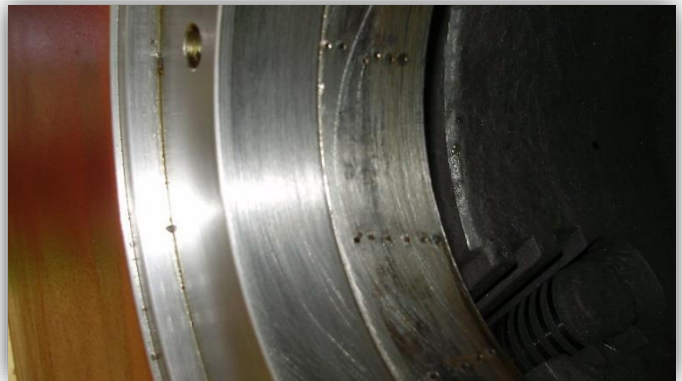
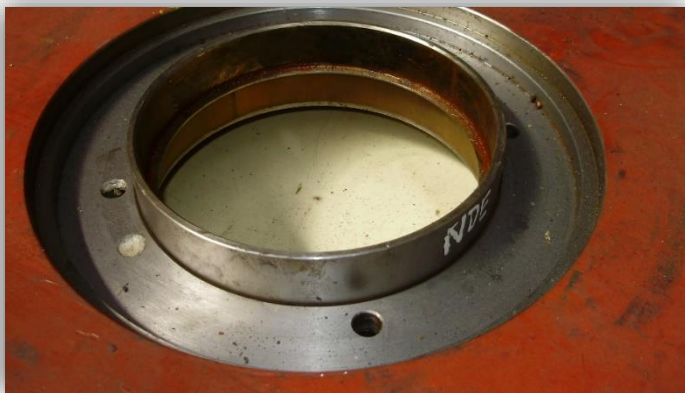
- Dent mark observed on coupling seat.
- DE side bearing found loose on shaft seat and found groove marked on shaft seat.
- DE side IBC seat found rubbed and damaged.

- NDE side bearing found loose on shaft seat.
- NDE side external fan found loose on shaft seat.

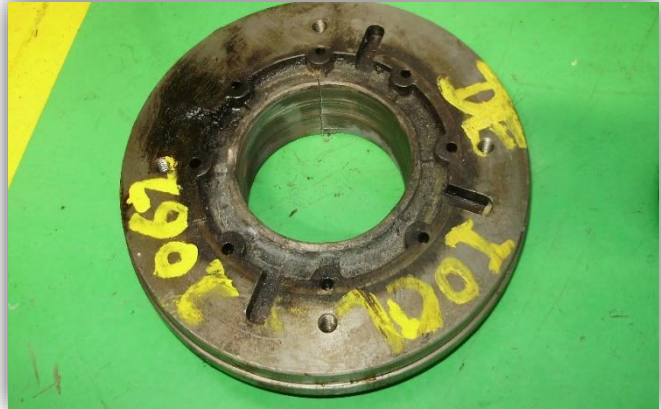
- DE side IBC found rubbed, cracked and damage.
- Dent mark observed on DE side labyrinth.

- The main cause of failure of rubbing of IBC on rotor shaft is due to shaft bearing seat worn out. DE and NDE bearing housing which lead to looseness in totality and reduce clearance between IBC inner dia. And shaft IBC seat area.
- Poor workmanship observed during previous job of motor overhauling.
- The IBC was found cracked and damaged the shaft seat due to overheat of the motor.
- The IBC was found rubbed on rotor shaft seat because of improper clearance of bearing seat on shaft.
- Misalignment and looseness also lead to increase of vibration of motor.
- The bearing found loose on shaft seat can cause generate the excessive heat and stress.

- Required to be completely overhauling of motor.
- All damaged parts to be replace by new.
- Proper measurement to be carried out of motor and maintained the proper tolerance and clearances of the shaft and end shield housing cover.
