PLHO/ MNT/MECH/05

Date: 08.08.2018

Sub: Brief report on breakdown of MP-1 SMPL Abu Road due to failure of cylinder head inlet valve

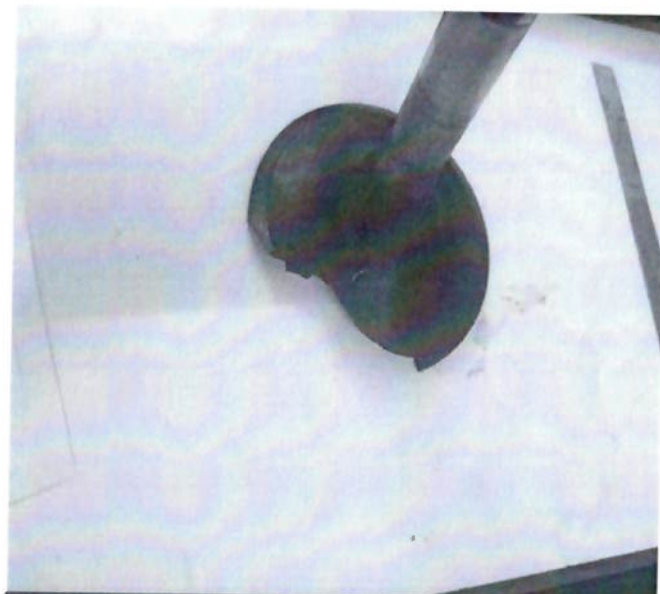
**Broken Inlet valve**
