Pipeline Head Office  
Maintenance Department

PLHO/MNT/MECH/05

August 31, 2017

**Sub: Inspection and analysis report on failure of MP-1 MJPL Mathura**

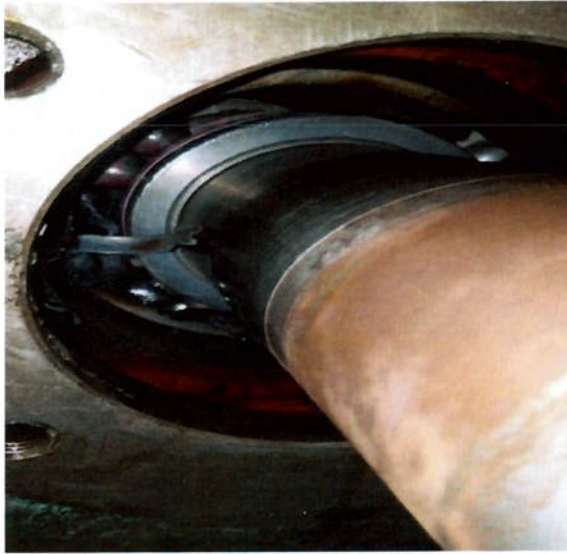
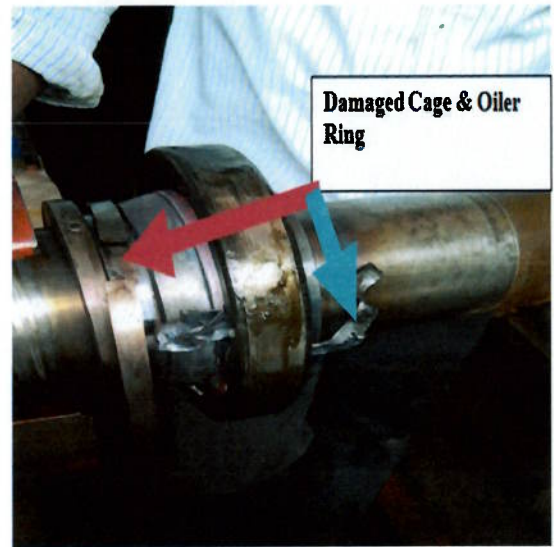
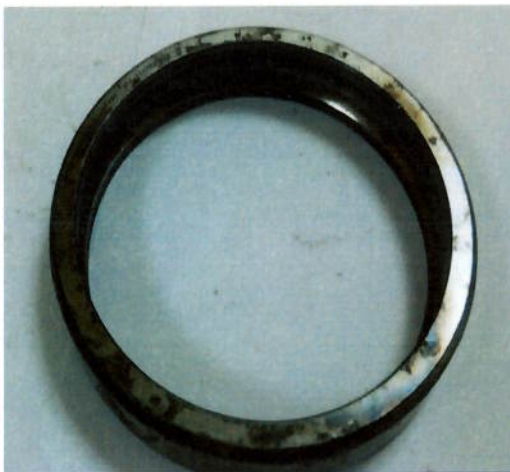
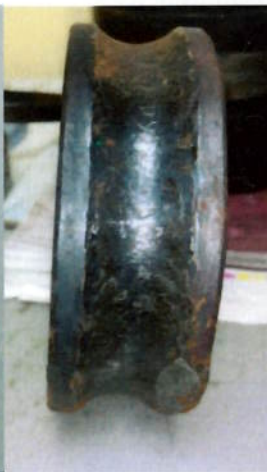
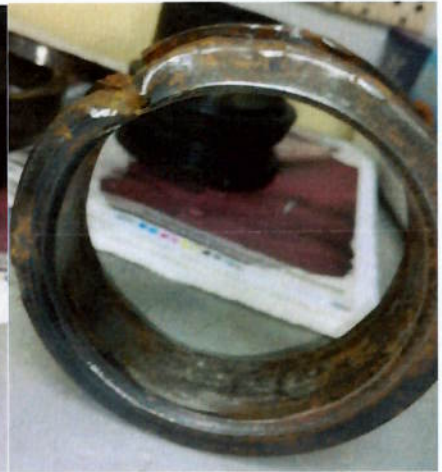
5. Bluish heat marks were observed on the inner & outer cage surface and also found deformed. Oiler ring was found damaged. Inner race of ball bearing can only be removed from the sleeve after being cut manually.

- From the above details it is inferred that the breakdown of MP1 MJPL Mathura occurred due to failure of pump DE side ball bearing and bearing failure was due to starvation of lubricant oil in bearing.
- DE side pump bearing data indicates rise in bearing temperature started around 00:00 hrs and first stage alarm at 00:35:41 hrs. The temperature rise pattern indicates lack of lubrication.
- After failure of ball bearing the rubbing between stationary and rotatory components of rotor assembly have taken place.
- Further, previous data indicates persistence of high, more than 14mm/sec and vibration level in DE side of pump which may also have contributed to bearing cage failure.
- An alarm based on rate of rise in bearing temperature will be helpful in averting such incidence.

- There is substantial indication to infer that bearing failure was caused by lack of lubricating oil aided by high vibration.
- The recording about lube oil top up in pumps should be a regular practice to enable monitoring of lube oil quality, quantity and top up frequency.

- The lube oil top up record to be checked by shift officer in regular interval to check the lube oil is being consumed in regular pattern. In case oil level remains constant for some time, the oil flow must be checked for any suspected blockage.
- The presence of high vibration especially in the DE side over prolonged time needs to be analyzed along with supports in the suction & discharge arm.
- After such failure we should preserve lubricating medium and damaged components for testing and analysis to establish the initiation of failure.

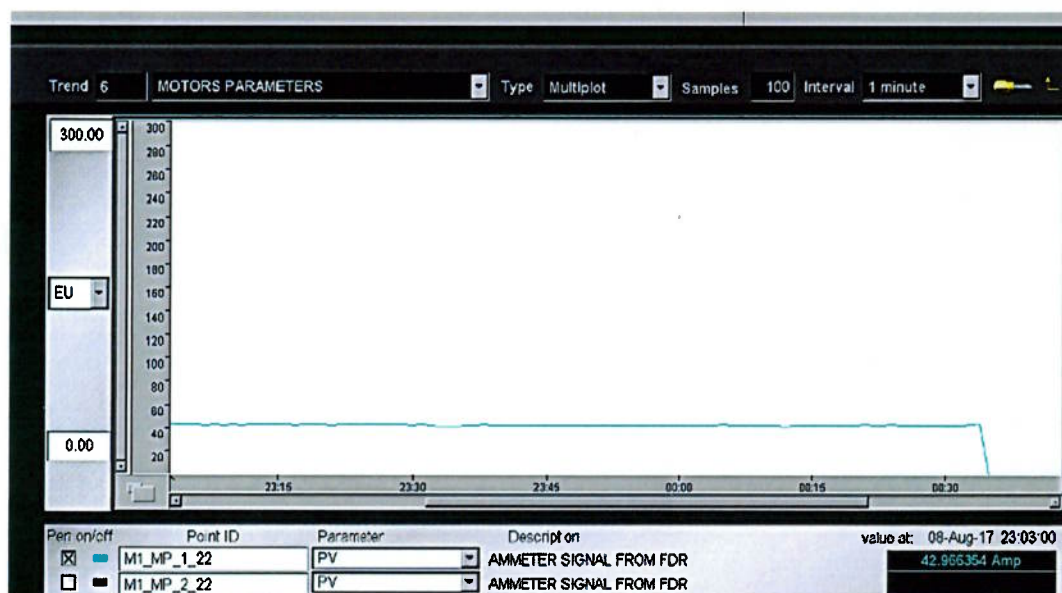
8. Balls and cage of DE side pump Ball bearing were not found hence could not be inspected for physical condition.
9. Oil was found in the bearing sump and constant oil leveler. Prior to this failure no abnormality was reported or found. However oil top up details and records were not found in station.
10. Motor current trend placed below indicates that the there is no variation in the current of the motor ie load.
