## **REPORT ON TURBOCHARGER FAILURE AT RAJOLA**

**SUB : Report of damage of Turbocharger of MP-2 on dt.  
28.12.2013**

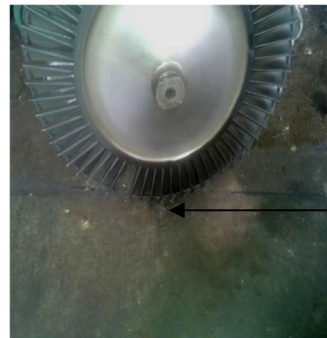
- One blade of T/C turbine was blown off. Remnants of the blade were also not found.
- A scratch mark on the periphery of stationary nozzle towards turbine entry was found.
- Turbine seal end bush got cracked (snaps attached)
- Impeller (Compressor wheel) got damaged (snap attached)
- Bush bearings and seal rings of both side badly affected.
- Rubbing marks of the face of thrust collar also appeared.

One tooth of turbine blades damaged

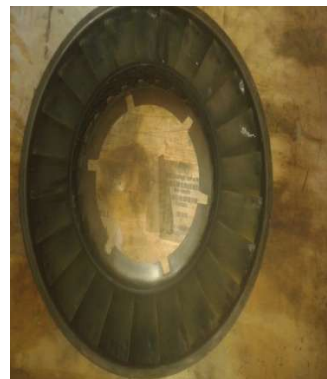
Scratch mark appeared on the periphery

After opening the stationary nozzle from double entry, it was found that other side (towards exhaust pipe) of the stationary ring was in perfectly good condition.

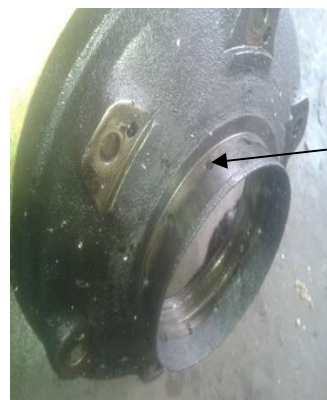
Crack appeared on the this position of turbine seal end

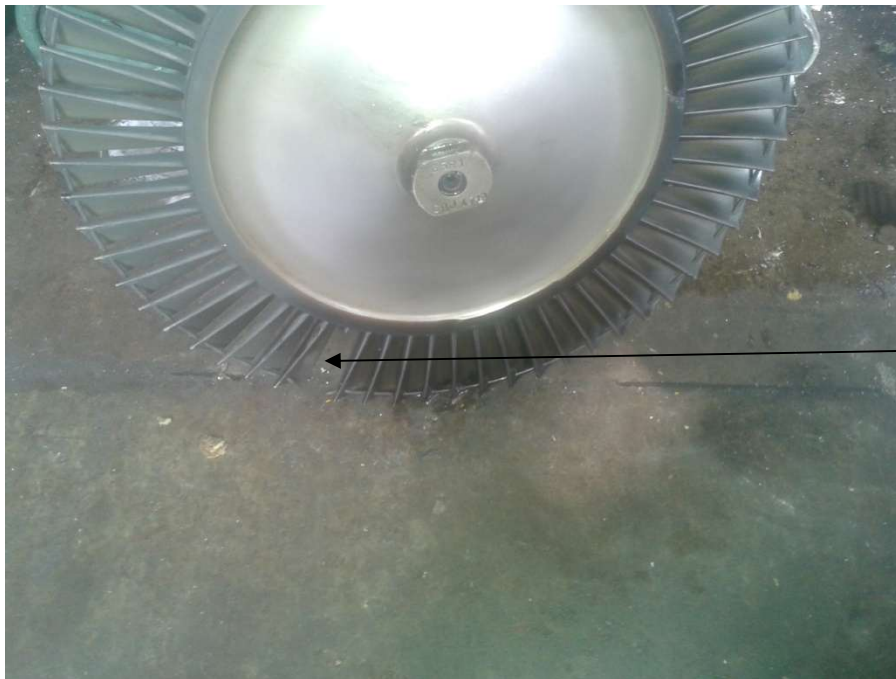
At Rajola, the rotor assembly is inspected by dynamic balancing at every 9000 hours and so far the turbocharger has performed well despite running beyond 48000 hrs. But with the use the rotor blades might have been fatigued and failed. The blades which are subjected to maximum stress have failed on fatigue and sheared off from the root and further damaged the other parts.

One teeth of turbine blades damaged along with lancing wire

1. New Rotor assembly along with thrust Collar  
No. depicted as follows  
[Turbine rotor shaft (New )  
BJ 4026/69/416796  
BJ 4126/07/5/909612 Aug.'13  
Comp. wheel ( New ) Dec.'13]
2. Nozzle assembly
3. Bearing of both side
4. Seal ring of both side
5. Seal ring bush of both side
6. Labyrinth seal plate and its peelable shim

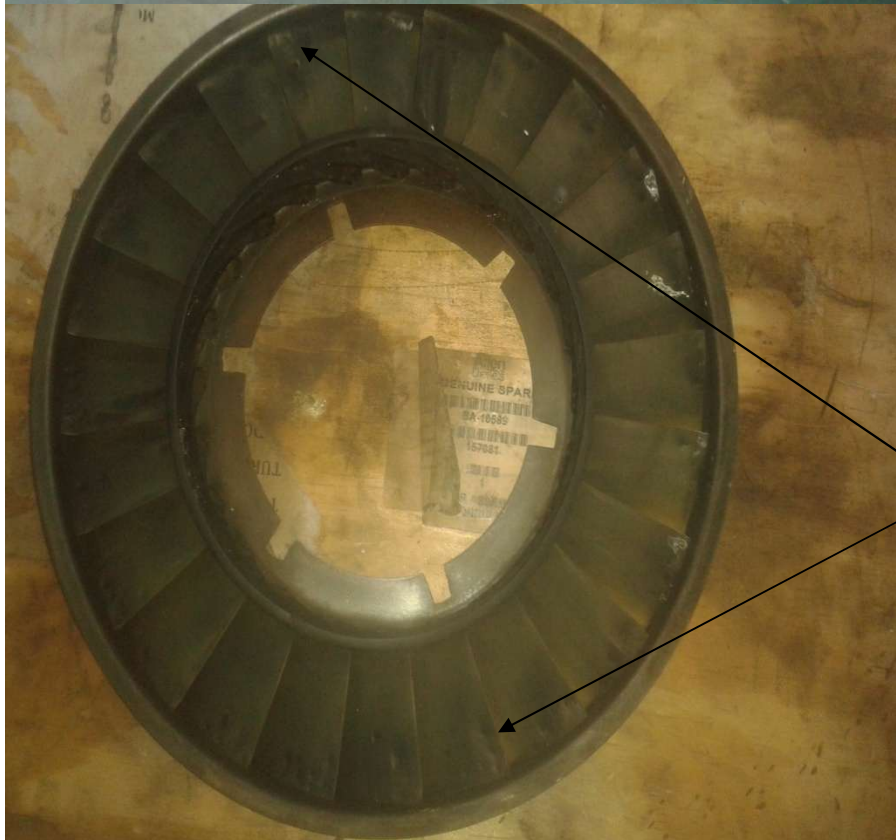
Scratch mark appeared on the periphery of nozzle assembly.

After opening the stationary nozzle from double entry, it was found that other side (towards exhaust pipe) of the stationary ring was in perfectly good condition.

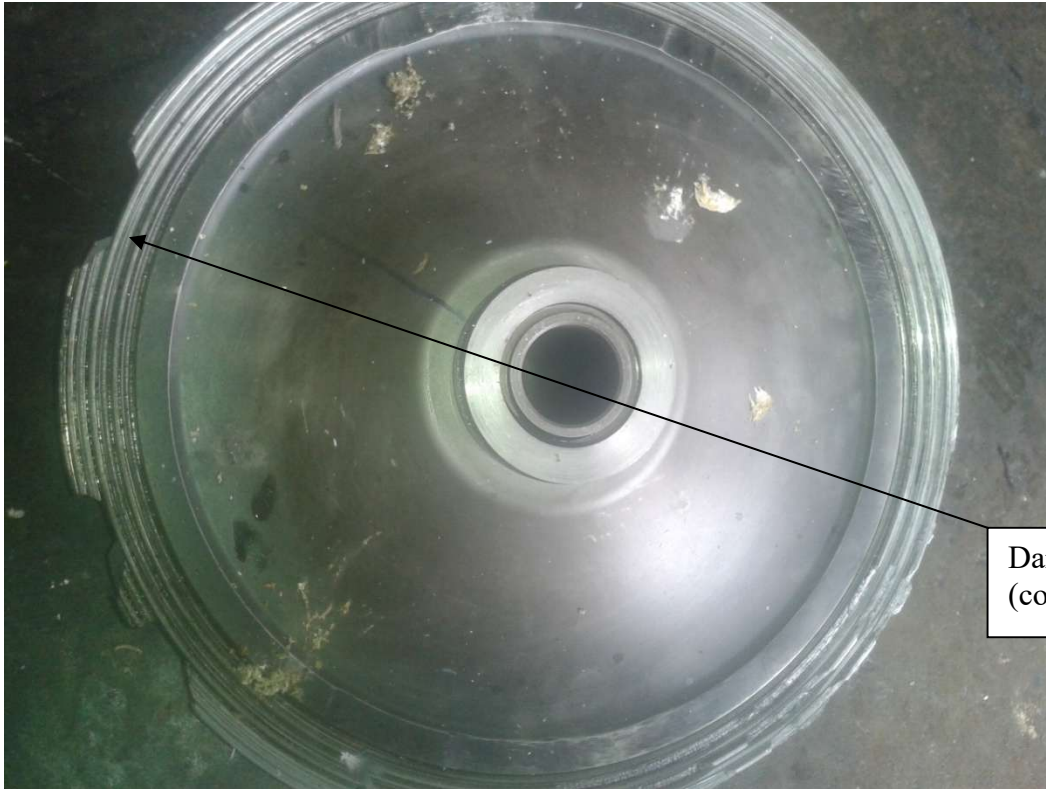
Damaged impeller  
(compressor wheel)

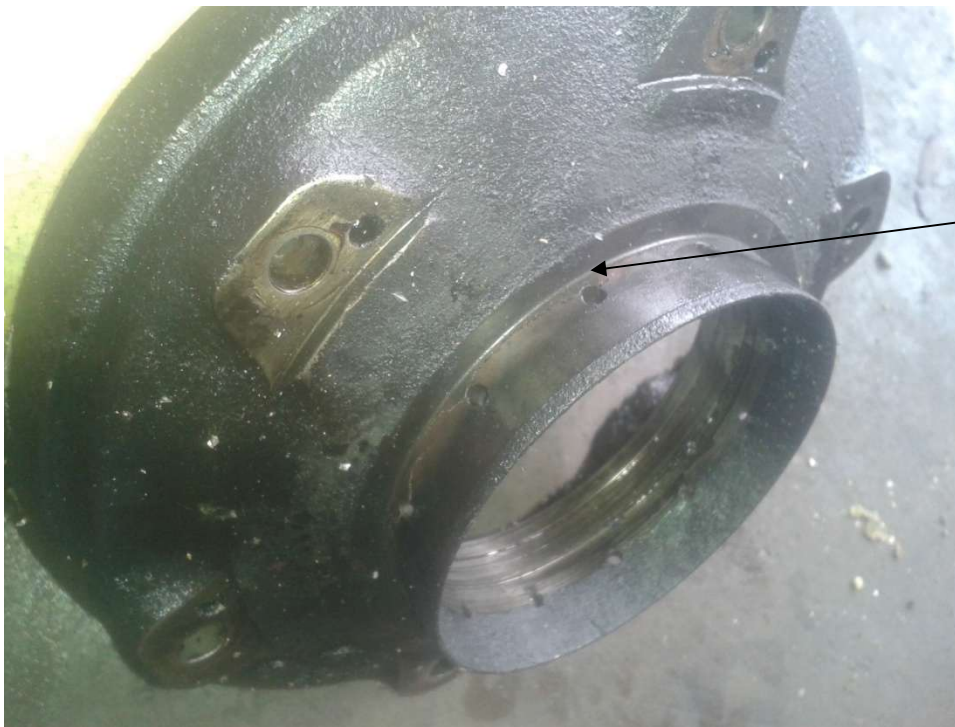
Crack appeared on  
the this position of  
turbine end bush
