## STATUS REPORT of MP1 MPPL Kot TURBOCHARGER FAILURE ANALYSIS

| Purpose of Report: | Management Appraisal and Root cause Analysis | Problem Reported | Abnormal Sound observed during trial of MP-1 |
| | | Date of Report | 22.03.2021 |

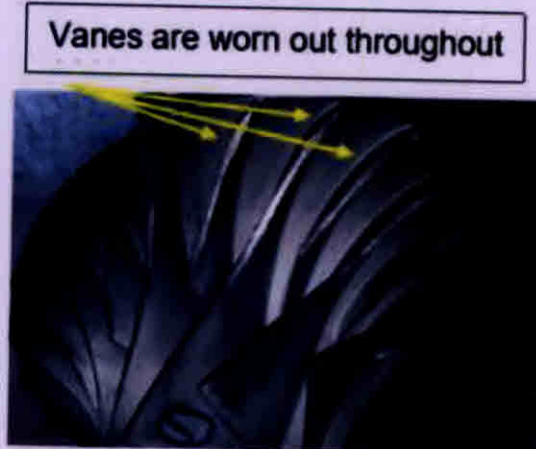
Picture 2: - Compressor wheel

Vaness are worn out in between impeller and inducer section due to that profile

1. Compressor wheel, thrust collar and compressor cone were replaced.
2. Glass bead cleaning of Turbine and dynamic balancing of rotor assembly was also carried out.
3. Clearances were again maintained within prescribed limits and crosschecked.
4. Turbo assembly was again assembled and put into place.
5. Lube oil pump bearings were also replaced.
6. Engine trial was again taken 20.03.2021 and turbo was found in good condition.
