### **Brief report of New Booster Pump-01 seal failure at WRPL Viramgam under SMPL DBL Project**

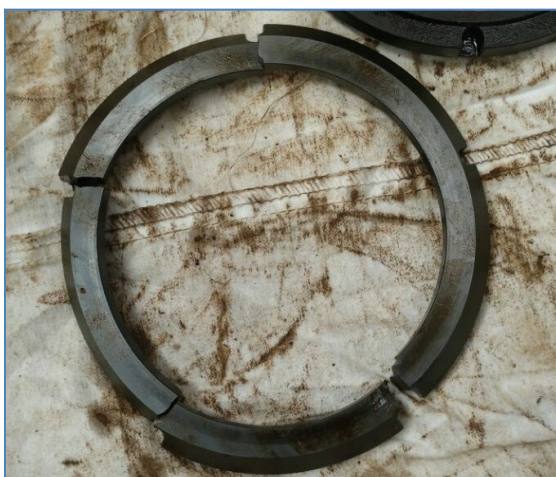
2. During commission under DBN project, Total 2 nos. of complete cartridge type mechanical seal for BP-1 & BP-2 received and used in BP-02 breakdown occurred earlier on 17.02.2017. Therefore the mechanical seal spares for higher capacity pump (BP1 & BP2) was nil and BP-01 was not-available till 17.03.2107. However simultaneously local seal was fabricated by M/s Apex. The same was fitted and trial run taken on 18.03.2017 but after running of only 9 hrs , the seal was again failed and found completely broken as shown in figure-1.

**Fig-01 : Carbon completely broken**

3. Pump was again not available till 06.04.2017. However instead of silicon carbide, tungsten carbide seal was fabricated and fitted on 06.04.2017 but again seal failed after installation. Pump is not available since then.

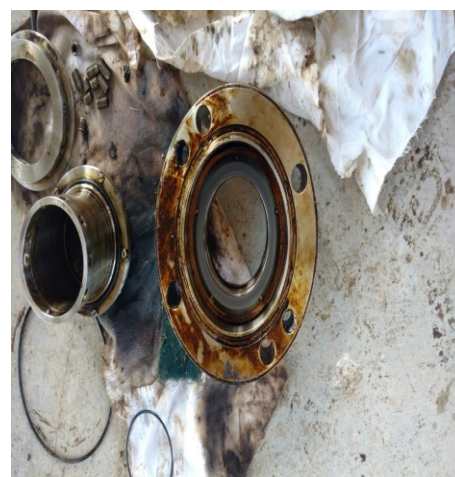
1. On 01.03.2017, seal failure on BP-01 has been reported after cumulative running of 160 hrs when pump was not running. After dismantling, stationary part of seal silicon carbide got completely damaged.

**Fig-02 : Seal failure**

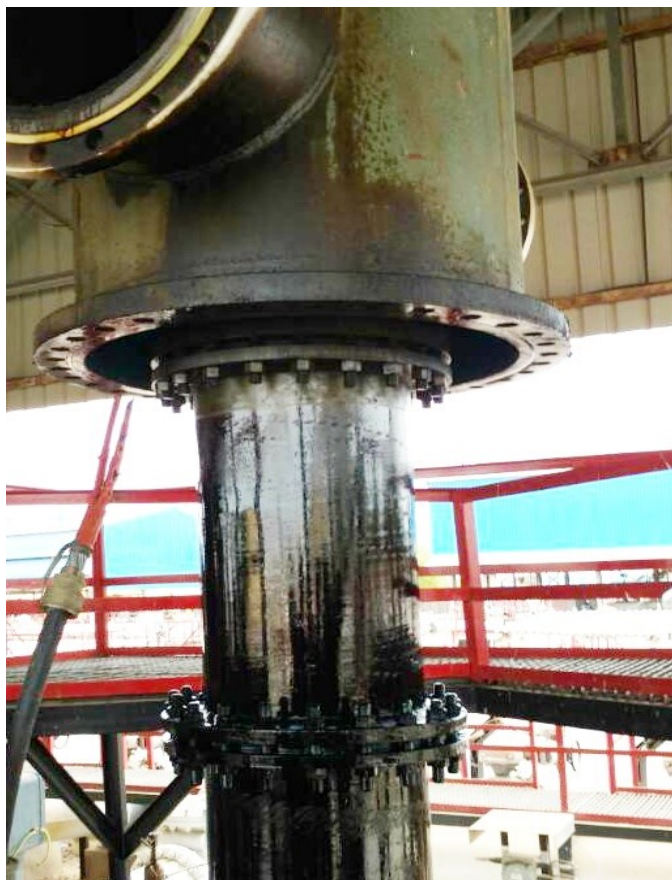
**Fig-03 : Dismantling of Booster at Site**

1. Pump and motor assembly dismantled.
2. Mechanical seal dismantled.
3. Complete pump shaft assembly was not able to lift as height of pump is 19 Ft (5.8 m) which is more than the effective lift (4.6 m of the EOT crane).
4. It was decided to dismantle the pump shaft in parts.
5. Clamps are locally fabricated to hold the part shaft.
6. Pump shaft was dismantled in three parts.
7. Pump shaft with 2 stage impeller along with part shafts and spares sent to M/s Allwyn Industries for further maintenance on 07.06.2017.

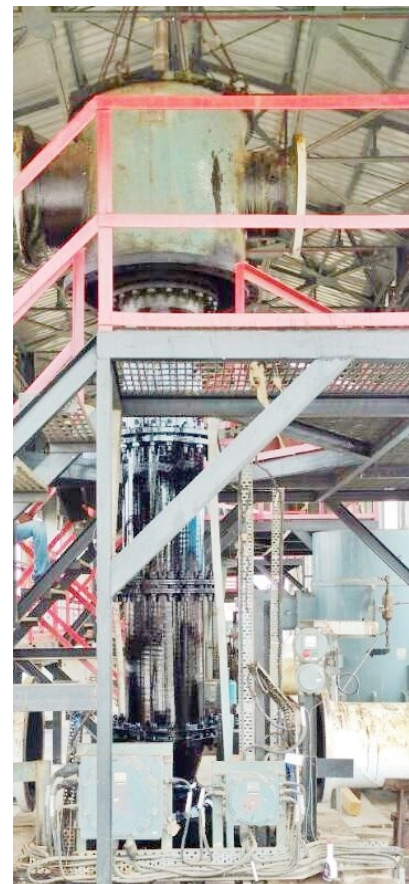
**Fig-04 : Main shaft removal**

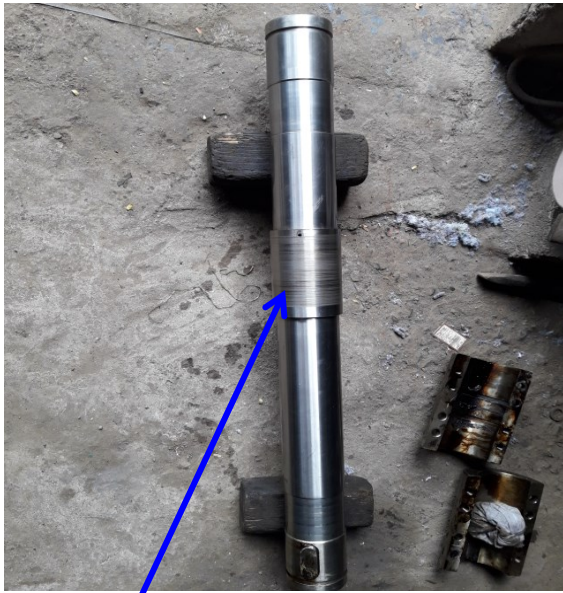
| S.N. | Service description | Maintenance description |
|---|---|---|
| 5. | <b><u>Checking of shafts</u></b> | Scoring marking & uneven marking was also observed in different segments of shaft. Polishing done. |

**Fig-05 : Scouring marks on shaft**

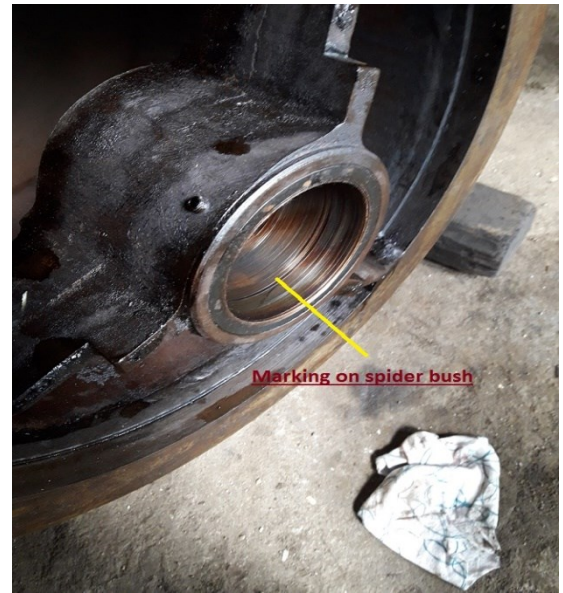
| S.N. | Service description | Maintenance description |
|---|---|---|
| 6. | <b><u>Spider Bush</u></b><br>a) <b><u>Spool part</u></b><br>b) <b><u>Pump lower part</u></b> | Spider bush was found damaged (concentric marking on inner side- Photograph attached)<br>a) 3 Nos. of spider bush of spool found excessive scouring marks so these bushes are newly fabricated and fitted . Clearance between sleeve and bush was kept in the range of 0.17 mm to 0.22 mm.<br>b) Light scouring marks found on 3 nos. of spider bush in lower part of pump therefore boring and machining of spider bush done and simultaneously metallizing of shaft done. |

**Fig-06 : Marking on Spider Bush**

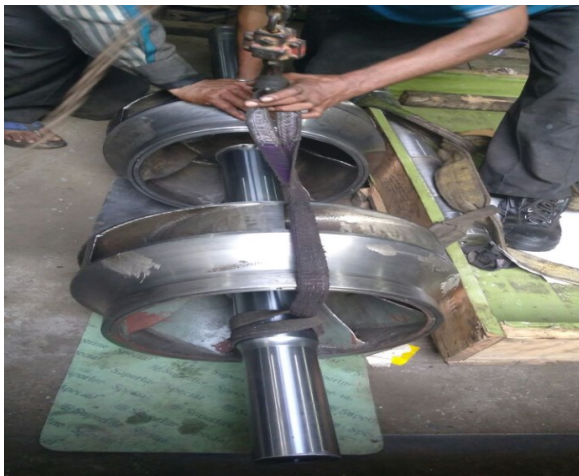
**Fig-07 : Pump rotor assembly after repair**

| S.N. | Service description | Maintenance description |
|---|---|---|
| 10. | <b><u>Dynamic Balancing</u></b> | Dynamic balancing of pump rotor assembly, shaft with hub and coupling done after repairing and found within limits |

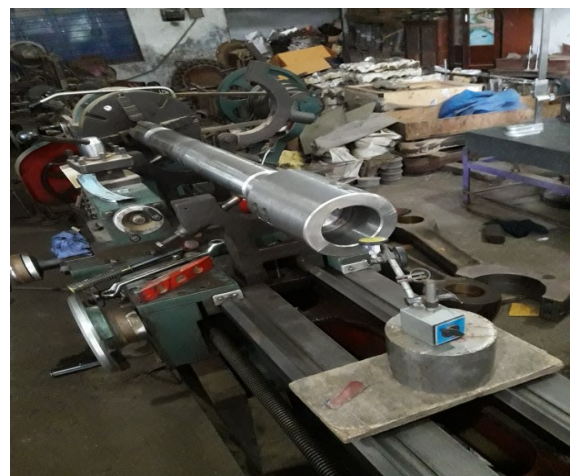
| S.N. | Service description | Maintenance description |
|---|---|---|
| 4. | <b><u>Muff Couplings</u></b> | Run out of all 4 Muff couplings found to be from 0.45 mm to 0.65 mm. Run-out in muff coupling was one of the probable reason of seal leakage as it acts a power transmitting media between the shafts. Therefore repairing done to remove run-out and further inspection of muff coupling was carried out on lathe machine and found OK. |

**Fig-08 : Muff Coupling run out checking**

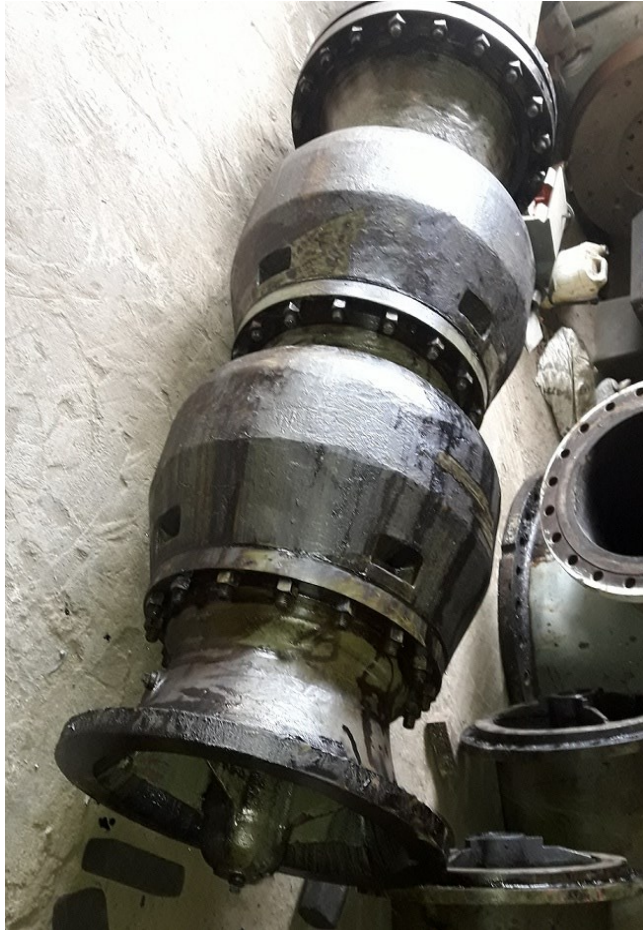
**Fig-09 : Pump rotor assembly before repairing**

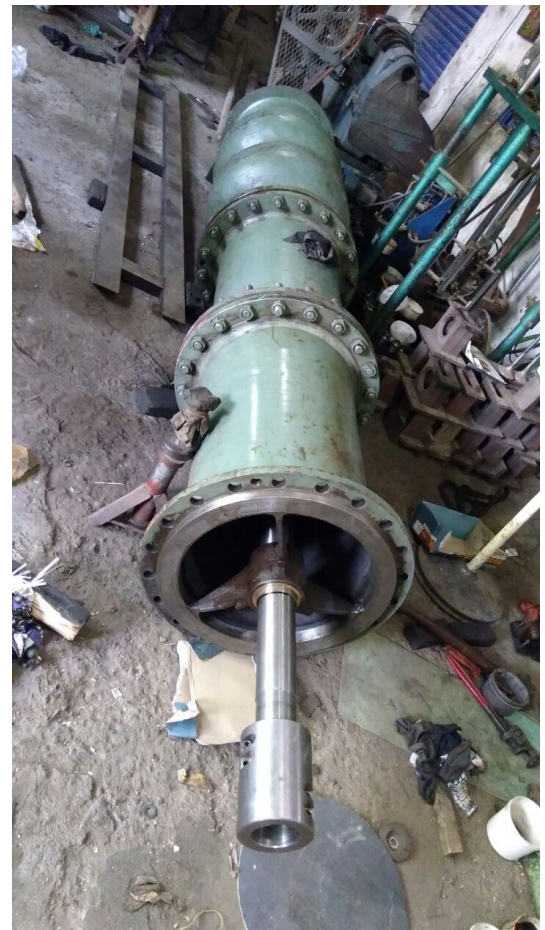
**Fig-10 : Pump assembly after maintenance**

- Maintenance activities started from 17.07.2017 at Viramgam station. Pump having main impeller shaft casing, 3 intermediate shafts spool pieces & header shaft housing fitted till 22.07.2017.
- Installation of Booster pump after repairing got delayed due to adverse weather condition at Viramgam.
- After installation of motor, mechanical seal (Make- Eagle Burgmann) fitted. Load trial of NBP-1 taken and all parameters found normal..
