**Subject: Long term solution of water leakage problem of MP1 MPPL Abu Road**

Sub : Permanent solution to water leakage from cylinder block of MP1 MPPL, Aburoad

**Sub: Cracks found in entablature of MP-1 where liner collar lands**

## **Brief Report on Rectification of Water Leakage from** **Entablature of MP-1 MPPL Abu Road**

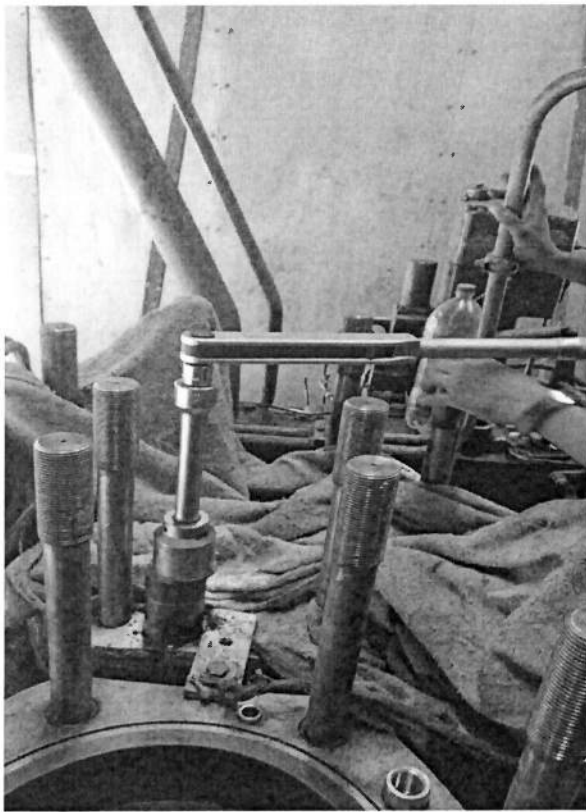
Figure 1 : Removal of sleeves by jacking

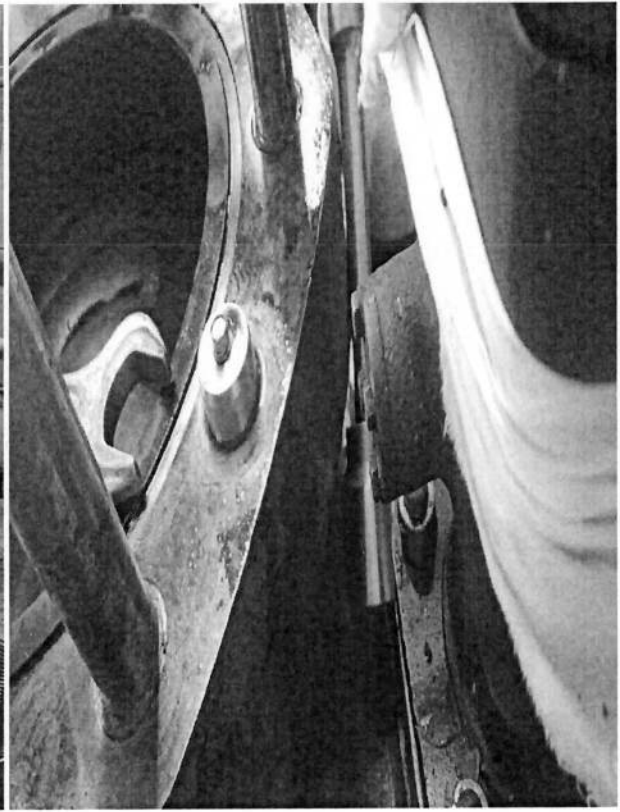
Figure 2: Broken stud being used for jacking

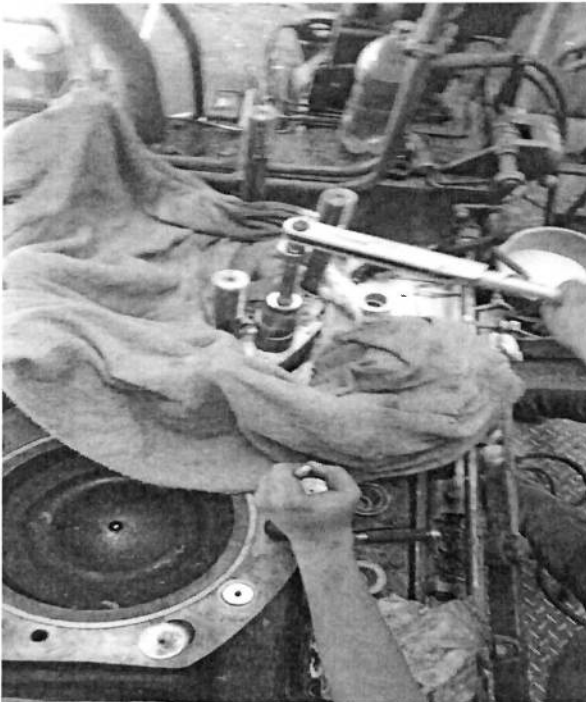
Figure 3: Removal of sleeves by jacking

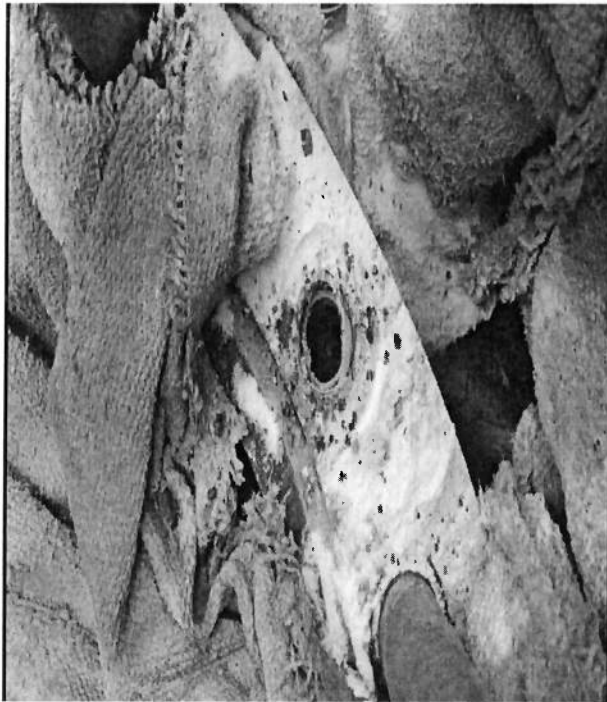
Figure 5: Safety precautions before welding

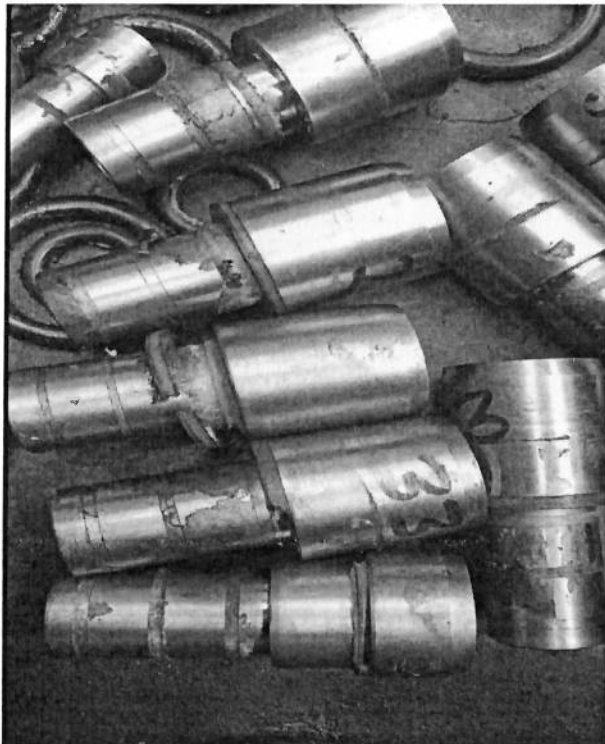
Figure 7: Sleeves retrieved from engine block

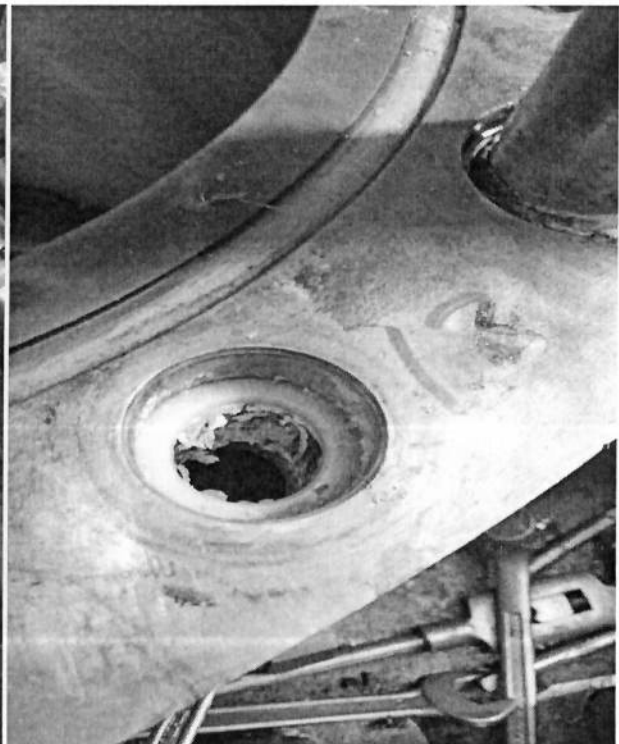
Figure 8: water transfer hole after sleeve removal

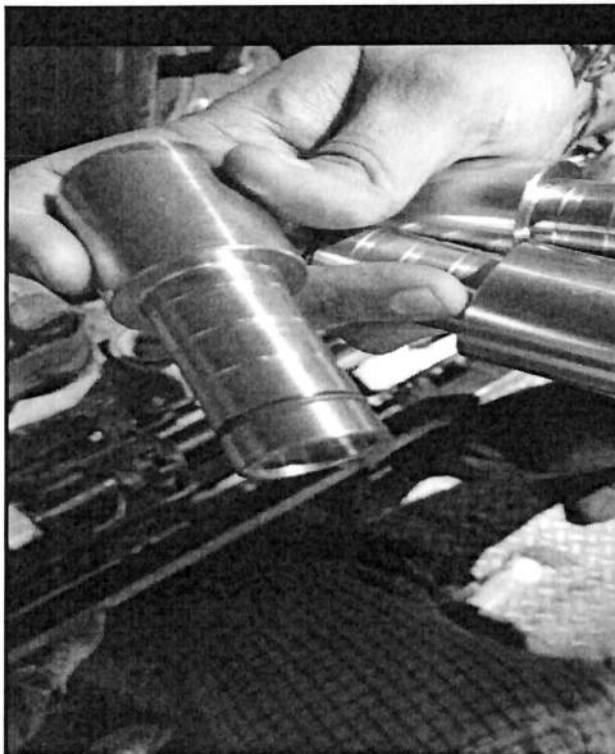
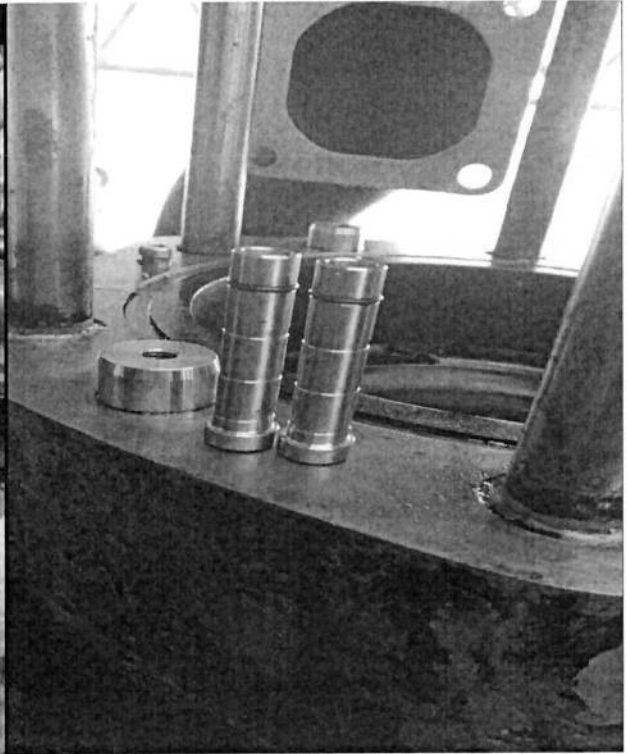
Figure 9: Water transfer sleeve with O-ring

Figure 10: Water transfer sleeve with O-ring
