**Report of BP-01 Major Overhauling  
Work at WRPL VIRAMGAM  
July-2020**

## **BP-01, Pump Bearing Temperature High Problem at WRPL**

### **Viramgam**

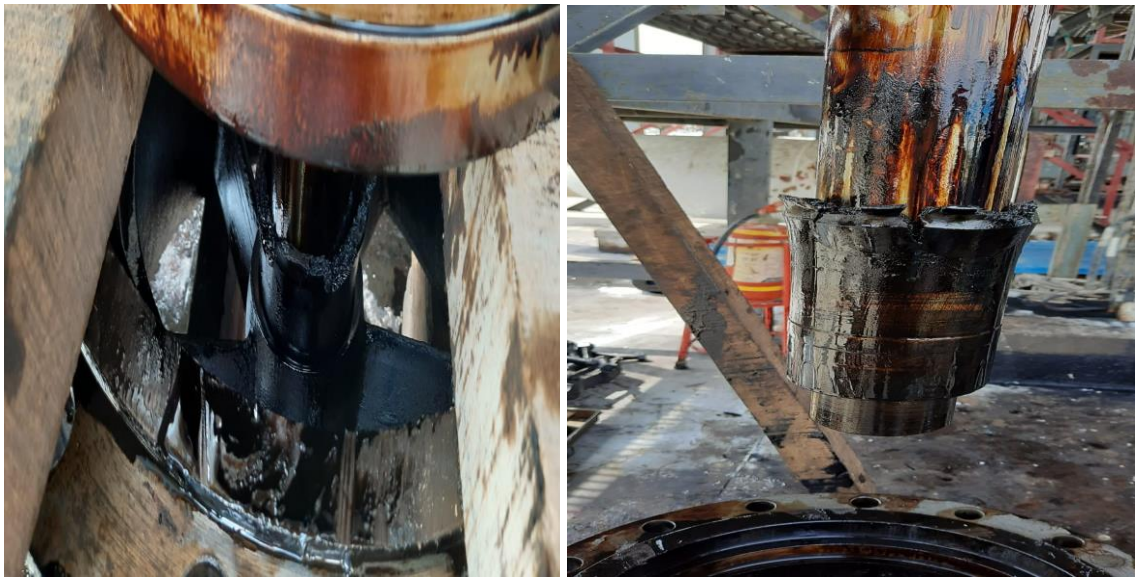
- 2nos. of sleeve found in loose condition.
- Bottom end bush found damaged.

**Suction bell bush found damage**

- Impellers (02 no's) checked and found 1st stage impeller have minor hair crack in vein, welding was done and balancing of both impeller were carried out.
- Impellers wear ring and case wear rings was found ok within limit.
- Dynamic Balancing of all the rotary parts, UT of Shaft, Case Wear ring, Impeller Wear and Sleeve carried out.
- Fabrication of one Gun metal bush done and fitted at pump suction lower part (suction bell) with nitrogen cooling.
- After Repair of Pump, pump installation done and trail taken on 23.07.2020.

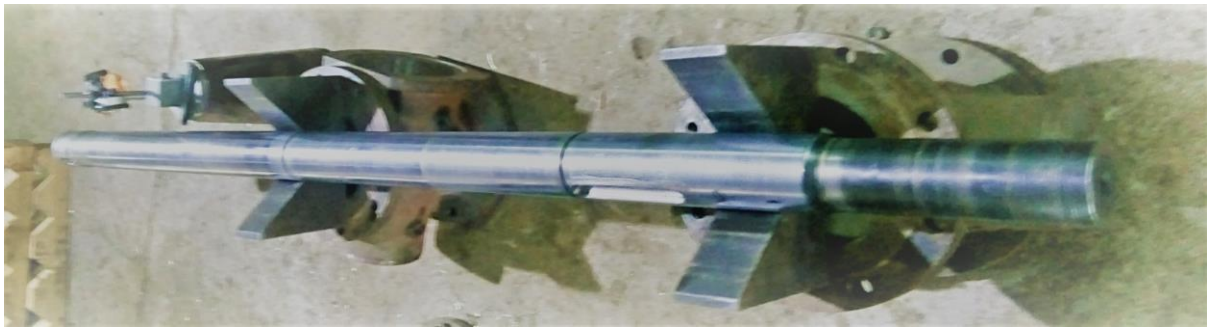
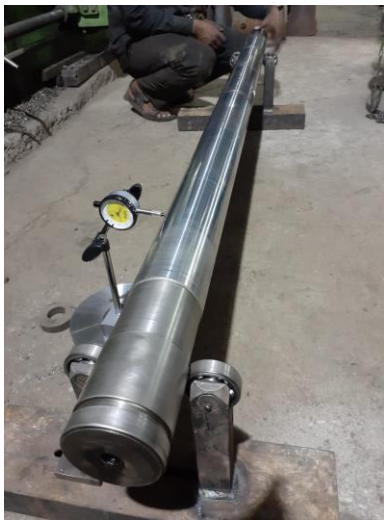
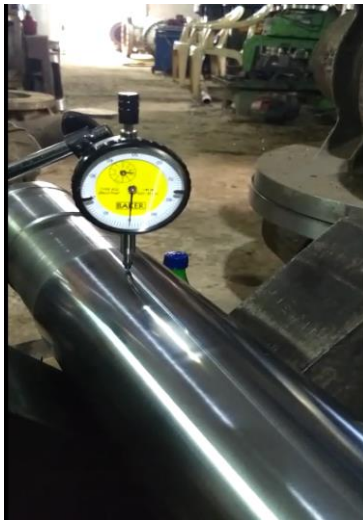
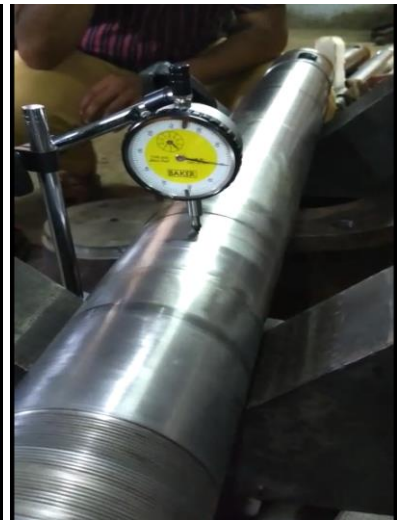
Shaft straightness checking on V-blocks.

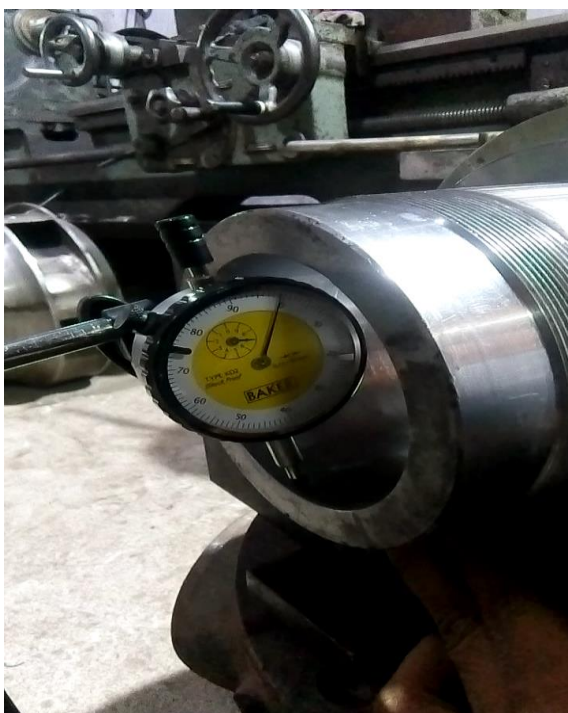
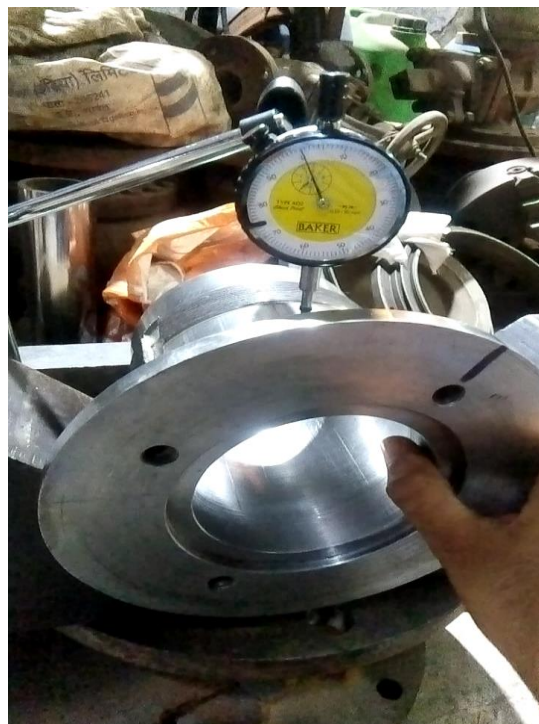
### Checking of Bearing Housing Sleeve.

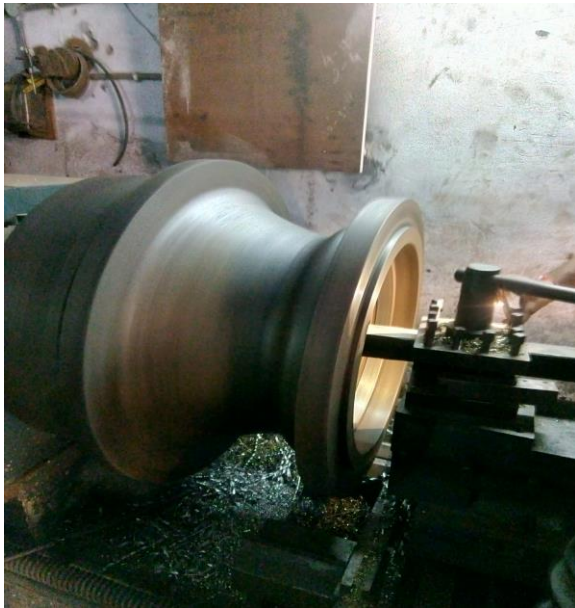
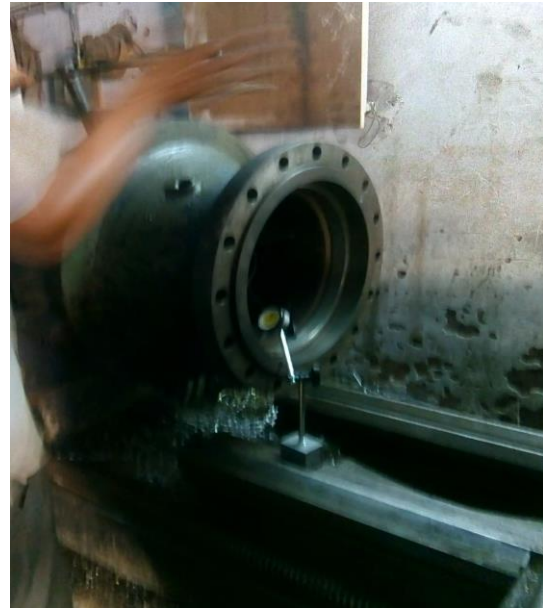
### Suction Bell machining work

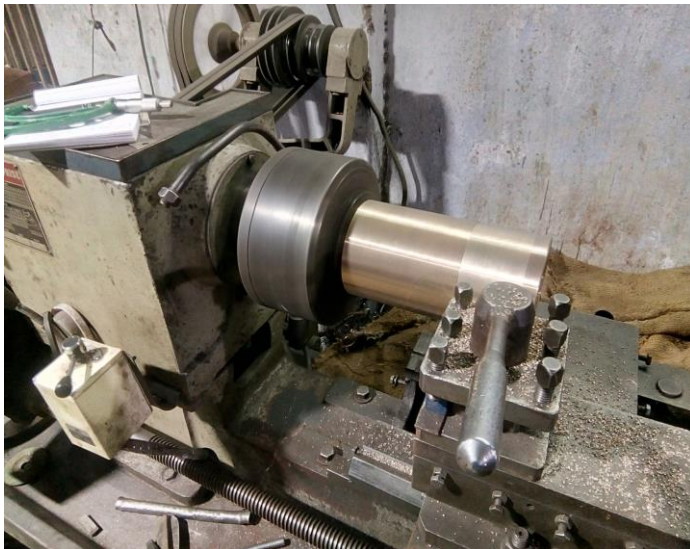
### Machining of Gun metal bush

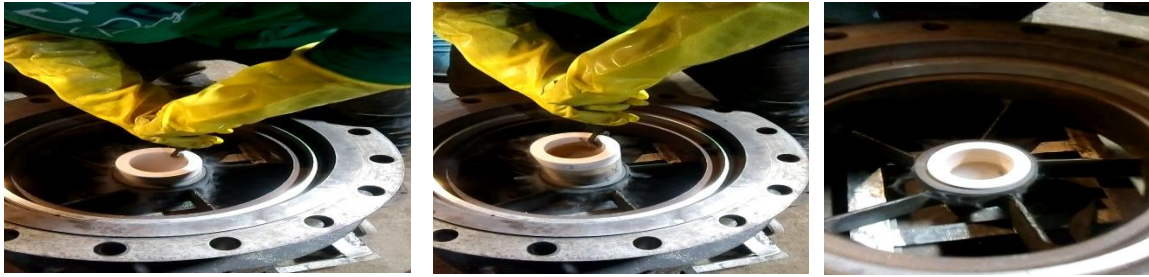
**Gun metal Bush shrink fitting process using Liquid Nitrogen into suction bell**

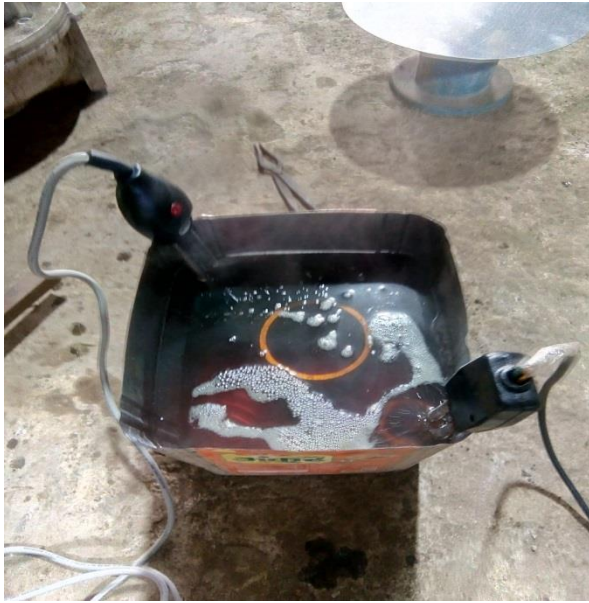
Shaft sleeve interference fit 0.05 mm oil heat process (Shaft OD=89.87, Bush ID 89.82)

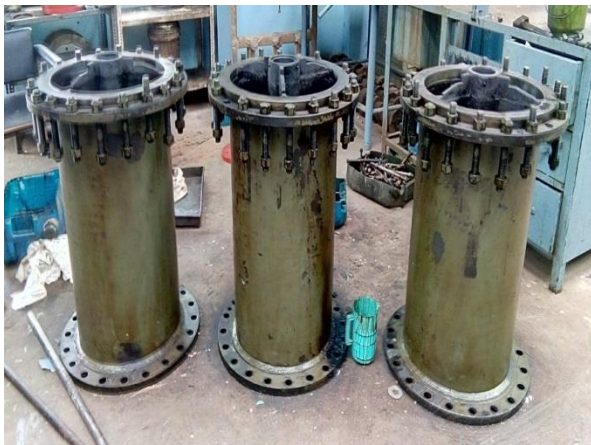
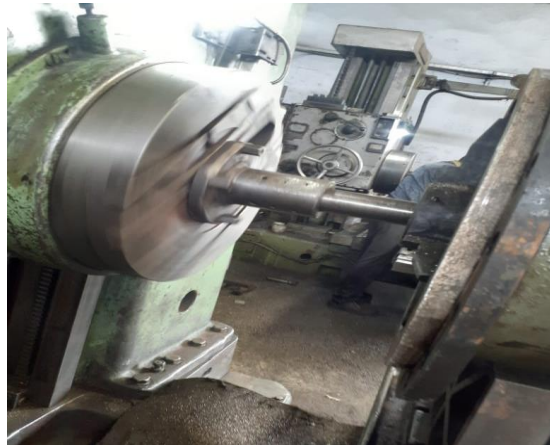
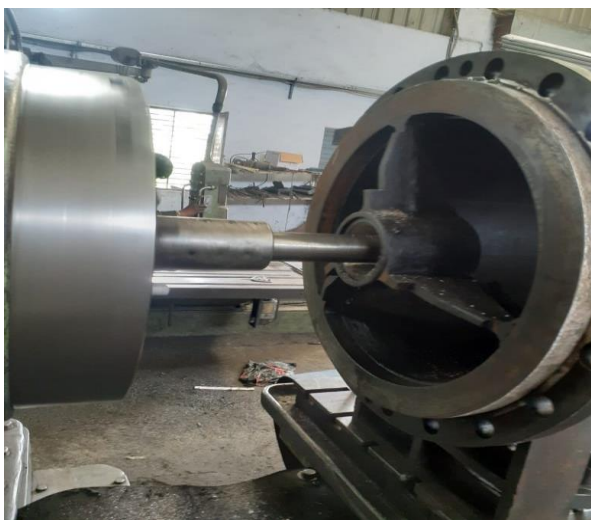
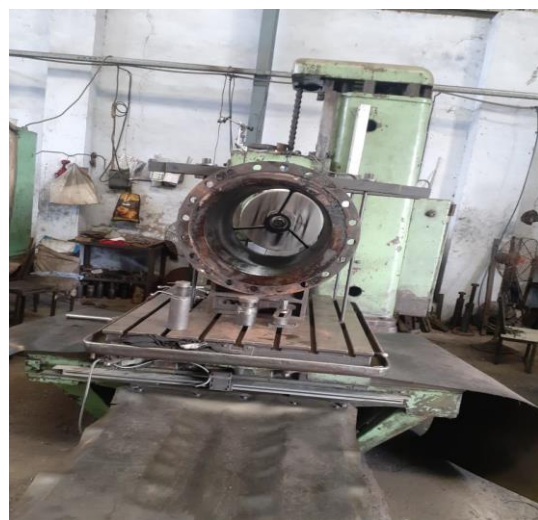
Transmission Column bush machining work
