**Sub: Investigation report on Breakdown of MP-2 at SMPL Sidhpur**

## COMMITTEE REPORT ON THE FAILURE OF MP2 AT SMPL, SIDHPUR.

**DETAILED REPORT ON THE FAILURE OF MP-2 OF SMPL, SIDHPUR****1. Preamble:**

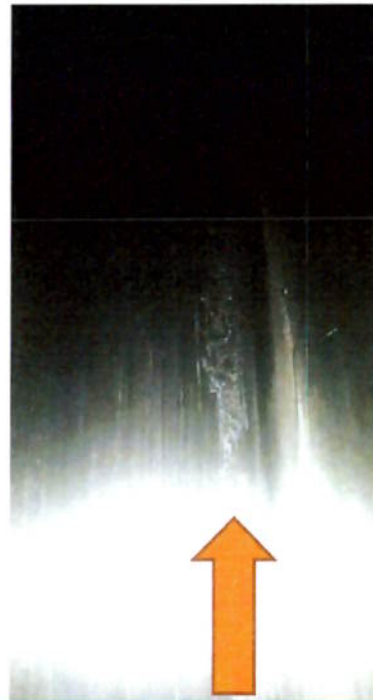
**Babbitt metal stuck on crank pin**

- 8) Crank pin-2 was inspected and white metal of the big end bearing was found stuck over the crank pin and scouring marks were observed. Cleaning of the same is under progress. Crank pin hole was checked and found normal.

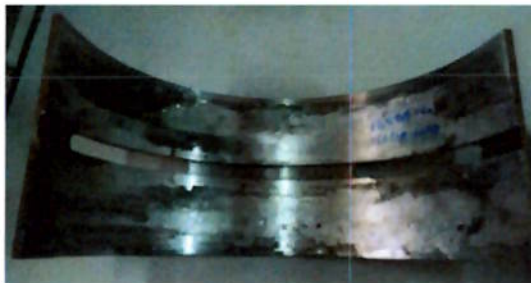
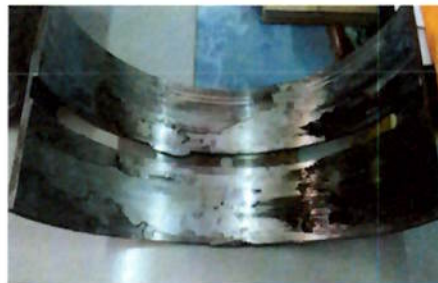
**Scoring and heat marks on Connecting Rod & Crank Pin ( Cy.No.2)**

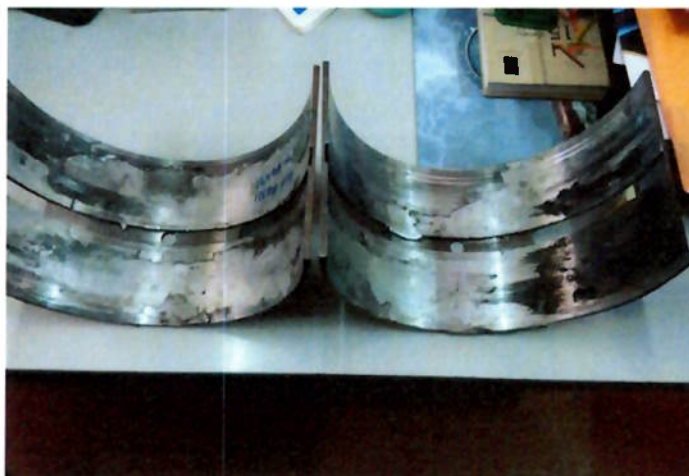
**Big End Bearing No.2**

- 5) Gudgeon pin-2 was removed and no abnormalities, heating marks, etc., were observed.
- 6) ***Checked big end bearing-2, observed 70-80% erosion and removal of white metal from the parent metal of the big end bearing.***

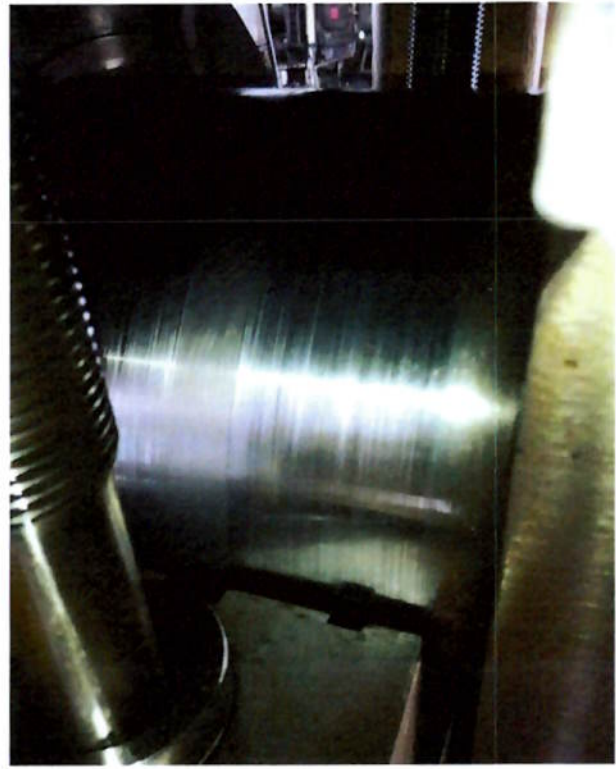
**Crank Pin Cylinder 1 & 5**

- Free spread of bearing no. 2 was negative
- Connecting rod no. 2 also have heat marks
- Damage in big end bearing no.8 observed.
- M/s Exacto Technology, Coimbatore has carried out hardness profile mapping and Magnetic Particle Inspection (MPI) test on all crankpin. Hairline cracks have been observed on crankpin no. 1, 5 & 8 during MPI.

- Hardness of 1, 2, 5 & 8 crankpin was found more than 350 HB; in some area the hardness found to the tune of 600 HB.

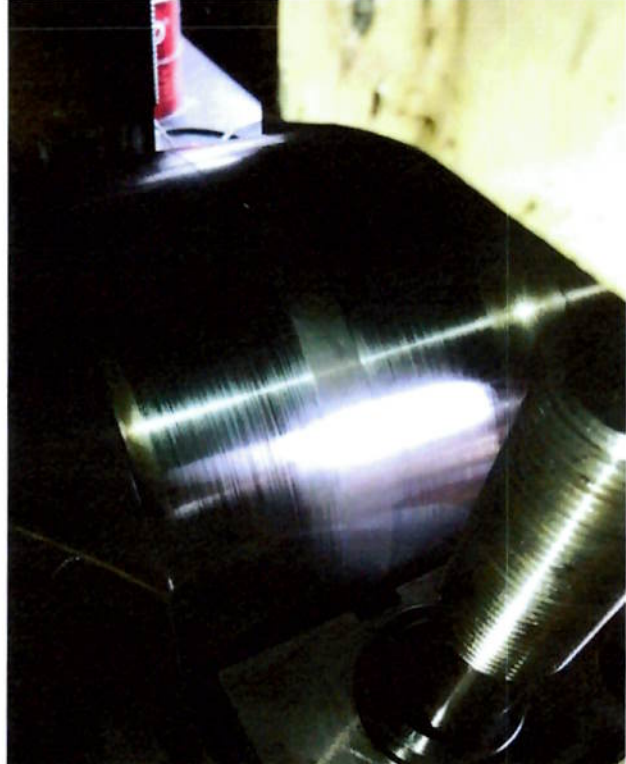
**Scoring marks on Journal**
