# **Report on Failure of MP-2 Engine at WRPL Surendranagar**

## INTRODUCTION

MP-2 Surendranagar is new 'G' series engine supplied by M/s Allen Diesels. The engine has run 83,854 hours till failure on 22.02.2023.

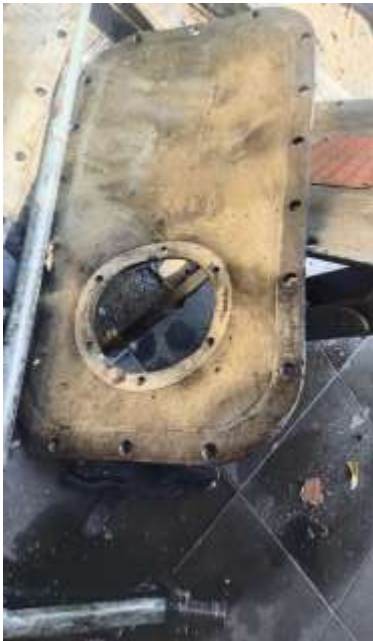
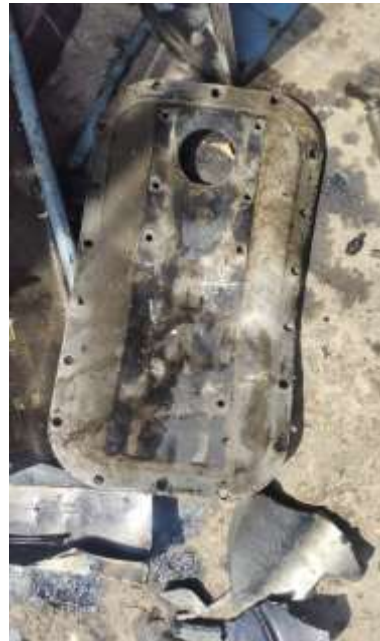
### 1. Crankcase Door

3. Jacket water found in Lube oil Sump due to which level of lube oil found increased. Lube oil also found spilled outside near UCP.
4. Bolts of right side Crankcase door (looking from engine end) of Cylinder # 4 found damaged and lying near MP-3. Ladder also found loose from bottom side.

5. Left side Crankcase door (looking from engine end) of Cylinder # 4 found loose
6. Connecting Rod of Cylinder # 4, Piston (damaged upper half) & Gudgeon Pin found outside engine near UCP.

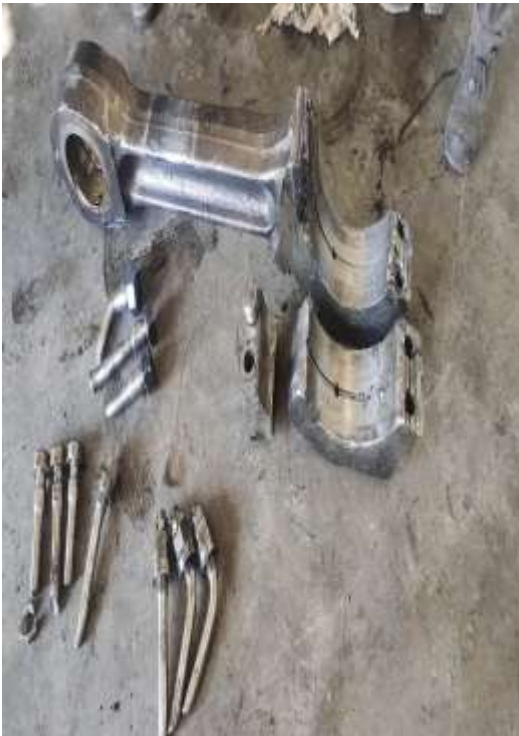
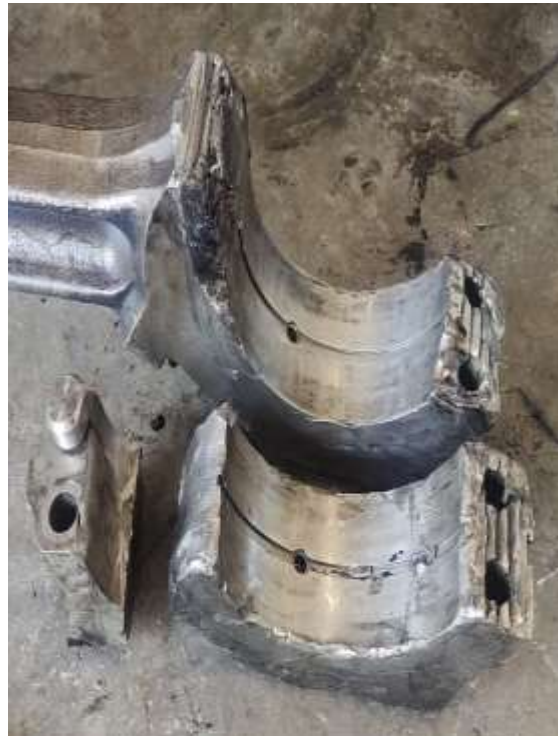
## 2. Connecting Rod

16. Serrated section of connecting rod also found damaged

5. Failure of Connecting Rod: Twisting and bending of connecting rod may result in damage to big end bearing and further damages due to seizure. However, white metal condition of bearing reflects that this type of failure has not occurred and therefore may be ruled out.

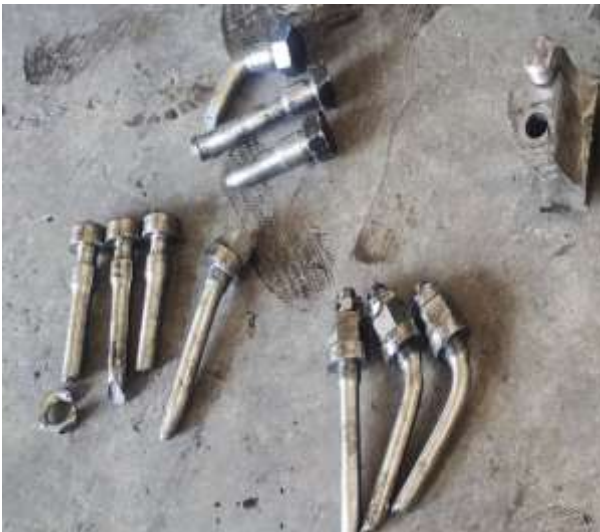
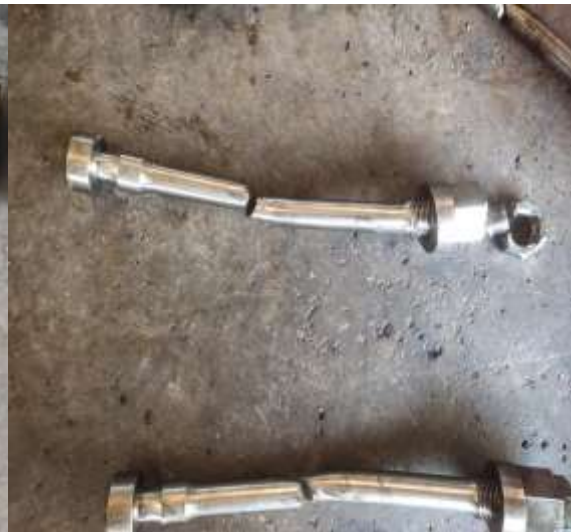
## 3. Big end Bolt

14. Damage in engine block interior is also observed due to hitting of failed metallic components.
15. Big end bolts of connecting rod broken and found in Lube oil sump (except one piece of bolt which was found with connecting rod)

8. Failure of Big end bolts: Connecting rod is in two pieces and is secured with the help of bolts (4 bolts, 2 set of short big end bolts and 2 set of long big end bolts). In the event of failure of small end bolts, load will be transferred on big end bolts. This may interfere the piston – connecting rod movement and may result in damage to lower end of liner landing insert & liner body which may result in breaking of liner from collar area. The failure of liner may result in free movement of piston and failure of big end bolts subsequent to elongation. During further inspection, Cylinder head no. 4 was found loose which may be due to stress cause by water leakage & mist generation inside engine chamber. This might have cause slight mis-operation of cylinder head valves resulting in bending of the push rods. Top end of connecting rod may damage lower part of piston and bottom end of connecting rod may damage counterweights. Subsequently, due to rotation of crankshaft owing to combustion in other cylinders, top end of piston, Gudgeon pin and connecting rod may be thrown due to centrifugal action. These assemblies hit the crankcase door, sheared the bolts and may eventually get thrown outside engine body. Failure in liner may result in water leakage and low jacket water pressure finally tripping the engine and OMD was activated with purging of CO<sub>2</sub>. Big end bolts may be sent for failure/metallurgical analysis to substantiate it.

1. Performance analysis of engine may be carried out properly in line with recommended guidelines and SOPs.
2. Cylinder liner, Piston and Big/small end bolts may be sent for failure analysis. These components may be tested for chemical composition and metallographic structure investigation (to analyse the macro and microstructures), Tensile tests, hardness and impact tests (to analyse mechanical properties) , finite element analysis (to evaluate the overall stress distribution with maximum stress criterion to check high stress concentration, fatigue & fracture analysis).
3. Matter may be taken up with OEM also regarding reasons behind failure of engine components.

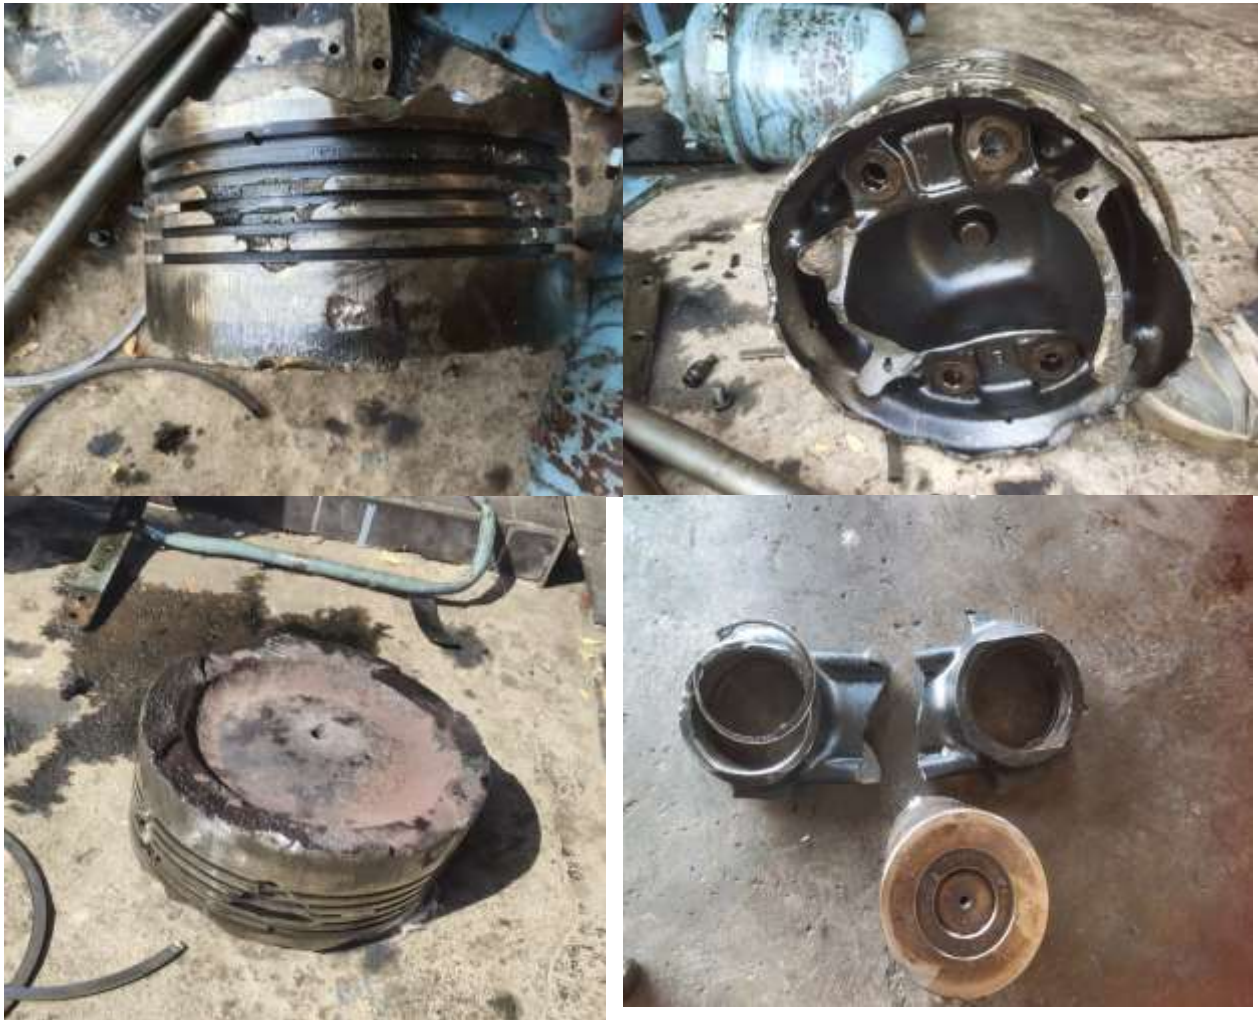
#### 4. Piston

9. Pieces of lower part of Piston found in Lube oil sump.
10. Major indentation marks observed on Crankpin # 4 on one side & minor indentation marks on other side.

1. Failure of Piston /Gudgeon pin area – Connecting rod is secured with Piston through Gudgeon Pin and circlip. It has been observed that Gudgeon was also lying outside the engine body along with connecting rod. Also, top end of piston and cylinder head assembly was not having major damages. Moreover, Gudgeon pin was found in good condition. Therefore, possibility of failure of Gudgeon pin or piston cavity at Gudgeon pin area is less likely, however it may result in failure at lower part of connecting rod, piston and crankpin. Therefore, though the probability is less likely, Piston and Gudgeon pin cavity may be sent for failure analysis.

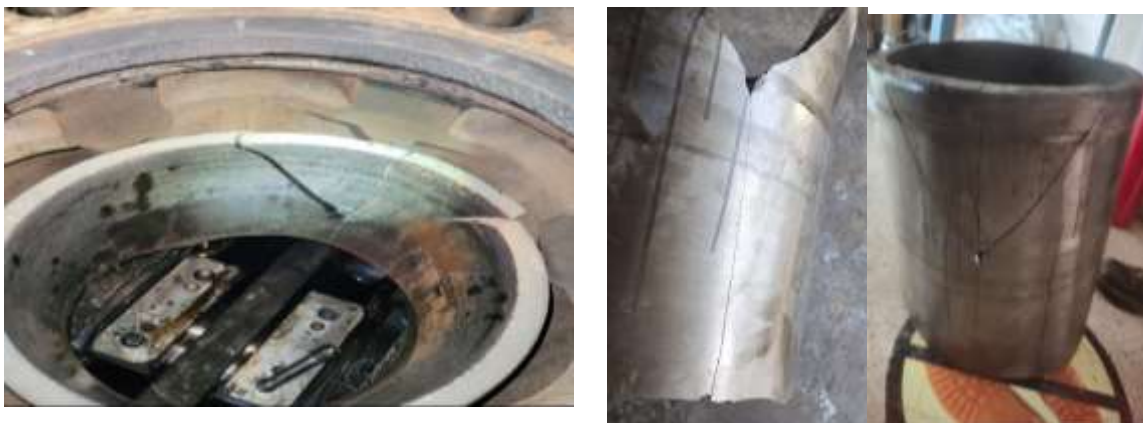
#### 5. Cylinder Liner

7. Collar of Liner of Cylinder # 4 separated from cylindrical portion. Liner found loose and dropped by almost 7 inch.
8. Both the push rods of Cylinder# 4 found bent (one push rod was more bent)

9. Failure of Cylinder Liner: Upon inspection, it was observed that Cylinder liner collar was broken and cylindrical portion lowered in cylinder # 4 by almost 7 inch. Failure of liner may result in water leakage and low jacket water pressure. Cylinder liner may get hit due to movement of crankshaft and damages at lower end. This may interfere the piston – connecting rod movement and may result in damage to lower end of liner. The failure of liner may result in free movement of piston and failure of big end bolts. After this, same phenomenon and sequence of events as mentioned above in point no. 8 may happen in this case too. Though, failure of liner from collar area and dropping of it by 7 inch may happen only after damage to liner landing insert, and reason for same could not be evidenced. Cylinder liner may be sent for failure/metallurgical analysis to substantiate it.

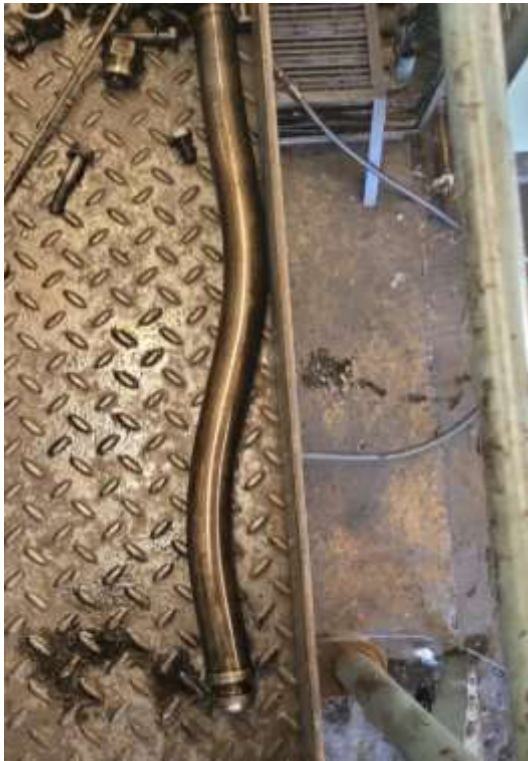
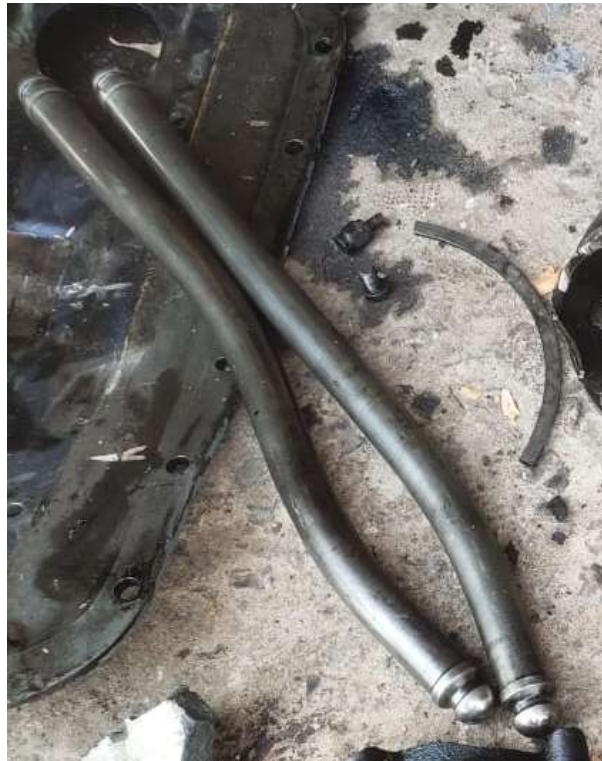
## 6. Push Rods

2. Failure of Push-rod: - Failure of push rod due to buckling load may interfere with normal cylinder head valve operation and cause subsequent failures. However, Cylinder head was found ok during hydro testing and valve operation was also found smooth. Piston top surface is also found in good condition except for some minor marks at skirt area. Therefore, failure due to push rod not seems to be primary reason attributable to failure.

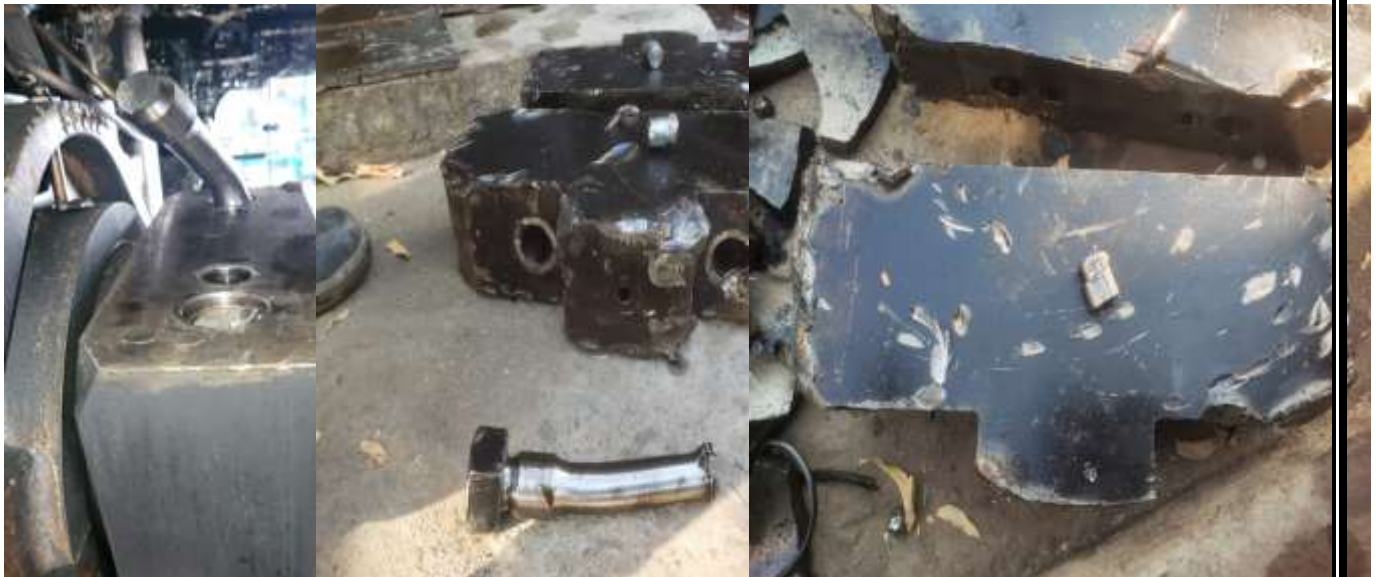
## 7. Counter weight of Crankshaft

11. Cylinder Head # 4 found loose.
12. Minor damages observed in Rocker arm assembly.
13. Bolts of Counterweights of Cylinder# 4 found broken and both the counterweights found in lube oil sump.

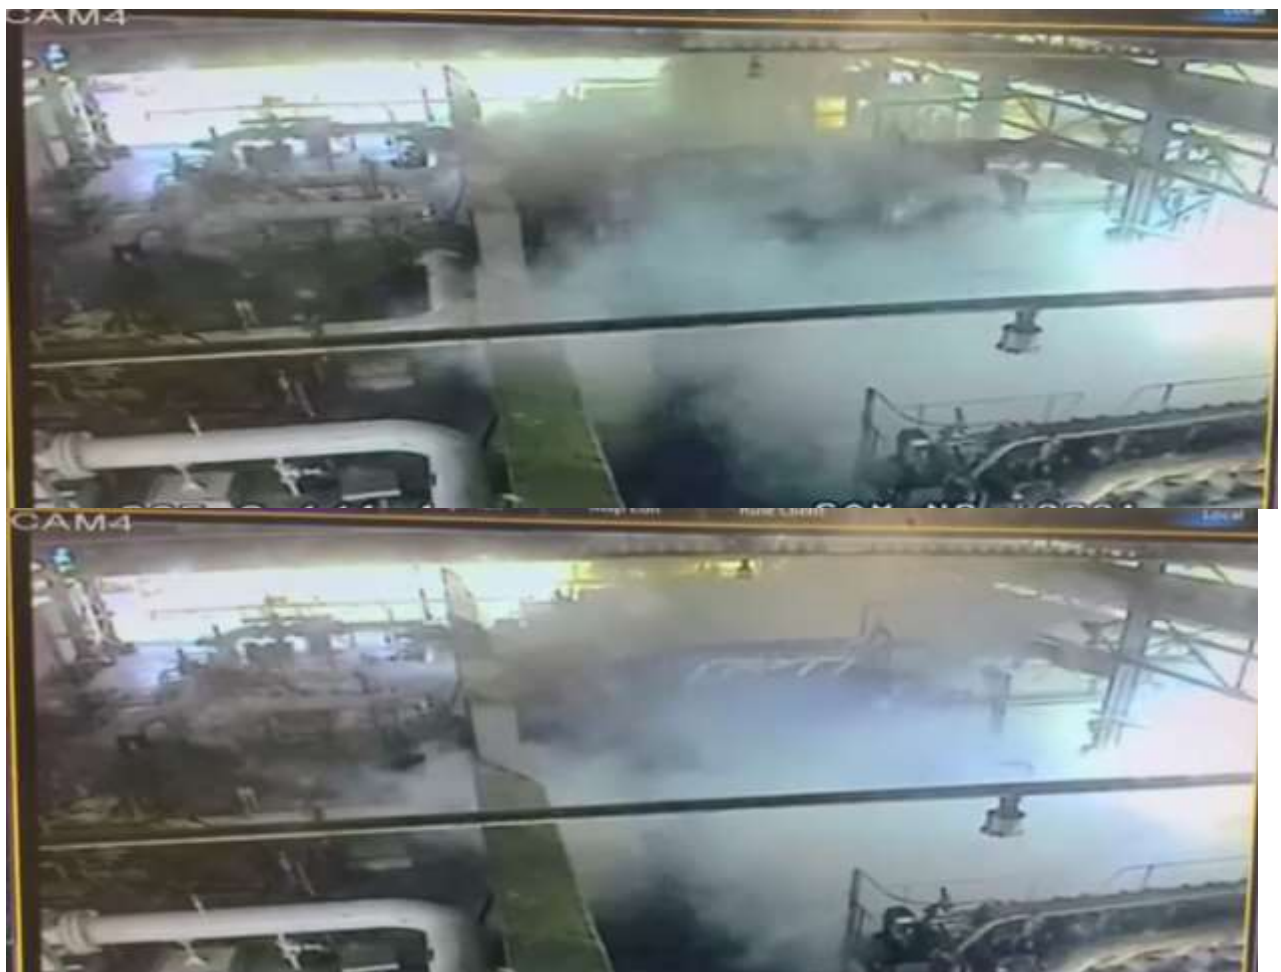
## 11. CO2 Purging

1. MP-2 was started at 12:02:40. Engine was running with stable parameters and suddenly tripped at 15:55:20 Hours along with abnormal sound.
2. MP-2 OMD fault recorded in SCADA at 15:55:29 & CO<sub>2</sub> found purged.
