Climatically Induced Insulation Degradation in Power Semiconductor Modules of Wind Turbines

Abstract

Power converters are among the most frequently failing subsystems in wind turbines. Humidity-induced degradation plays a key role, especially in locations with geographically high absolute humidity. In a laboratory experiment, a failure of a power module induced by humidity and condensation could be replicated under extreme climatic conditions.

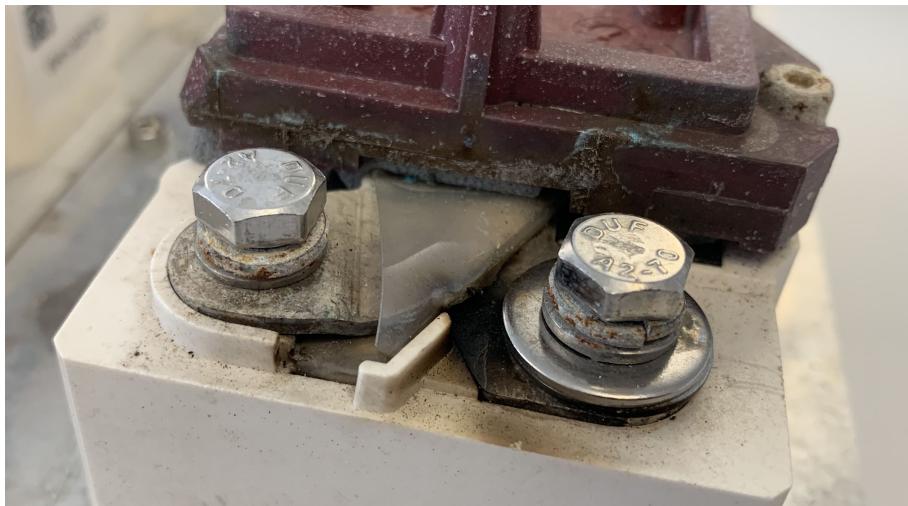
After the removal of the damaged submodule from the test bench, significant, visually recognizable damage can be observed, see also Fig. 5 and Fig. 6. Residues from repetitive water condensation are found on the surface of the entire submodule. Metallic surfaces have undergone corrosive processes, particularly visible on screw connections and load terminals. The insulation foil which is folded between the DC terminals of the module has lost its insulation properties due to partial disintegration, see Fig. 6 (b). It is likely that the presence of condensed water in combination with the voltage between the terminals has driven the degradation process. We suspect that the low resistance path that formed due to the degradation of the film resulted in an increased temperature at the spot and that the temperature impact finally became severe enough for carbonization to occur.

Fig. 5: Close-up image of the damaged insulation foil between the DC contacts.

The disintegrated area on the foil is located at the folding zone of the foil between the two busbars. There is also massive damage to the housing of the power module in the form of melted plastic and black stain at this point, see Fig. 6 (a).
