## Case Study on Major Incidents

**Case Study No.:** PNGRB/Tech/2026/11

**Type of Installation:** Gas Processing Plants/Units

### Incident Title : 181 minutes fire due to hydrocarbon leakage in Slug Catcher Area

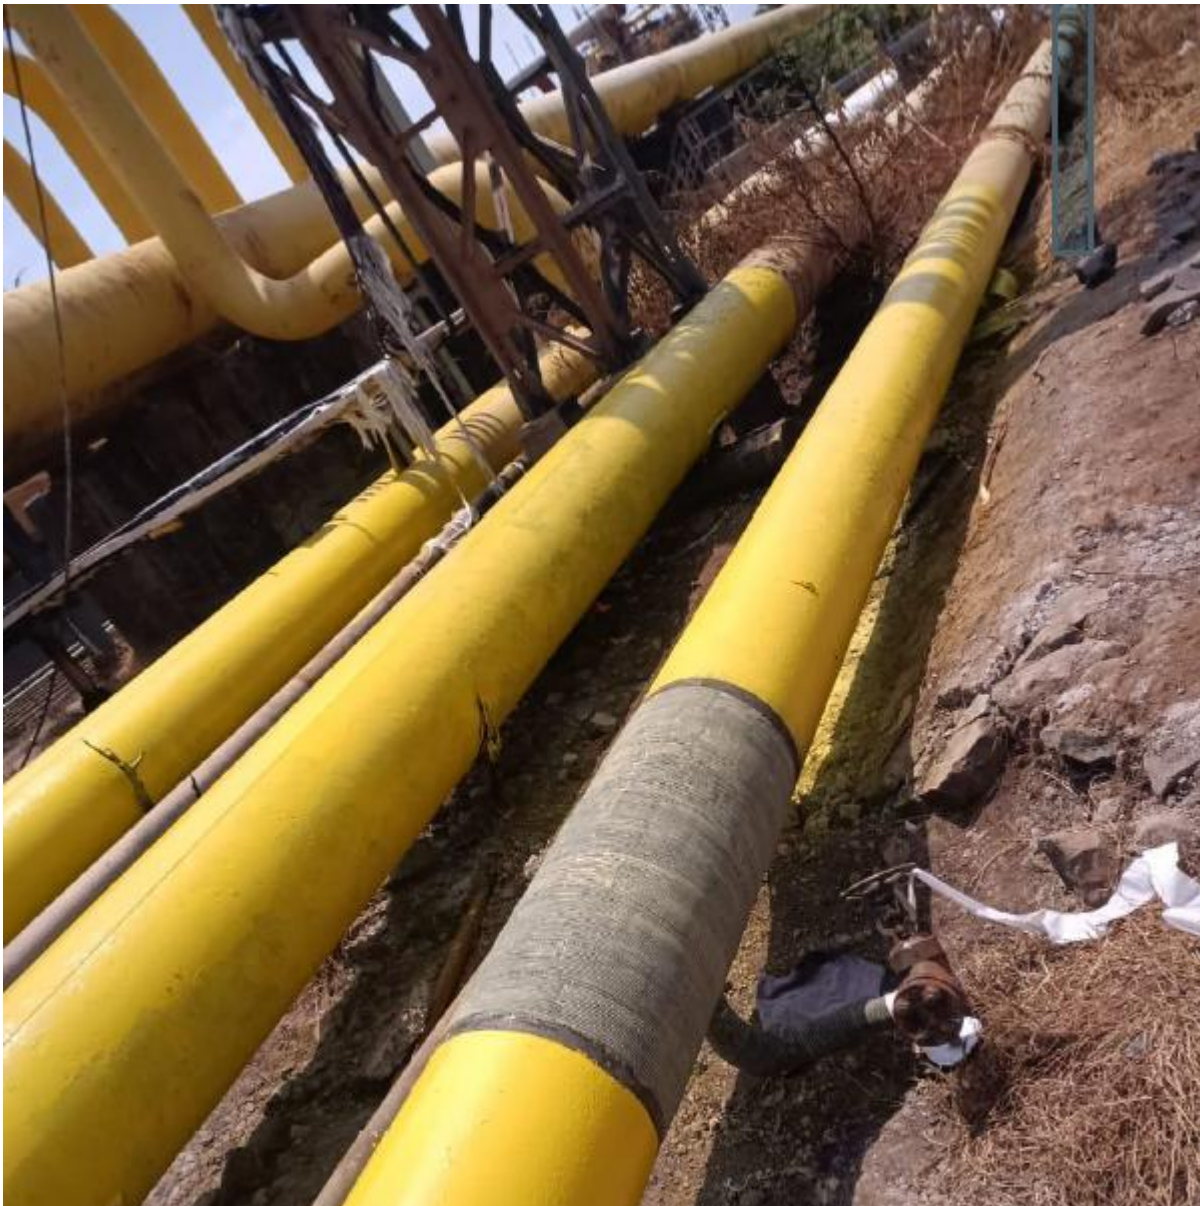
**Brief Description:** An incident of hydrocarbon leakage followed by fire occurred in the slug catcher area of an oil and gas processing facility during excavation activities being carried out as part of a revamping project. The leakage originated from a small drain point connected to a live high-pressure gas pipeline.

At the time of the incident, an excavator was operating in close proximity to the pipeline. The excavator bucket struck the protruding drain point, resulting in sudden release of hydrocarbon. Multiple HC leak detection alarms were activated immediately, and evacuation of the affected area was initiated.

Within a few minutes, ignition occurred from a nearby operating unit, leading to a fire. Emergency response actions were promptly initiated, including isolation of the affected pipeline section, depressurisation, firefighting, and shutdown of adjoining units. The fire was contained within 30 mins and fully extinguished later. No injuries or fatalities were reported.

1. Excavation activity was undertaken in close proximity to a live high-pressure gas pipeline without adequate physical protection.
2. Protruding drain point connected to the pipeline was vulnerable to external mechanical impact and was not adequately safeguarded.
3. Heavy excavation equipment was allowed to operate near the pipeline without sufficient risk assessment or defined exclusion zone.
4. Permit to Work (PTW) issued for the activity was generic in nature and did not clearly identify the specific hazards associated with excavation near live pipelines.
5. Mandatory clearances from relevant technical disciplines prior to excavation were not effectively ensured.
6. Job Safety Analysis lacked clarity on individual responsibilities for implementation of control measures.
7. Adequate on-site supervision of contractor activities was not evident during execution of the work.

1. **Inadequate risk assessment** and planning for excavation activities in a pipeline corridor.
2. **Non-compliance with permit-to-work** requirements and ineffective implementation of job safety controls.
3. **Absence of physical protection** for exposed pipeline drain point.
4. **Inadequate supervision** and control over contractor activities.
5. **Weak enforcement of safety management systems** during project execution.

1. Excavation activities near live pipelines shall be permitted only after detailed risk assessment and implementation of adequate protective measures.

2. Physical guards, barriers, or encasements shall be provided to protect vulnerable pipeline appurtenances such as drain and vent points.
3. Use of heavy excavation machinery shall be restricted within defined buffer zones around live pipelines, and manual excavation shall be adopted where required.

4. Permit to Work system shall be strengthened to ensure permits are specific, hazard-focused, and strictly complied with.
5. Mandatory joint site survey involving operations, engineering, safety, and contractors shall be carried out prior to commencement of excavation activities.

6. Effective on-site supervision by responsible engineers shall be ensured during execution of high-risk jobs.
7. Contractors' personnel shall be adequately trained and sensitised regarding hazards of working in hydrocarbon installations.
